The unit illustrated is an early Shopsmith Inc. gray version with the older Magna castings. The stickers are original and were carefully removed then reattached after painting. There are two other differences between this unit and newer vintage, and those will be pointed out below. The new paint colors are my personal preference - gold and coppertone from Rustoleum(hammered).

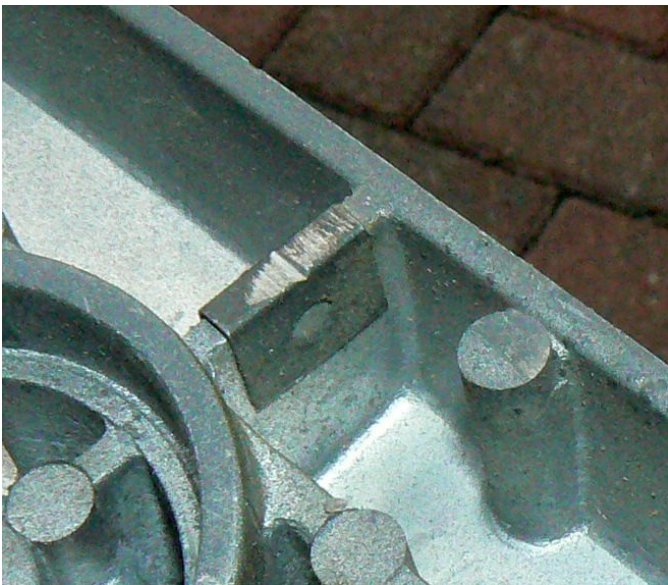
On the back side of both castings there are two clips on each that serve as sacrificial lambs when the belt tracks too close to either side. The hardened tinnerman clips will last longer than the softer aluminum casting.

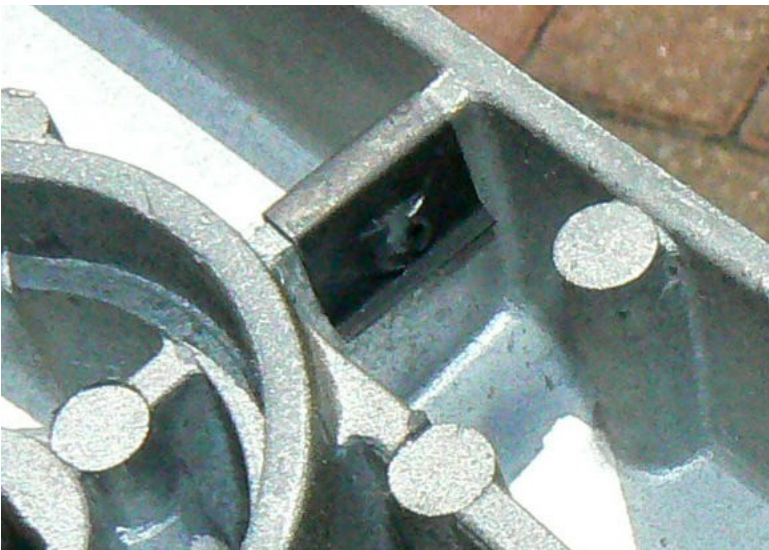
I pried the originals off and replaced them with new clips.

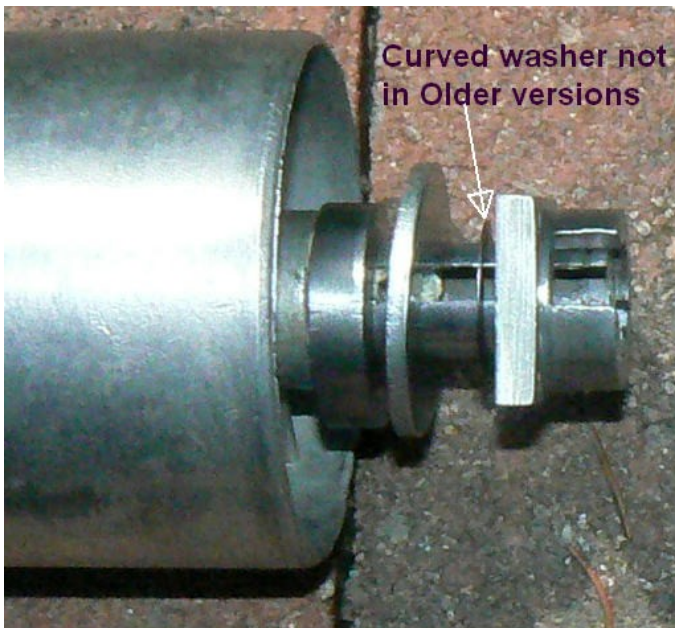
The 'knob' end of the idler drum has two or three parts to put back on. The large flat washer goes on first. Then on newer versions, a curved washer followed finally by the 'guide bushing'. The idler drum was cleaned out of old original grease and replaced with lithium grease. Not easy to do, but the ends will pull out(under spring tension) and provide access to the grease and each end of the shaft where the bearing bushings contact the shaft. Need extra hands or vise to do that.!

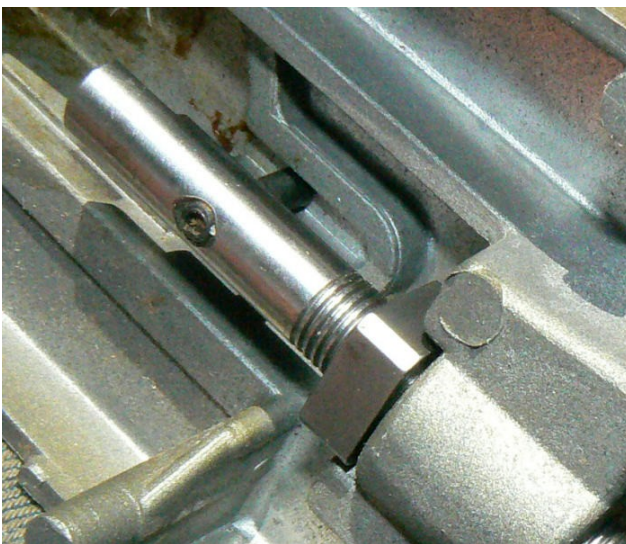
As promised a pix showing the fixed tracking screw roll pin properly inserted with the roll pin facing out into its groove.

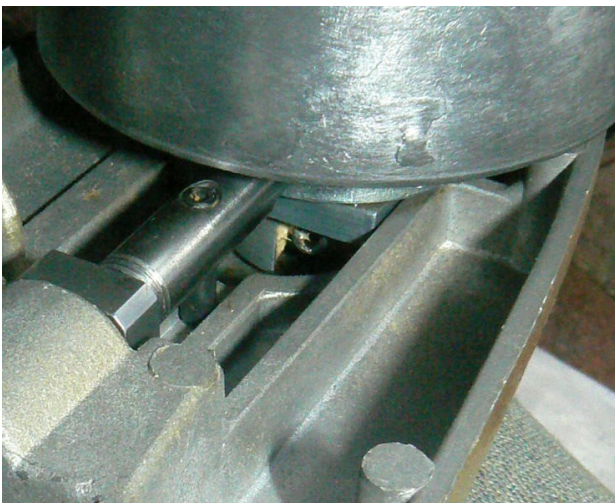
Finally the idler drum etc. installed in the casting. Notice the tracking screw is inside of the large flat washer so as to properly contact the tension cam. The guide bushing is riding in its slot and the tension pin is in its groove.

Not shown, but the drive drum bearing was never removed from the non-adjustable side casting we have been working with.(see 1st pix post #1). With that casting positioned so that the both drums(the drive drum is also inserted into its bearing) face up, we will now address the 'other' end of the idler drum.

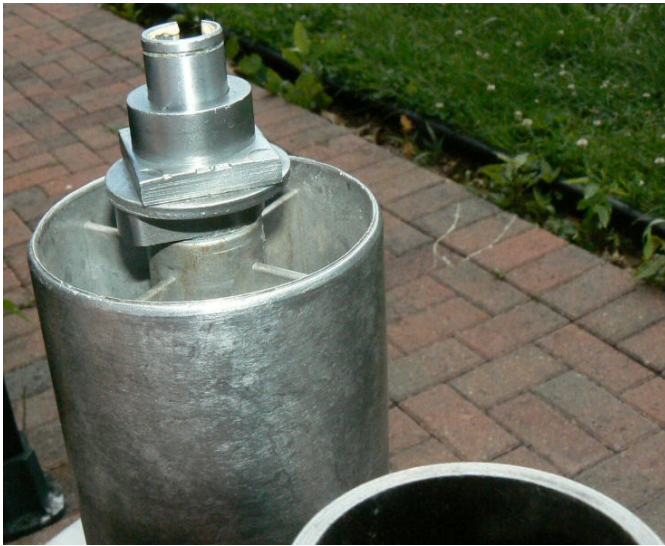
Insert both spacers in their bores and position the guide bushing so that the long sides run front to rear(so it will fit into the slot in the second casting).

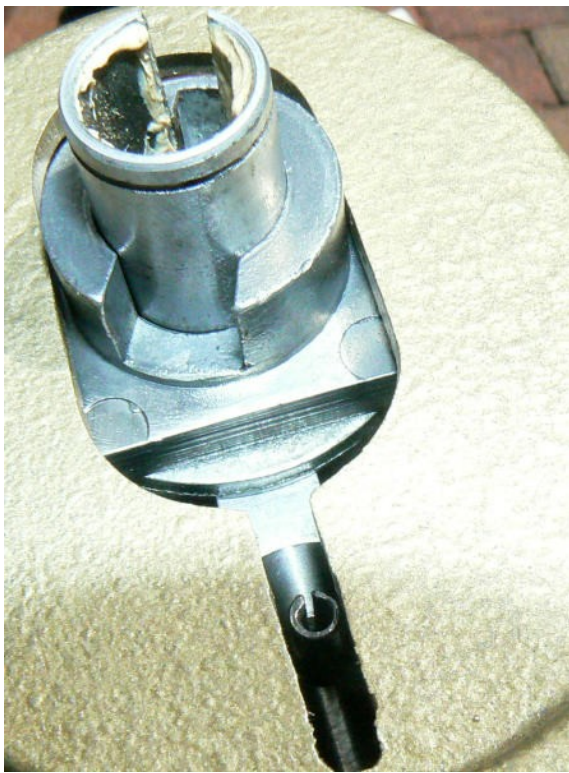
After sliding the casting onto the drive drum shaft and the two spacers and the guide bushing, the idler shaft etc. should look like this.(Yes all that at once is a bit of a challenge, but perseverance will get it done) Notice the tracking screw roll pin, the tracking screw end and the guide bushing are all in the proper place.(Just like the other side).

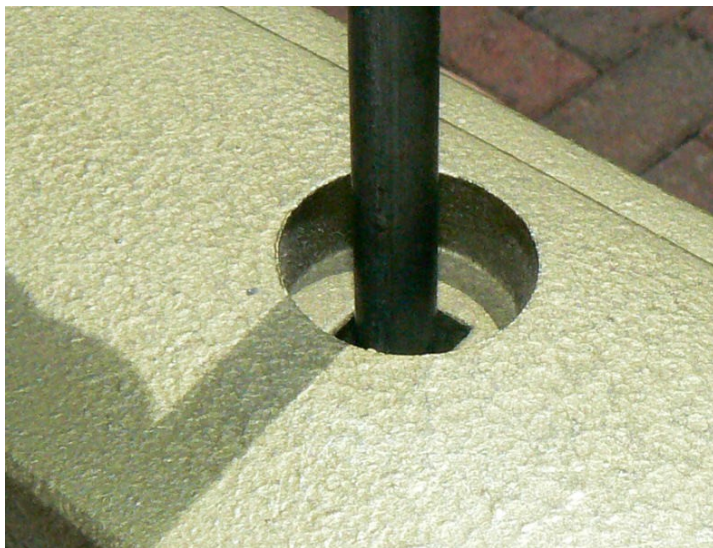
If the bolt is held vertical over the square hole in the casting and the assembly is positioned correctly, the bolt will drop straight down into the hole on the opposite casting.

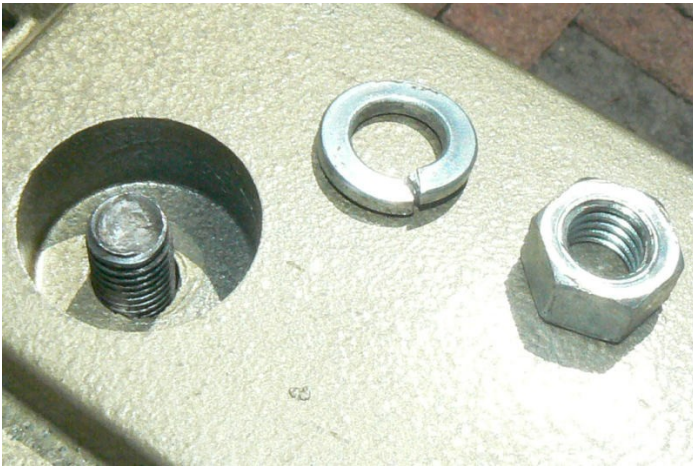
Pretty obvious, but the lock washer goes on first followed by the nut. At this time only finger tighten the two nuts.

The tension release knob slips onto the idler drum shaft, but make sure the knob is oriented to the slot in the shaft.

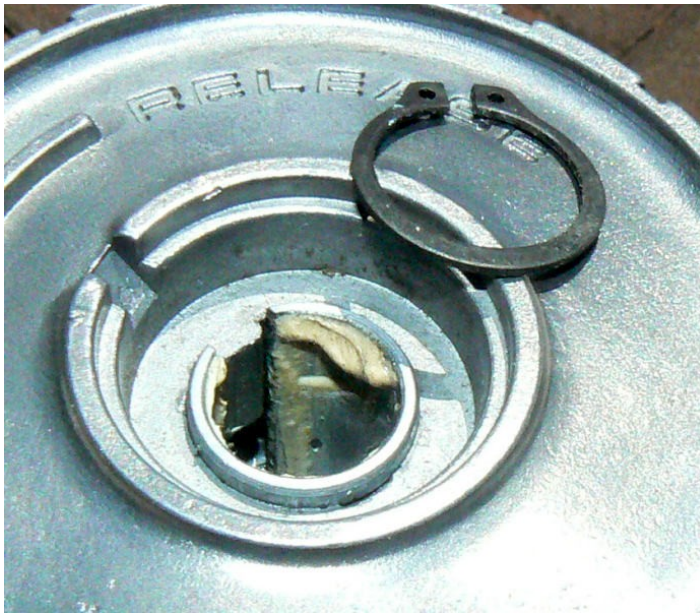
The knob is retained onto the shaft by an external ring that fits into a shallow groove near the end of the shaft.

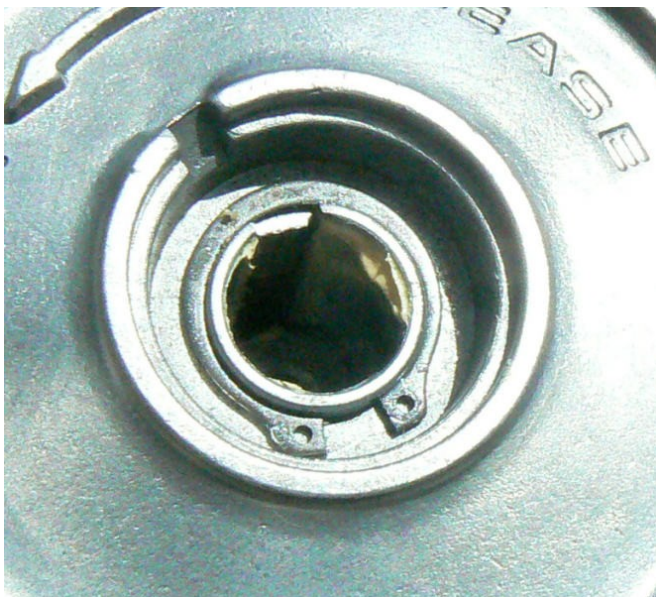
I think it a good idea to position the open end of the ring away from the open slot on the shaft.

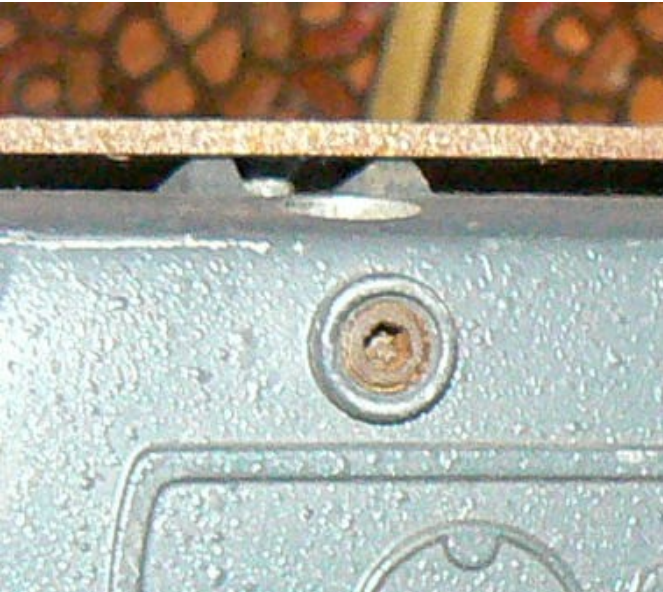
This pix is of a newer version and shows the platen mounting tabs are raised above the side of the casting. This eliminates the need for the 12 spacer washers(shown below) used in this older version. Yes the rust indicates it resides in the 'to do' pile.
