Mark VII - Another journey begins

Breakdown and reassembly efforts with a Mark VII that I am restoring – original post by JPG

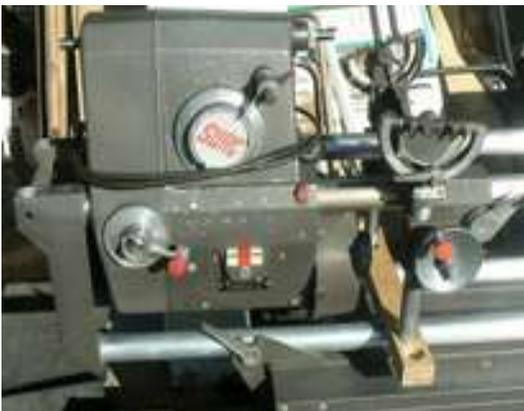
Tis a bit different since the lower tubes always travel with the way tubes. The table tubes in this case maintain the tube spacing rather than raising the way tubes on one end for headstock removal.

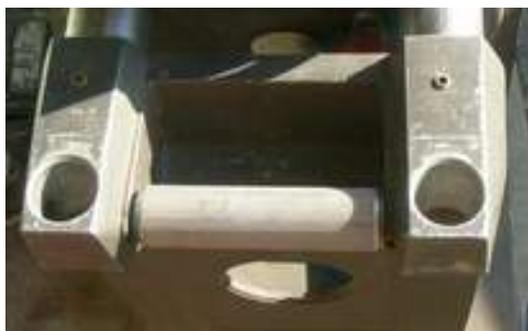
Hmmmmm! Where have I seen way tube retaining screws on top of the end castings before?:rolleyes: There is another set on the bottom of the casting that secures the lower tubes.

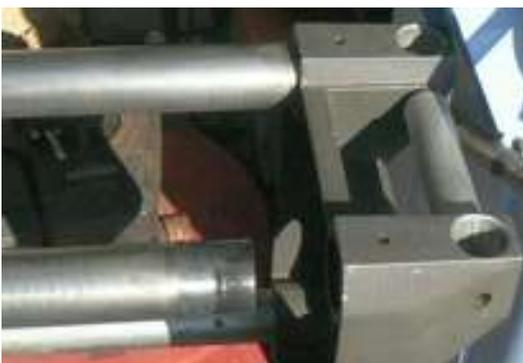
After a bit of selective tapping and pulling, the end castings came off.

In this case any of the four tubes can create a jamming situation, so small increments of motion is needed.

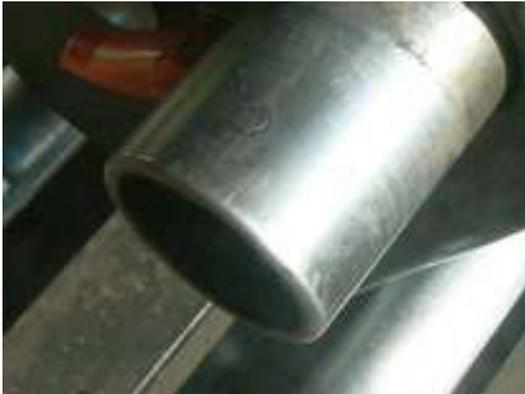
Next step was pull the headstock off the end of the way tubes. Doing so created a surprise! One of the way tubes pulled out of the other end casting. Reminds me of the common M5/V loose bench tube problem.

In addition to the set screw at the opposite end being 'loose', a burr on this end contributed to the 'pull out'.

Solution was to gently remove the burr by filing.

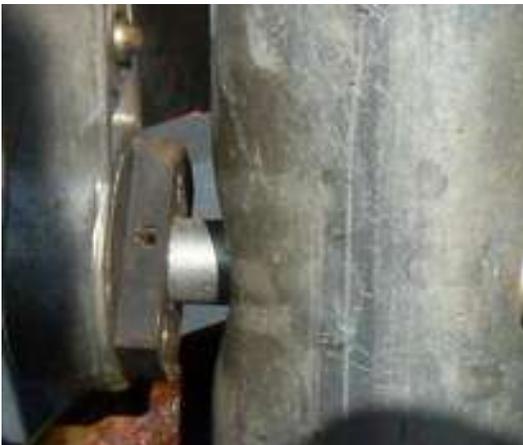
This pix shows the clamp details. The cam is secured to the clamp shaft by a tension(roll) pin. The spring loaded ball provides a lock for the shaft when the tubes are horizontal.

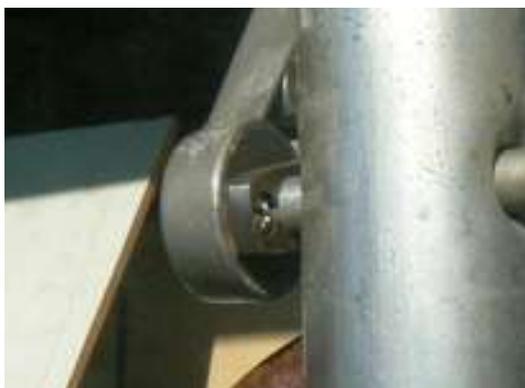
The lever is attached to the cam by a pair of screws.

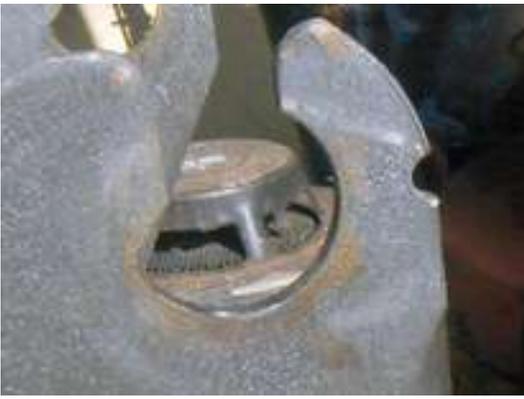
The tube clamp drops down into this 'socket' and when rotated the tubes are secured to the base. The notch supplies the detent for the spring loaded ball to drop into.

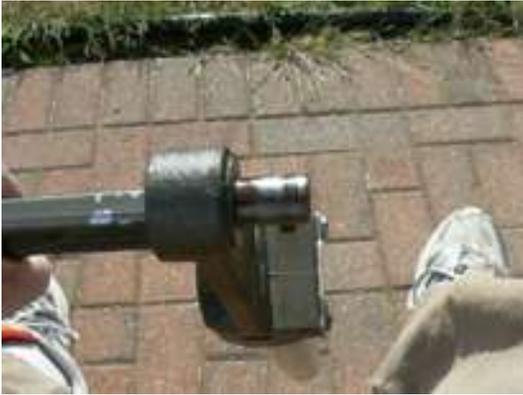
The table was very hard to move. I worked with it after removing the table and before using it to maintain way/lower tube spacing. The reason for the 'stiffness' was a buildup of crud on the pivot. Probably the result of using grease on the pivot.

First step was to remove the segment clamp post by backing the nut all the way out and applying considerable torque to back out the post threads in the trunion itself. The post was staked, and I will use blue loctite when reassembling. The Mark VII has two separate trunion clamps(a second one at the rear segment).

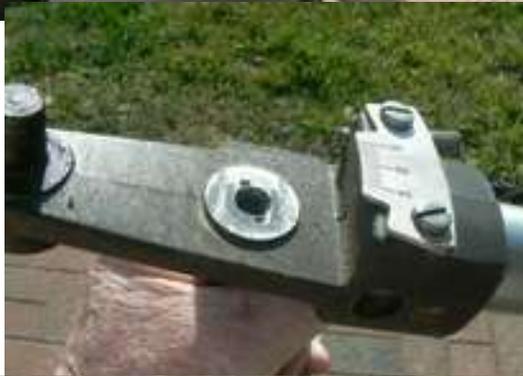
Not too clear, but the crud buildup caused the stiffness (both pivot posts).

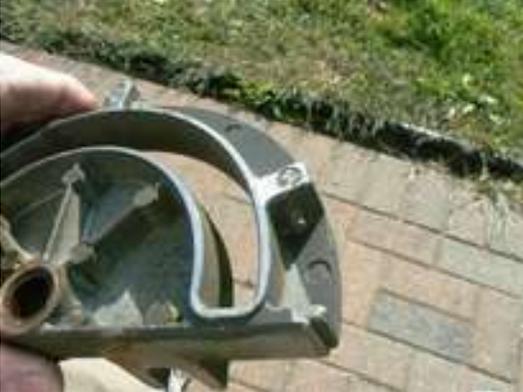
A second problem(also observed by me on other models) was a scraping noise when tilting the table. Closer looks revealed the segment was rubbing on the trunion pad that the segment clamps to. The pad showed rough wear and apparently was also initially painted. I filed the burrs off to create a flatter surface. The scraping diminished, but was still occurring at one end position.

The segment was not perfectly perpendicular to the post so it was closer to the trunion pad at one end of the tilt range. A minimal filing of the segment surface that clamped to the trunion pad eliminated the scraping. The rear segment was also scraping at the same location and was similarly filed.

You can see in the pix above where I filed the area of the segment that the stop(45 degree) screw is located. I then realized that a burr on the trunion pad was causing that. The burr was around the outer periphery of the trunion pad.

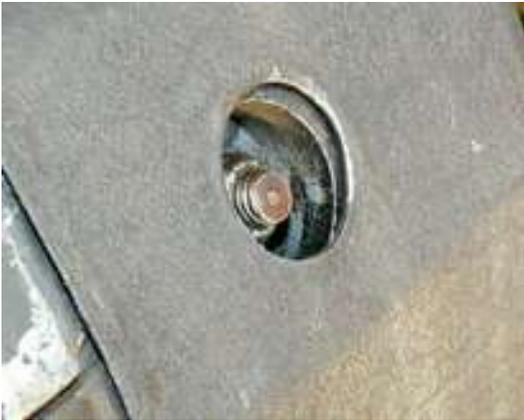
The headstock lock was 'engaged' and the interference went away.

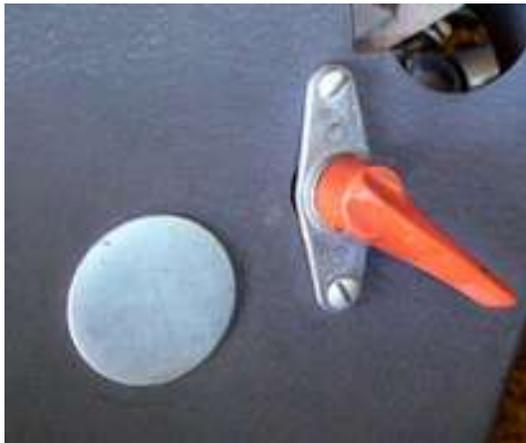
Well this is certainly 'different'. It is to disengage the drive gear that engages the gear rack on the way tube to allow positioning the headstock sans crank(just like a 'normal' SS).

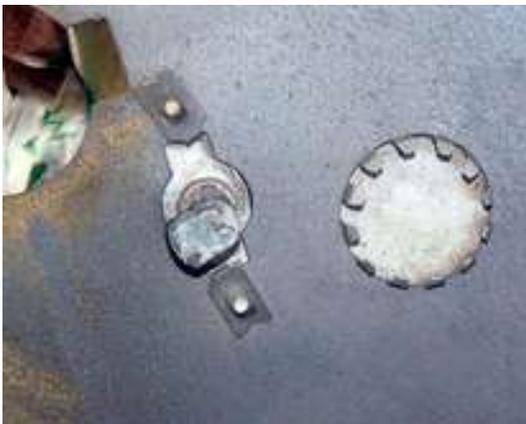
And here it is on the inside. Notice the end of the shaft has a cam. What that does will be explained later in this thread.

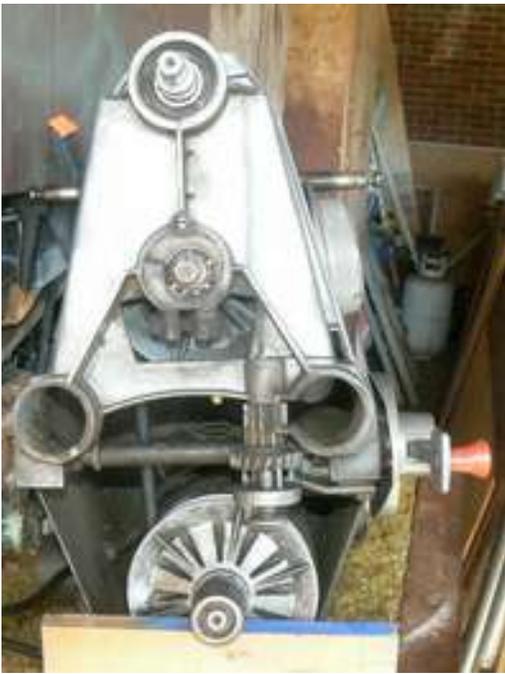
The most noticeable thing here is the larger size of the eccentric (other than those gears - more about them below).

Belt jam inside also. The eccentric can be moved to release it.

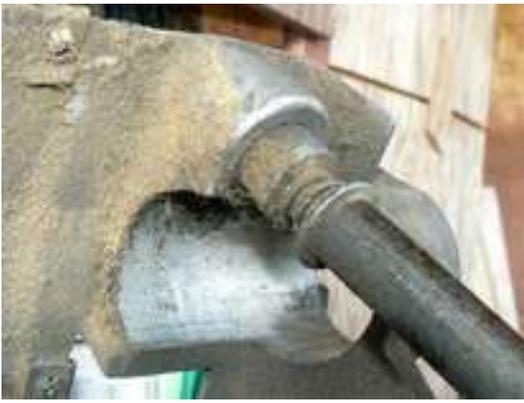
There is **only one** headstock lock and it is located at the opposite end(left) from the Mark 5/V. **Subsequent tear down reveals a second wedge between the worm gear and the headstock lateral movement crank.**

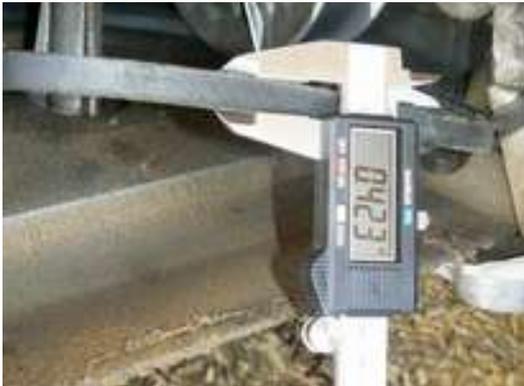
The speed control changed very little near the slow range, and wanted to jam near the fast range. The reason is shown here - badly worn belt.

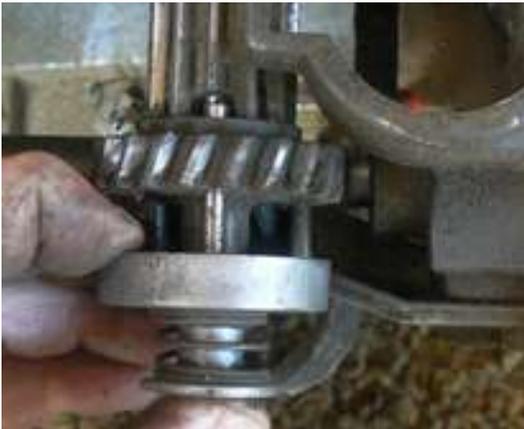
Now about those gears and the cam on the belt cover. The spur gear(on top) engages the gear rack on the way tube. The bevel gear is manually driven by a crank that also controls the headstock lock.

Notice the pin that is partially pulled down. The pin engages a recess in the spur gear. The cam on the belt cover pushes the plate below the bevel gear as I am doing manually. The cam is located between the lower plate and the bevel gear.

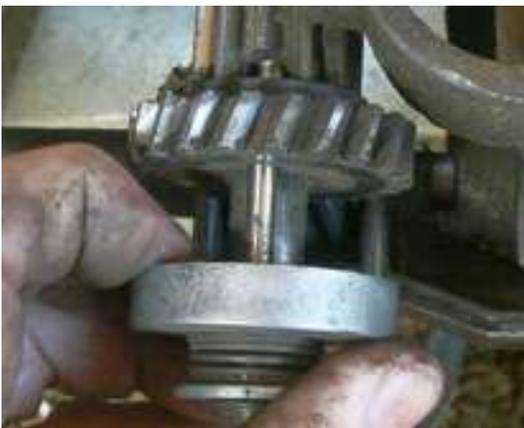
The plate when fully lowered pulls the pin entirely out of the recess in the spur gear thus allowing it to free wheel. The shiny surface in the recess is the shaft, not a pin.

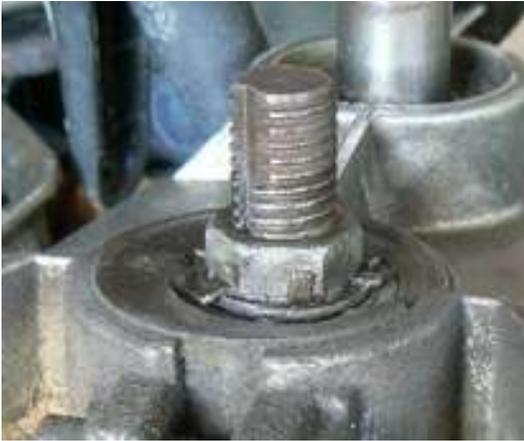
The eccentric in addition to being larger than that on a Mark 5/V appears to be split on the bottom as well. It may be two pieces as indicated by the difference in the distance extending from the bore (or it may be 'broken'). **It is NOT broken. It is ONE piece.**

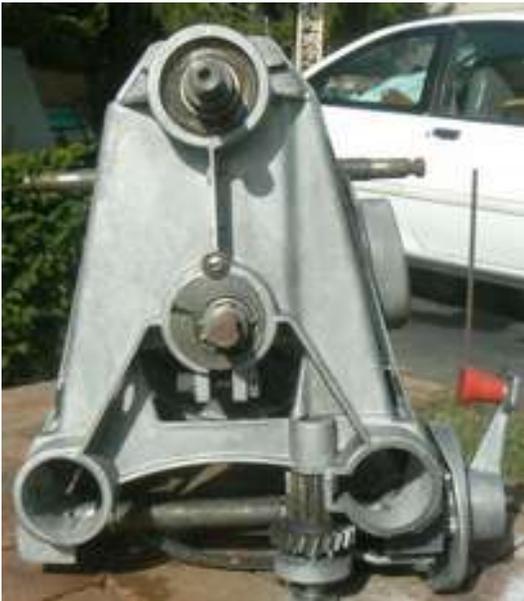
Well the idler shaft itself looks different. That nut secures the idler shaft and prevents it moving into the headstock. The 'tab' prevents the nut from loosening.

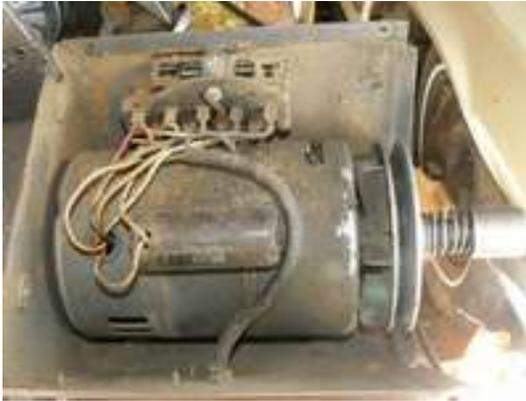
Inside motor pan(no bath yet!). A difference here is that ALL wiring is contained within the motor pan sub assembly.

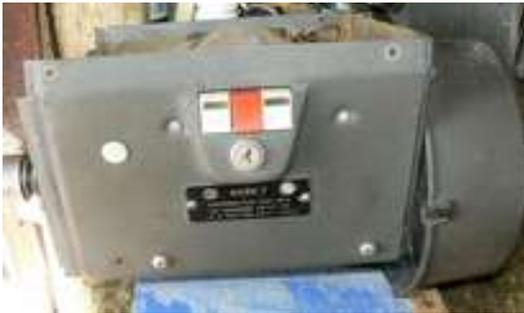
Outside motor pan. One of the mysteries is why it says Mark '7' here and Mark VII elsewhere. The three 'buttons' control forward, reverse and stop. The stop must be pressed prior to changing directions and the key switch must be set to enable either direction. The key switch is actually a mechanical interlock. Rotating the key counter clockwise allows the forward switch(on the left) to be depressed. Rotating the key clockwise allows the reverse switch(on the right) to be depressed. When the key is in the center position(and removable as shown) neither forward or reverse switches can be depressed. Thus to change directions, the stop button must be pushed, the key repositioned and the other direction button pushed.

One last 'difference' is that there are two screws in the quill end of the motor pan. The vacuum housing is in the center.

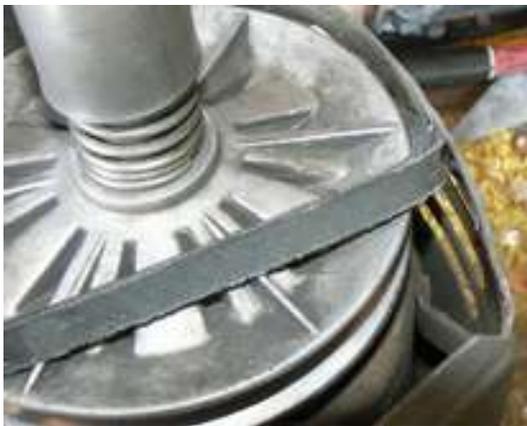
The motor belt could not be removed from the motor pulley due to close spacing to the pan.

'Solution' was to loosen the pan to motor screws which allowed raising the motor away from the pan.

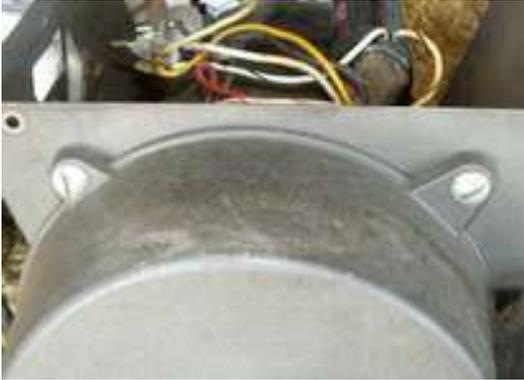
The vacuum housing is secured to the motor pan end with two large headed screws. This housing is plastic and shows some cracking. After all it is almost a half century old.

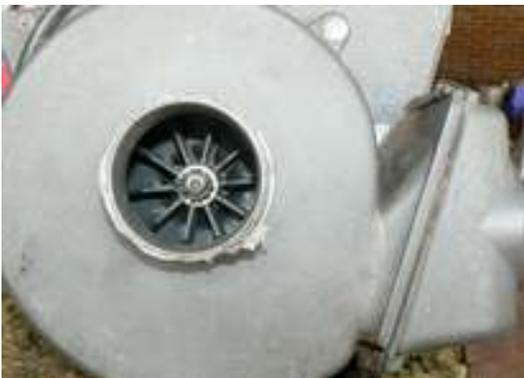
The impeller is secured to the motor shaft by a castle nut and a cotter pin.

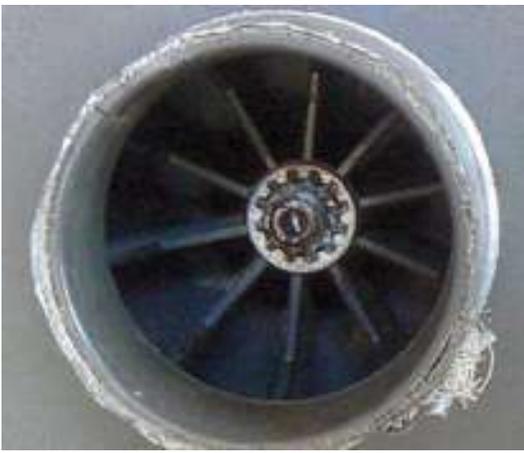
After removing the cotter pin, the castle nut was removed. An external tooth lock washer and flat washer were behind the nut.

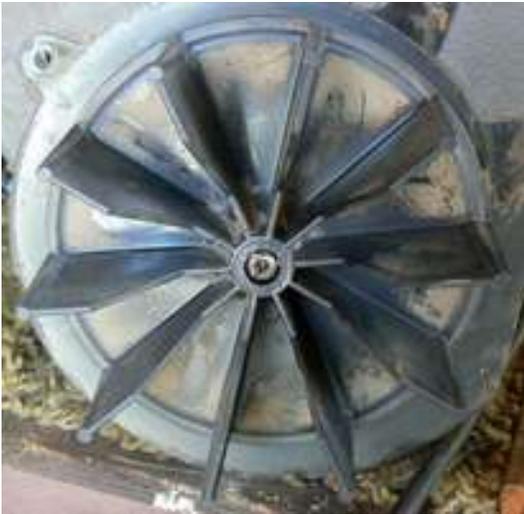
After removing the housing and exit ports, the impeller was removed. It was stubborn to pull off the shaft.

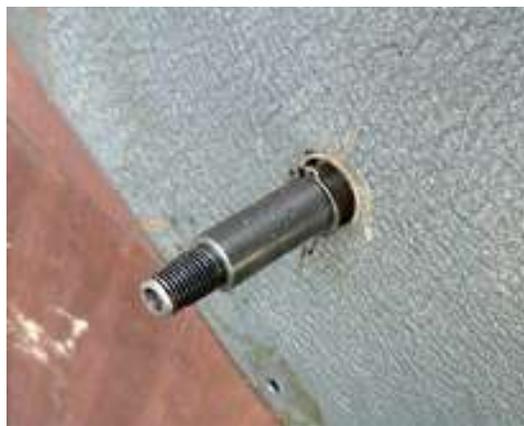
Behind the impeller was a flat washer and a retaining ring and a back plate.

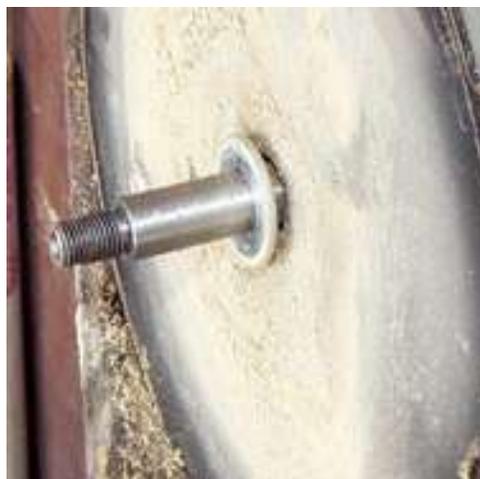
Apparently a PO decided the impeller was too loose on the shaft. These explain why the impeller did not easily slide off the shaft.

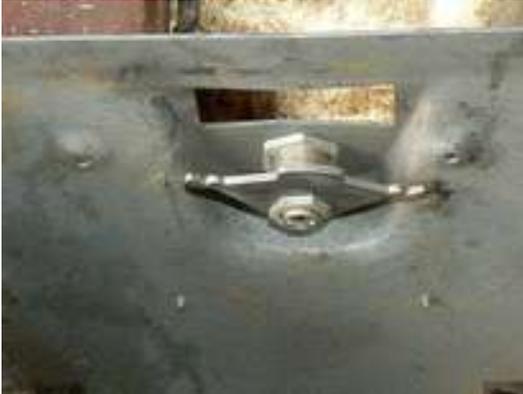
This shows the cam that is moved by the lock. The cam when moved away from the switch button(s) allows that button to be depressed.

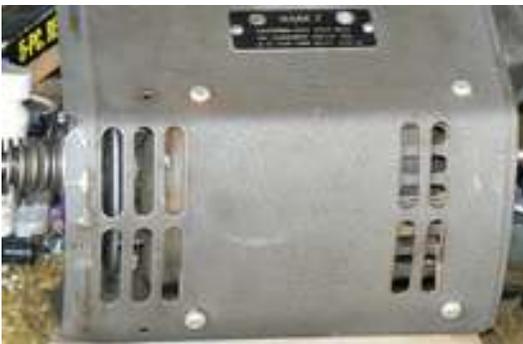
This shows the motor mount is different from the Mark 5/V in that one side is screwed to the front of the motor pan and the other side to the bottom of the pan.

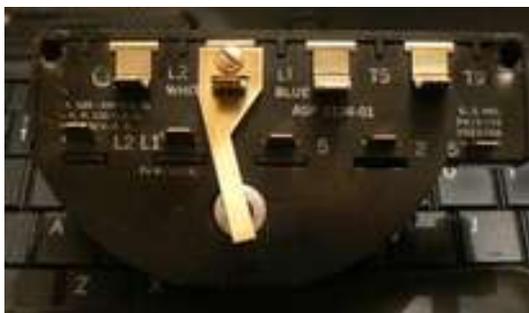
Wiring side of switch.

Line cord wires attach to lower 'L1'(black) and 'L2'(white) terminals.

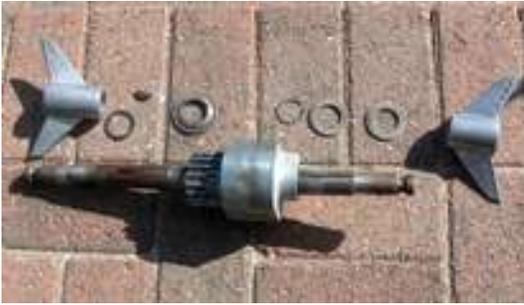
The quill lock bushing and stop dial are missing from this pix. The bushing is shown in the last pix below. As is typical for quill stops made in the 1950's, the inner serrated keyed washer does NOT have a flat washer between it and the retaining ring.

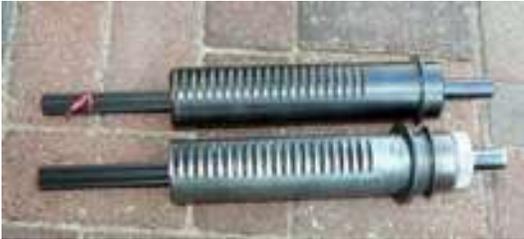
The quill at the top is a Mark V quill. The lower one is the Mark VII quill.

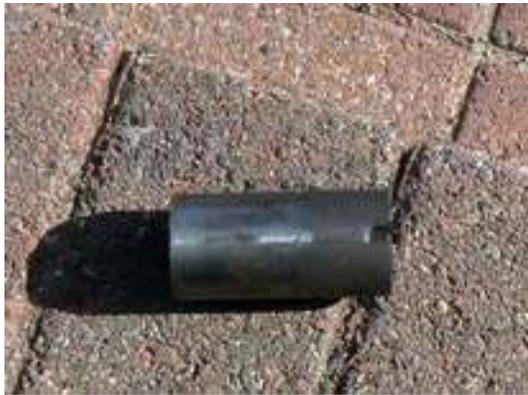
Apparently a PO installed the lock bushing forcibly with the woodruff key not fully inserted.

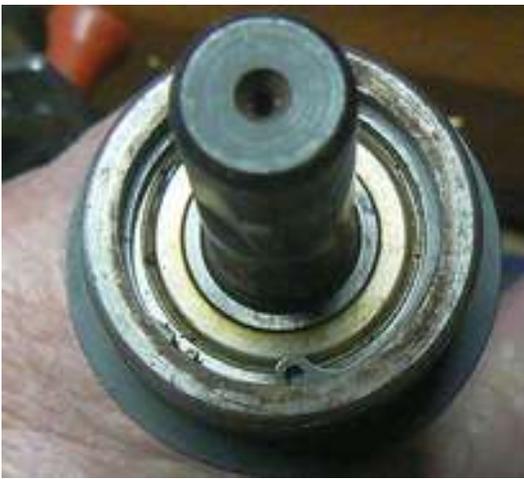
First time I have encountered a broken retaining ring.

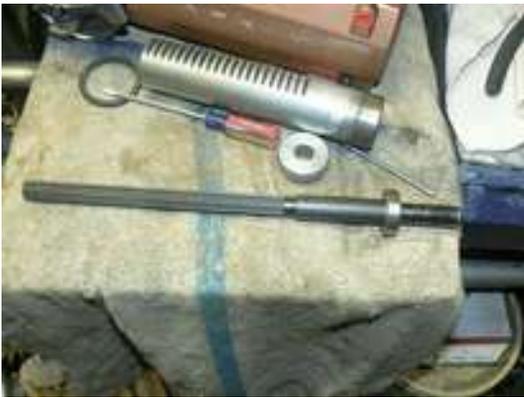
Inside is a surprise. A two piece shaft.

I am suspicious of the pedigree of this quill. The shaft is blox that is not typical of that era. The two piece quill shaft. The spline end of the shaft appears to have been cut(PO or SS????). The bearing is different from all other models(10mm width rather than 11mm)

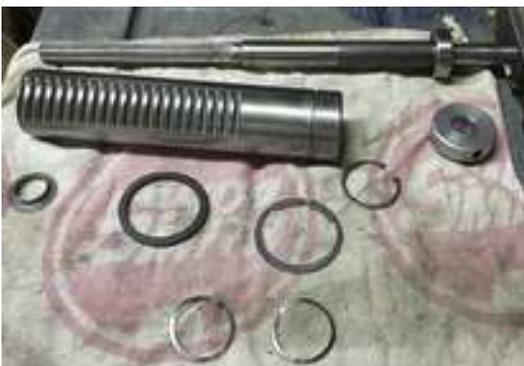
This looks more like I expected. Essentially the same as a Mark 5 of the same vintage. The splined shaft is shorter.

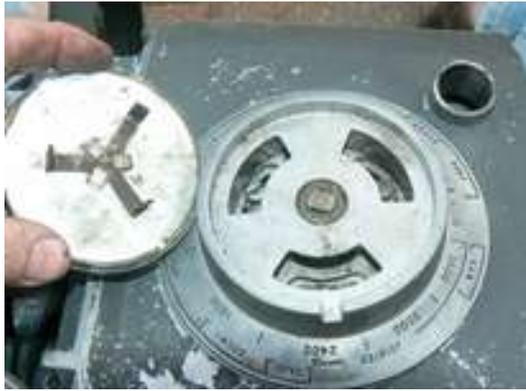
The Mark VII speed control is almost identical to the Mark 5/v, except for the method in which the control sheave is moved. A single dial is rotated by hand. That in turn rotates a cam which bears against the control sheave. Two 'bullet' detents fall into notches in the back of the dial thus preventing drifting. The control sheave has a cam follower in place of the button/bearing.

The original cam was plastic and is one of the major design flaws. This machine had it's plastic cam replaced with what appears to be an aluminum casting.

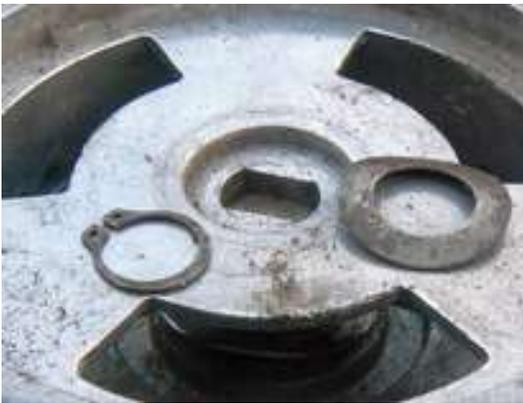
The shaft is held captive by a retaining clip and a wave washer.

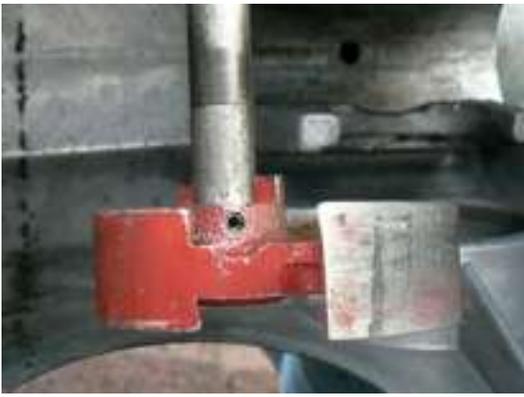
The cam is secured to the shaft by a tension pin. I refrained from attempting the remove the pin at this time.

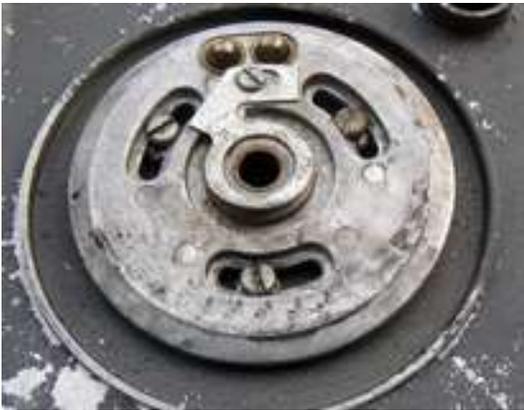
The speed control base is attached to the headstock by the three screws in the 'slots'. At this point I am not sure why the base has such a large positioning range. The 'bullet' (spring loaded detents) can be seen near the top. Perhaps the base positioning range is related to the detents. An additional adjustable stop is located below the 'bullets'. As will be seen later, a stop pin on the back of the 'dial' rides in the inner groove and the adjustable plate provides the stop. I assume the combination of the base positioning and that plate correspond to a Mark 5/V high speed adjustment and dial calibration. Realize the cam and dial are indexed by the tension pin on one end, and the double flat on the other end of the shaft.

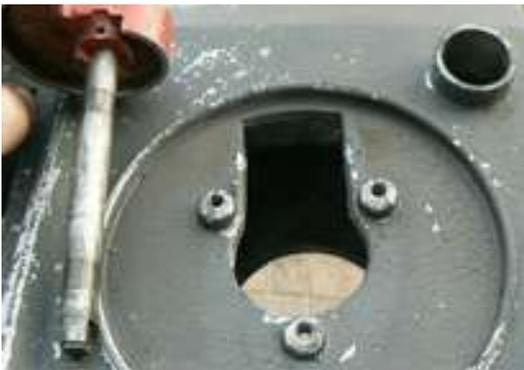
Once the base is removed, the cam and shaft become free. That large 'snout' in the earlier pix is the rear of the base.

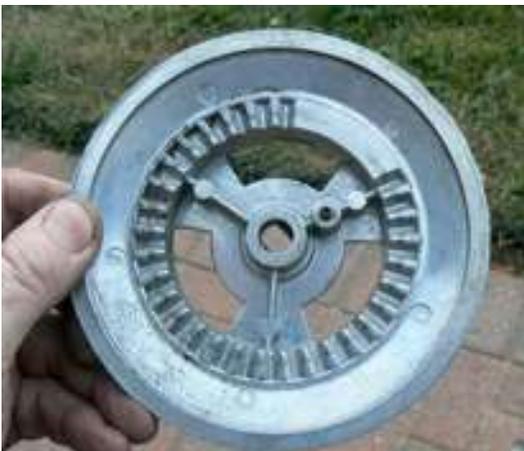
The back of the dial has the detent notches and near the center the stop pin can be seen.

I initially thought the dial need be removed to make the adjustments, but I think the 'high speed stop' screw is accessible with the dial set to highest speed, and the other three are accessible at the slowest setting as shown in the first pix.

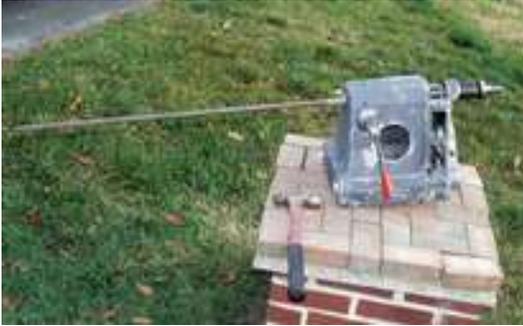
Removing the shaft was quite difficult. It was essentially glued in place. A PO had punctured the bearing seals and forced grease into them. The grease I believe migrated to the bearing/headstock gap, broke down and hardened there.

After removing both the inner and outer retaining rings I could not get it to move either out or in.

I had to seek advice from the sage in Plant City. I did not have a piece of rebar, but a cut off grounding rod worked well. I was afraid that too much force would crack the headstock - he assured me he had never had one break. He uses a 4# sledge, I used a 2# ball peen hammer.

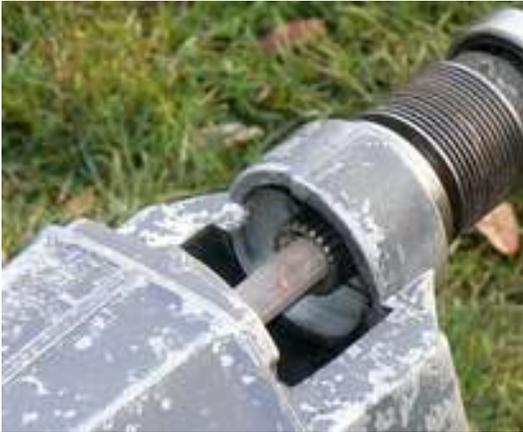
Free at last! The 'push rod' fit into the quill shaft bore and the force of striking the rod essentially pulled the shaft/bearing rather than pushing the bearing as is typically done. I had NO intention of salvaging the old bearings.

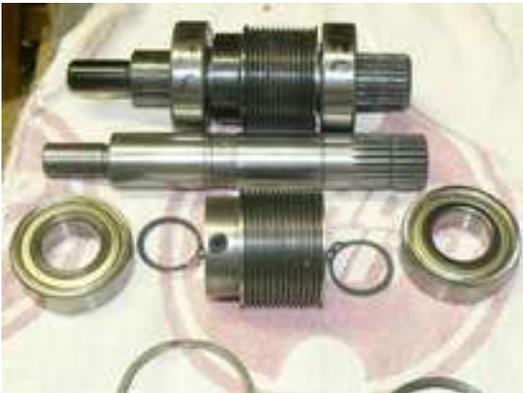
In this pix, a Mark 5/V shaft is on top, but in the following two pix the Mark VII shaft is on top. This shows the shaft disassembled and shows it is ALMOST the same as a Mark 5/V. All the parts are identical except the shaft itself which is longer on each end.

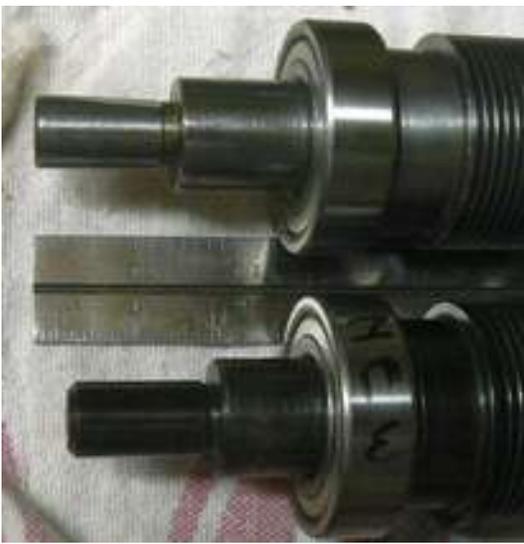
The rear shaft is about 1/4" longer.

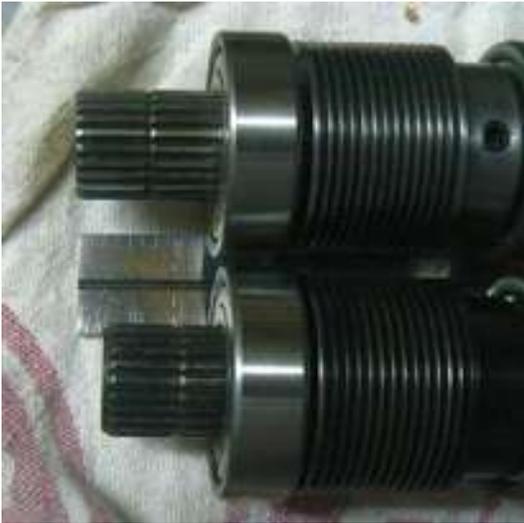
As is the quill end.

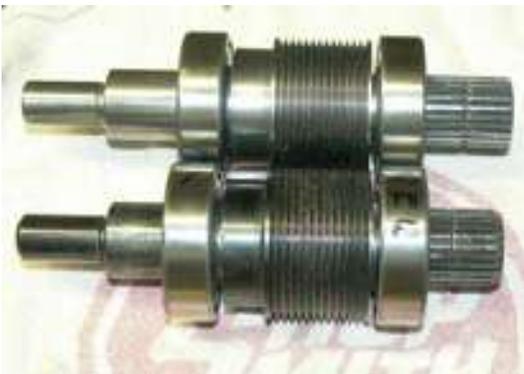
This is 'premature', since reassembly comes later, but here it is after replacing the bearings and stop rings beside a Mark 5/V shaft assembly.

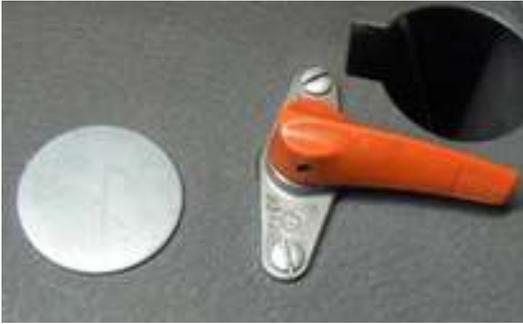
It is attached by two screws and tinnerman clips. The access hole is plugged like earlier Mark 5 of this vintage. This was **supposed** to allow oiling the floating sheave without removing belt cover.

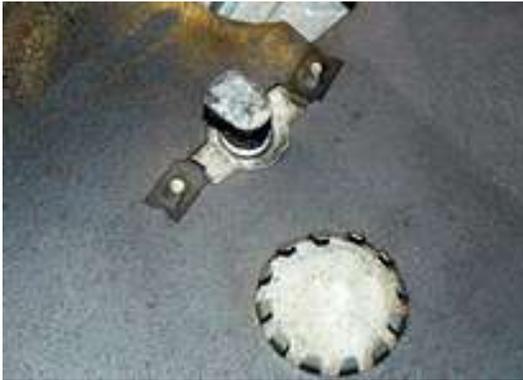
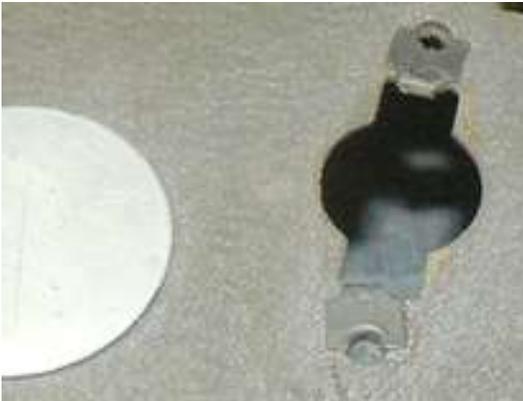
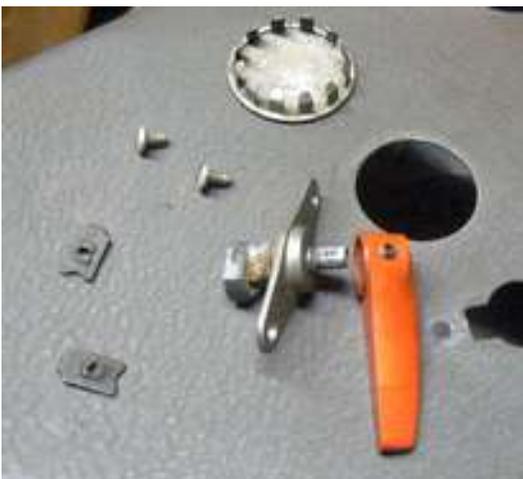
The inside-note the tinnerman clips, and the hole plug 'fingers'.

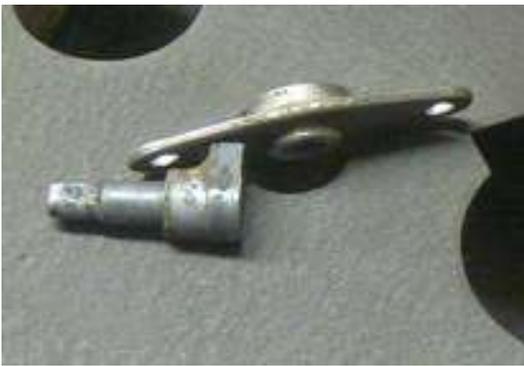
Notice the 'mount' is tapered to match the belt cover slope.

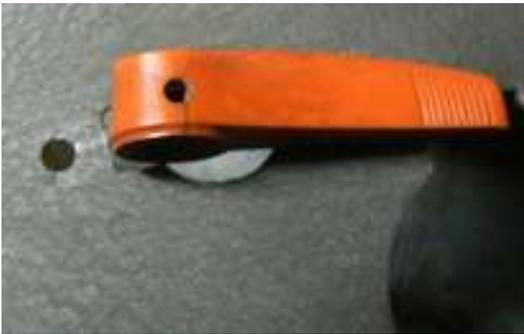
The knob is cracked.

I will 'seep' some thin CA into the cracks anyway.

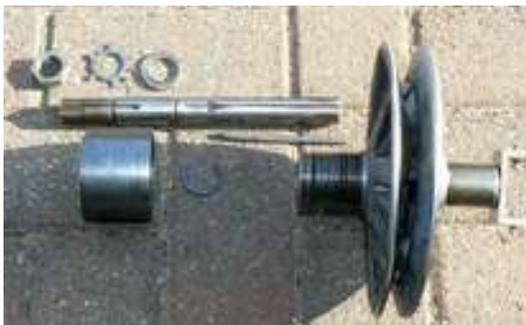
The inner end of the bearing/eccentric is 'stopped' by a retaining clip. The outer end is secured by a nut. The shaft is a slip fit in the bearings.

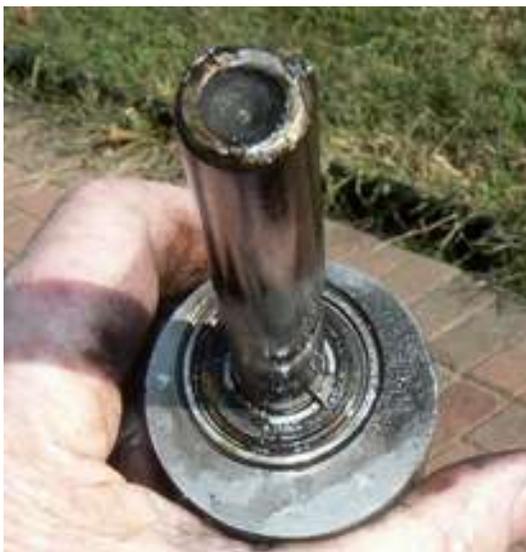
The/a PO liked grease over machine oil. ugh!

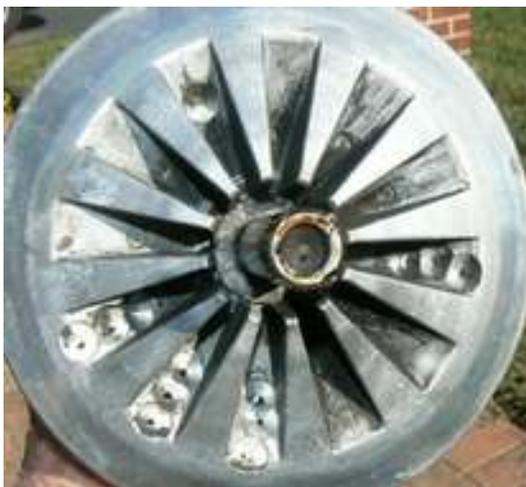
The idler sheave balance was achieved by drastic spot drilling(all the way through in some).

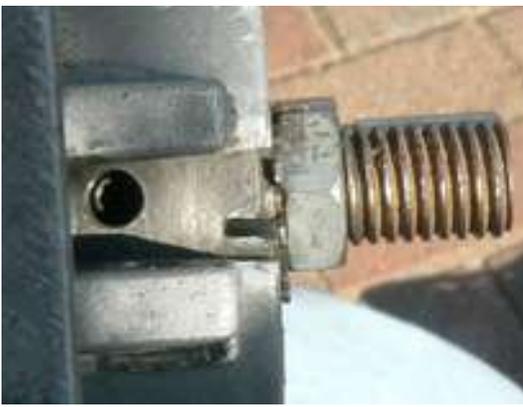
The nut is prevented from backing off the shaft by a keyed and tabbed washer that is bent over a flat on the nut. The nut is removed by carefully prying the tab off the nut (limited number of times before the tab breaks off)

This picture shows the set screw which resembles the Mark 5/V water pump bearing retainer. It will be shown below that its function is quite different.

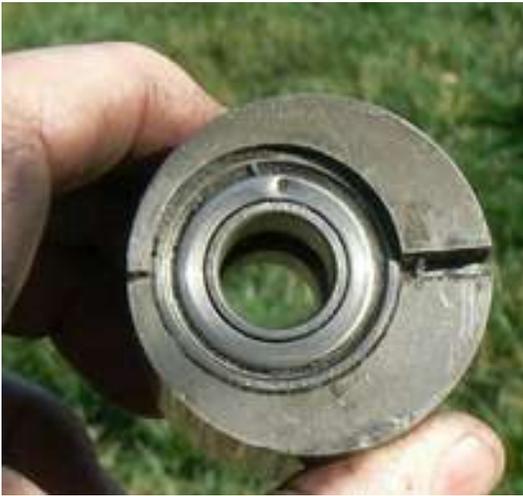
Here is the next puzzle. How to get the bearings out of the eccentric. There is a bearing on both ends. They appear to be stopped internally, so they need to be pulled out each end.

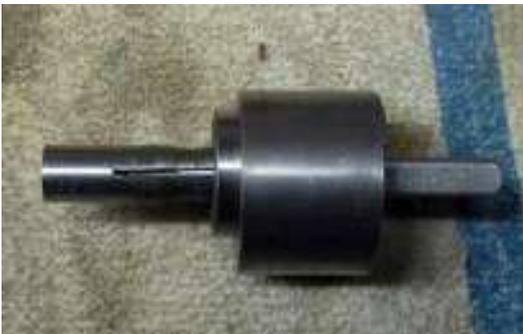
I made a crude bearing extraction tool to push the bearings out of the eccentric from the opposite end. The 'tool' has 4 slits that create 4 fingers with lips that are expanded by driving a gradual taper shank punch into a hole in the center of the 'tool'.

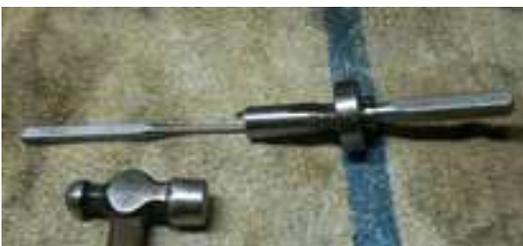
Once the bearing is free of the eccentric, the punch is driven back out from the opposite end (the hole extends from end to end).

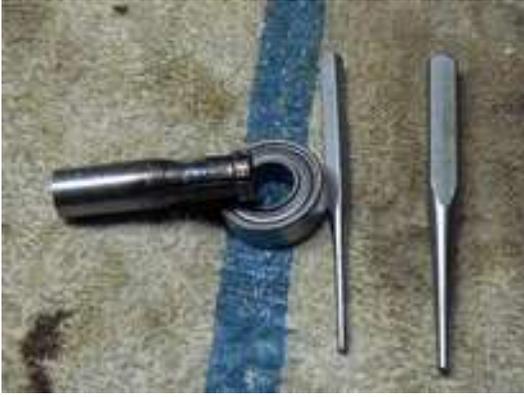
Once both bearings were out, the purpose of the set screw became apparent. The point of the set screw positions and retains an internal spacer that provides an internal stop for both bearings. So bearing removal could have been accomplished by removing the set screw and pressing the bearings and spacer from one end out the opposite end.

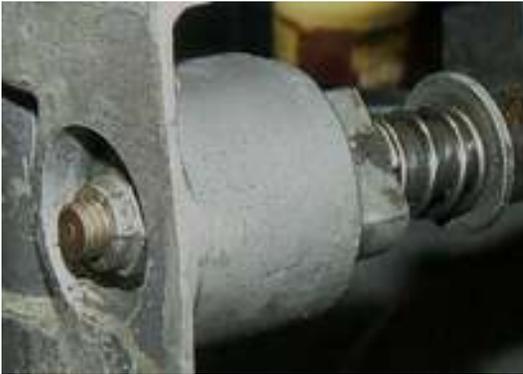
Since the shaft has a compressed spring, the first step is to remove the nut on the end of the shaft.

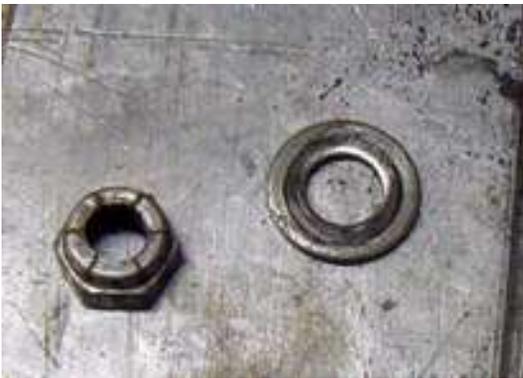
The nut is a 'castle' nut that can be adjusted for wedge wear, but does not require a jam nut. A washer is under the nut.

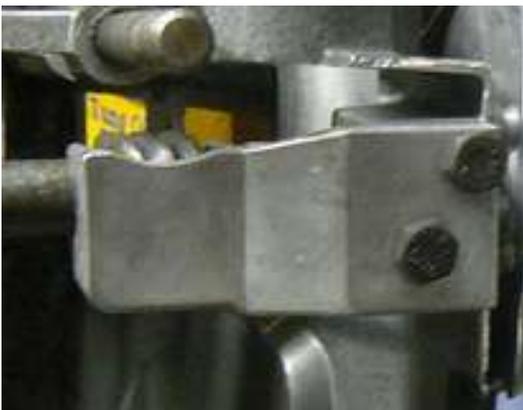
This bracket retains the worm gear. The worm gear rotating rotates a counter shaft that has a spur gear that engages a gear rack on the front way tube.

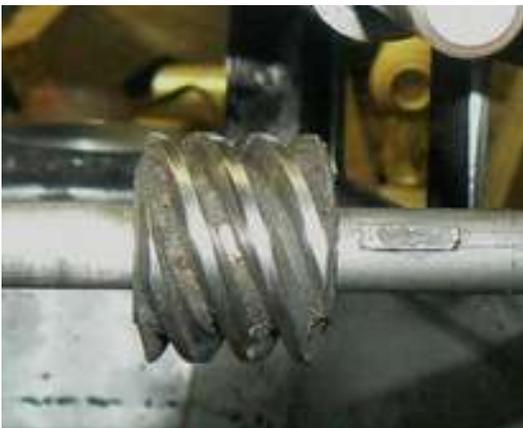
The worm gear is keyed to the headstock lock shaft by a woodruff key.

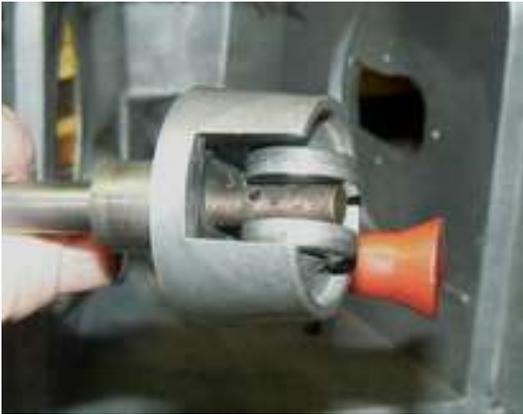
Now a puzzle. How to get to the pivot of the knob to the shaft.

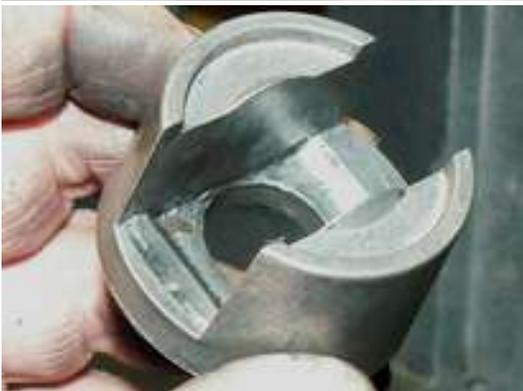
This has a small ding that was preventing it being removed from the shaft.

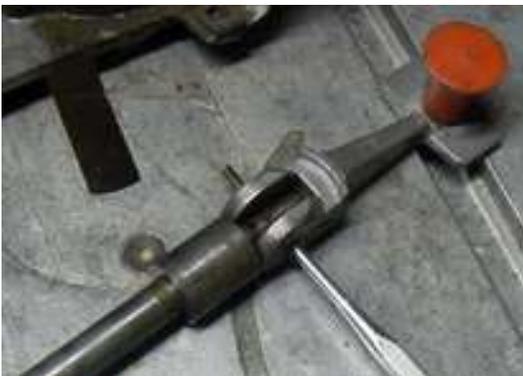
The pivot is a tension pin that is driven out.

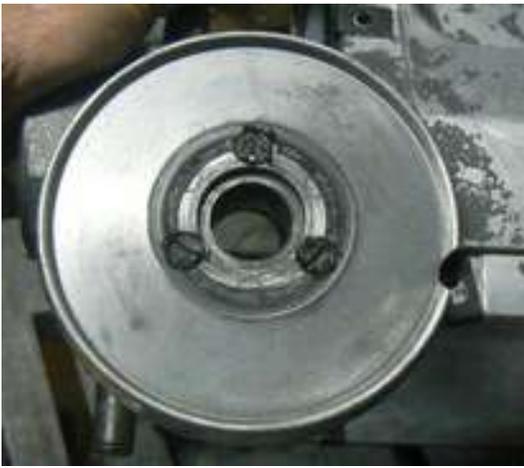
Last three screws remove the shaft cover.

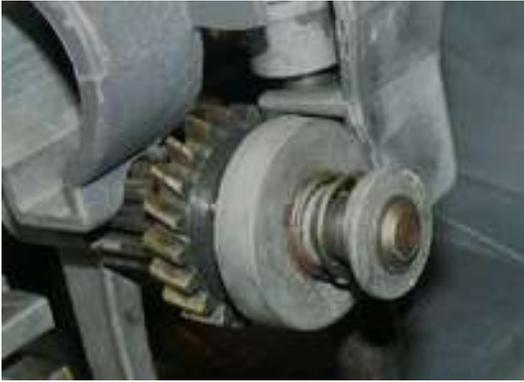
A ring on the end of the shaft retains the clutch 'plate'.

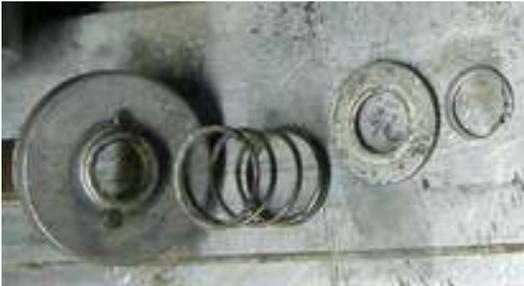
Removal frees the spring and clutch 'plate'. The plate has two pins that extend through the worm gear and into the spur gear. Moving the plate away from the gears withdraws the pins from the spur gear allowing free wheeling.

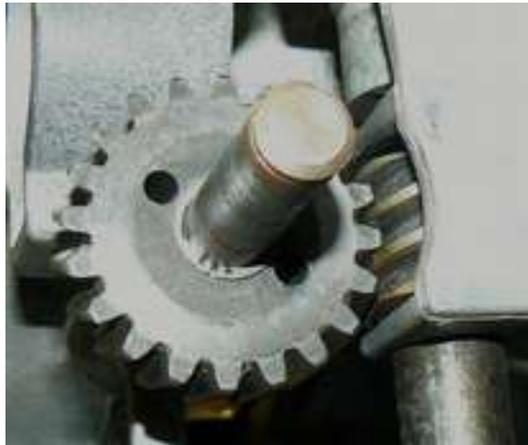
The worm gear is also retained by a ring.

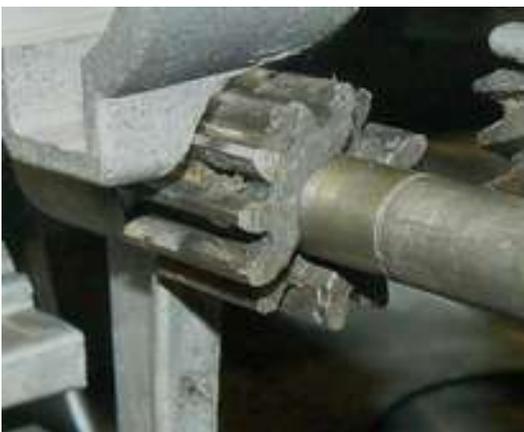
Removal of the worm gear reveals the spur gear and the two slots which the clutch plate pins engage.

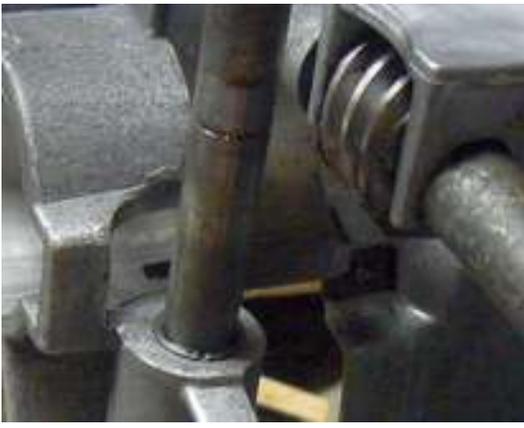
An additional retaining ring does not actually retain anything. Since it appears the shaft is pressed into the headstock casting, I believe its purpose is as a stop for that operation.

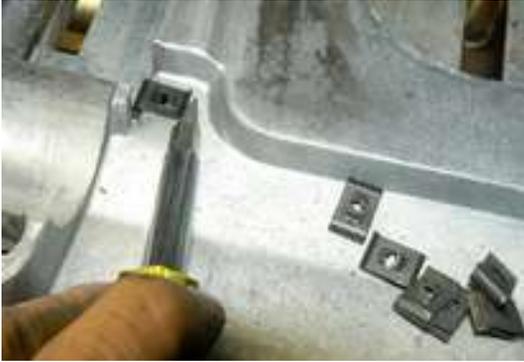
A few parts remain attached to the headstock.

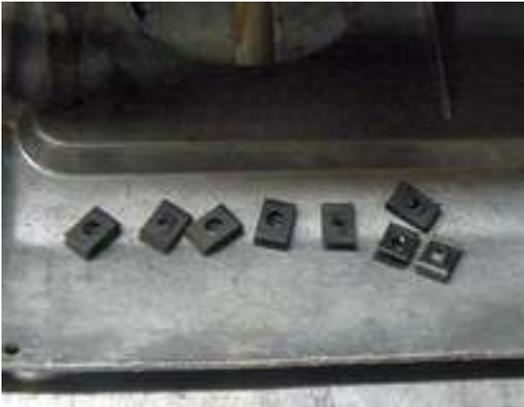
The tinnerman clips are all too easy to remove.

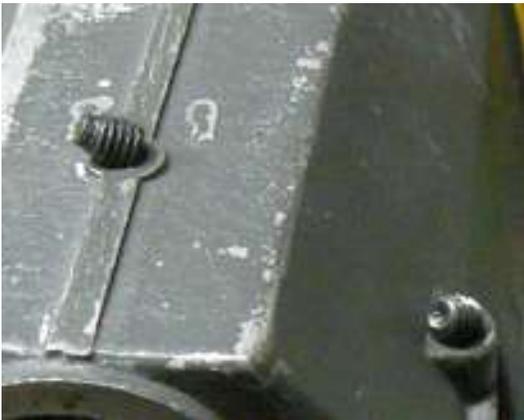
There are 8(one more than Mark 5/V since two are on the vac blower end).

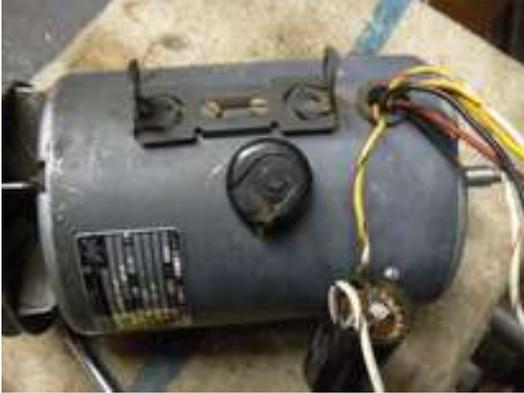
First the cap and spring and floating sheave were removed. I am fortunate to be able to do that by hand (with good retaining ring pliers). The parts are the same as the current Mark V.

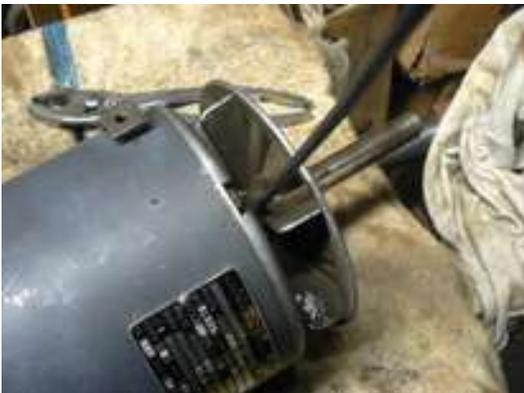
An interesting 'alteration' by a PO. Not sure this was a wise move, but I will use it 'as is'.

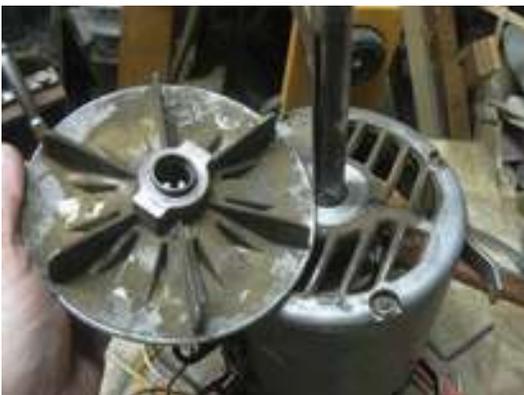
The fan sheave set screw was misplaced. It should have been tightened against the key.

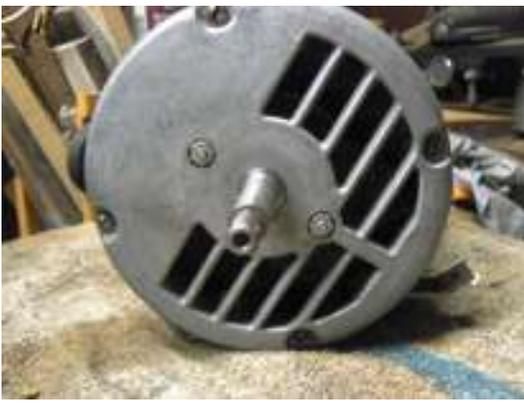
A 'problem' that is common to later versions as well. The spacer has worn INTO the fan sheave which allowed the sheave to rub against the motor end cap. This may have been the result of the set screw misplacement. The spacer sets against the bearing inner race and **should** rotate with the shaft and sheave and bearing.

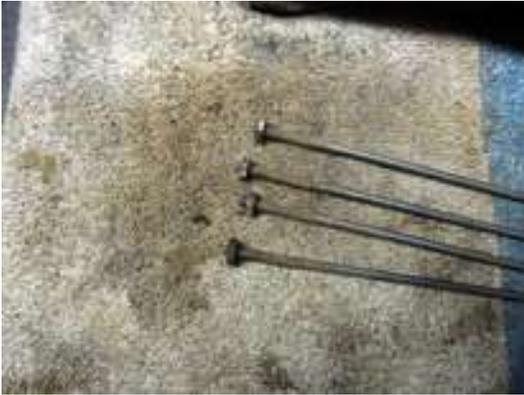
Next comes removal of the end caps. This shows the 4 screws that pull the two end caps onto the motor shell.

Before removing the end caps, make a mark on the shell and end caps(both ends) so the end caps and shell can be realigned the same later. A simple scratch across the joint will suffice. Just make sure it is 'permanent'.

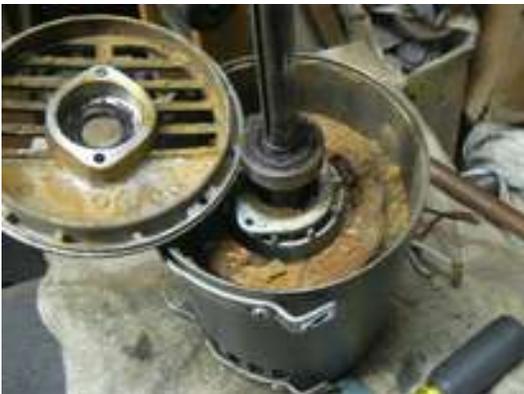
The screws that hold the end caps on are quite small(but long), but typical and adequate.
