Mark VII - Another journey begins

Breakdown and reassembly efforts with a Mark VII that I am restoring – original post by JPG

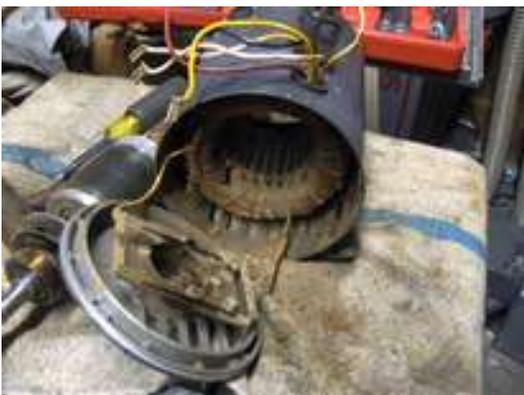
Shaft end cap removed. A bit:D of saw dust buildup! Notice the bearing retaining flange that is secured by two screws through the end cap which must be removed to get the end cap off.

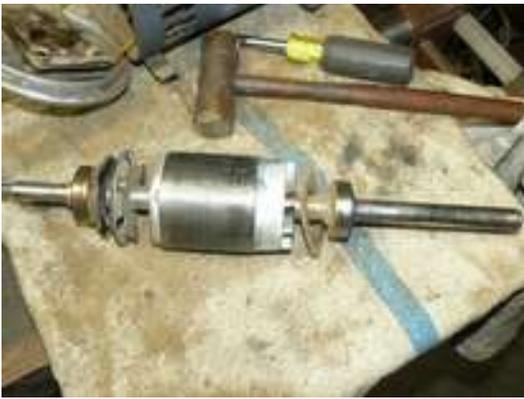
The vacuum end cap pulls off easily. More sawdust. 😞

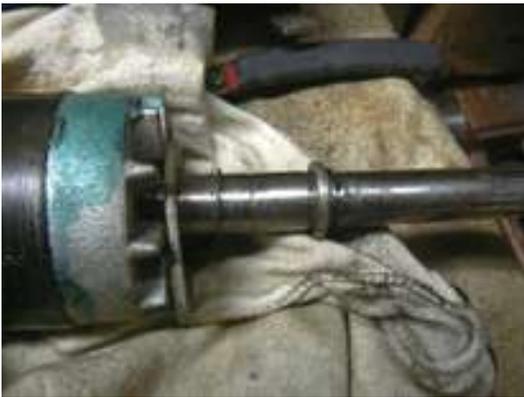
Armature removed. Notice the start switch actuator. The brass weights merely pivot slightly (when shaft rotating), but that causes the ring to move in away from the end of the shaft.

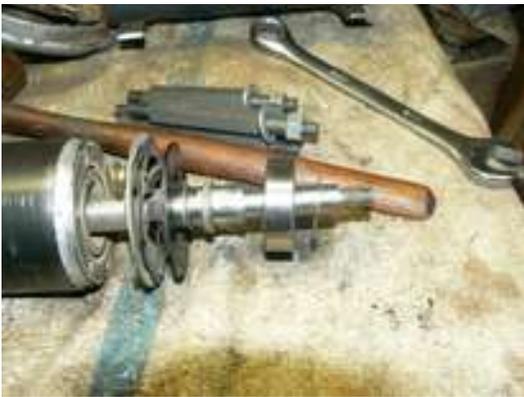
Notice the parts on the 'output' shaft end. There is both an inner and an outer retaining ring. The spacer was between the inner retaining ring and the bearing. Both rings and the spacer need to be moved away so a bearing puller can access the inner race.

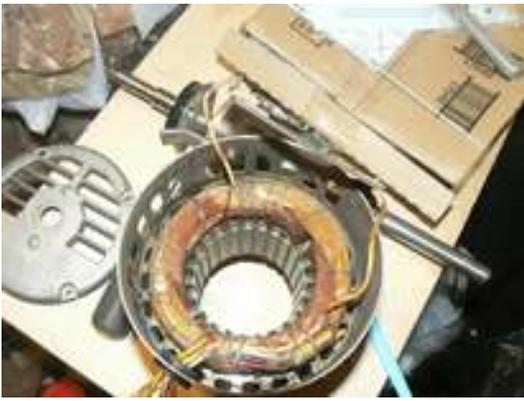
The end cap bearing cavity holds a flat washer and the bearing end play spring.

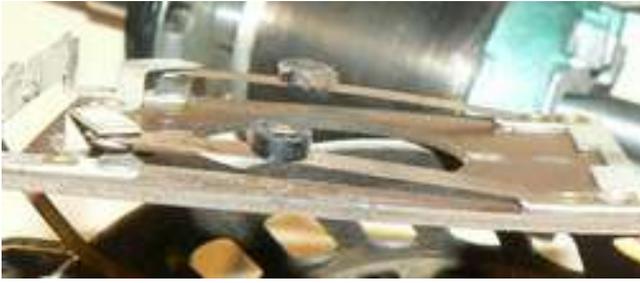
The switch is secured to the end cap by two screws and a nut on the outside of the end cap. Three washers space the switch board away from the end cap on each screw.

This shows the start switch contacts. The actuator presses the leaves down(in the pix) and close the contacts.

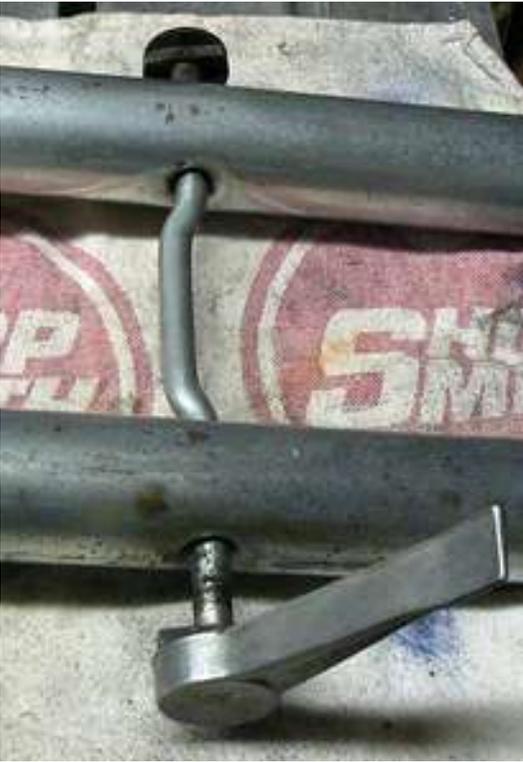
I would refer to them as bench tubes, but they do not function as such. They remain part of the 'upper' assembly that includes the way tubes and headstock etc.

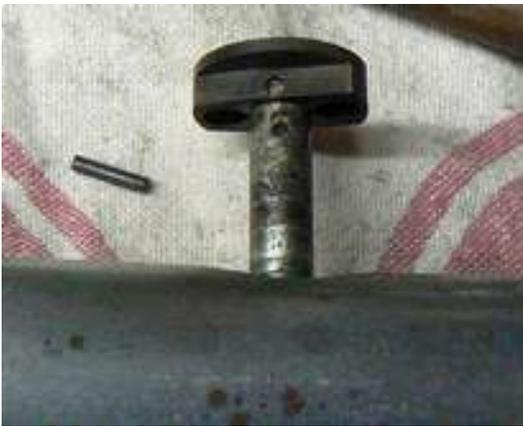
There are two tilt locks, one for each 'direction'.

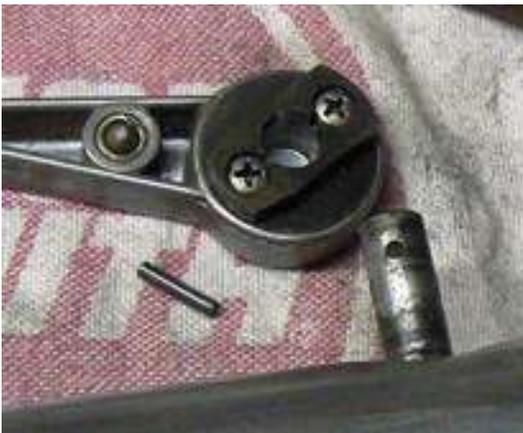
The rear end lock cam is retained by a tension pin.

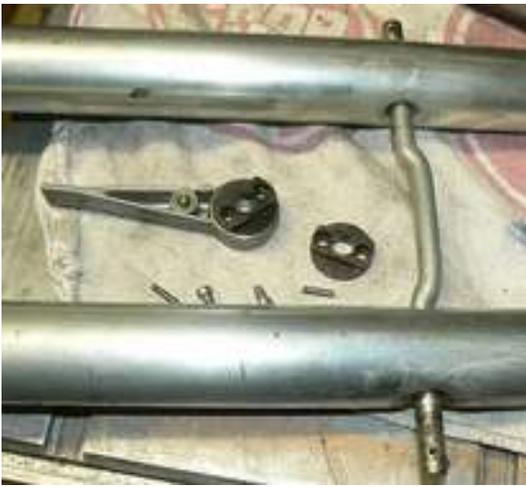
As is the front lock cam that also has the lock handle attached.

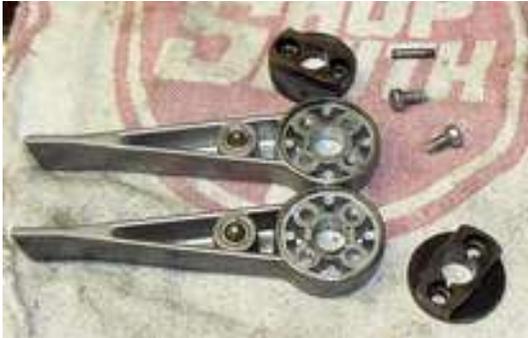
The handle is secured to the cam by two screws.

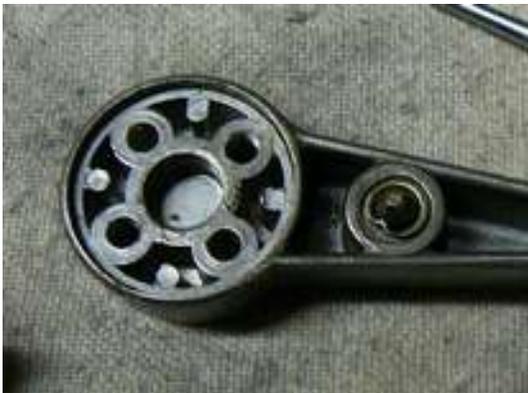
The two lock levers are identical, but have the opposite pair of holes tapped. This is so each locks in opposite directions

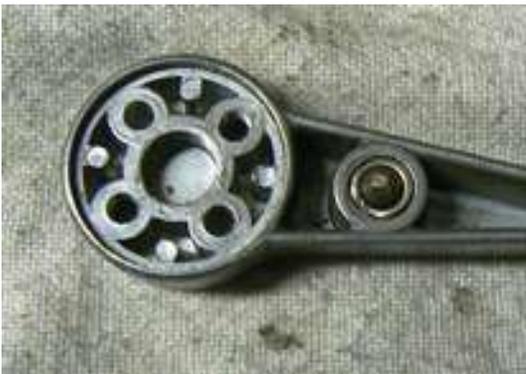
One lever had a bit of damage(PO attempted to remove bullet detent?)

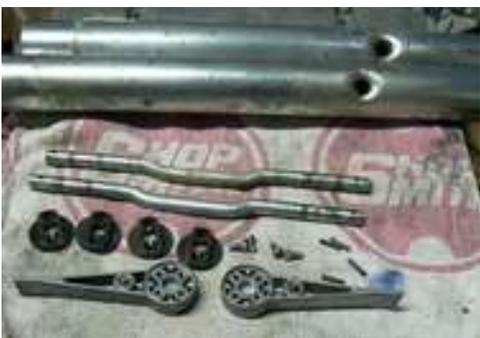
Not pretty, but more 'normal'.

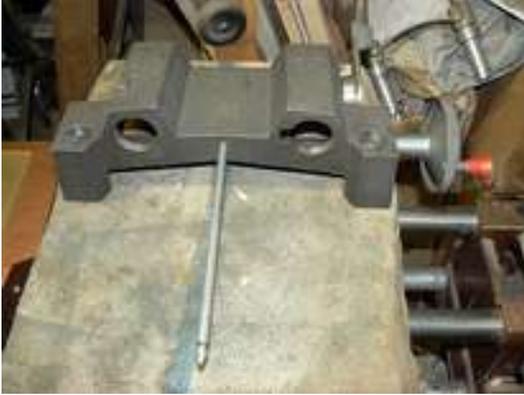
The Mark VII does not use a way tube spacer to position the carriage to the headstock (blade to slot etc.), but instead has a notched rod with three indexed positions. Resembles an arrow protruding from the carriage. 🇺🇸

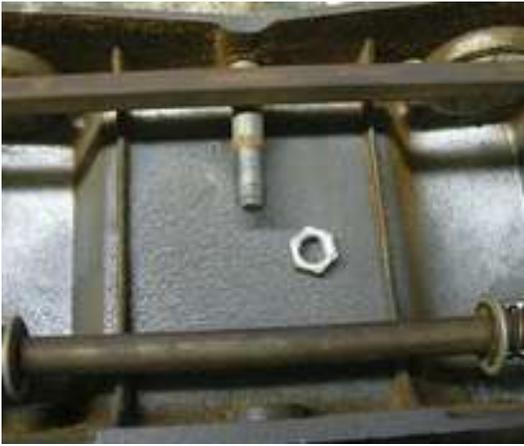
The rod is threaded and screws into the outer (bottom in the pic) side of the carriage. The carriage end of the rod is slotted to enable adjusting the stops. A jam nut secures it in position.

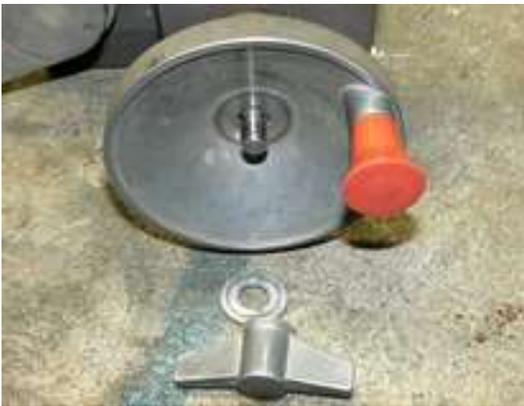
The table height lock nut and crank are similar (smaller) to Mark V 505-520.

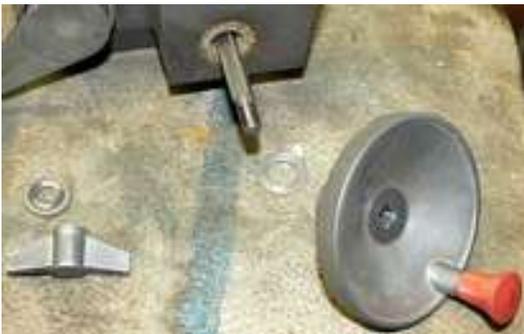
The pinion gears are the same as all Mark 5 through Mark 7.

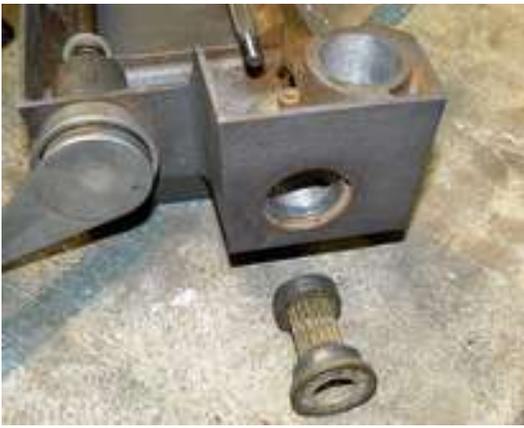
Both pinion gears are merely pulled out from the carriage.

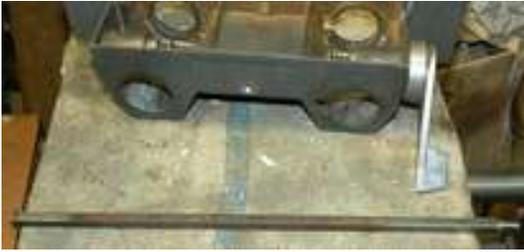
The pinion shaft resembles other models and has a c-clip on the rear end.

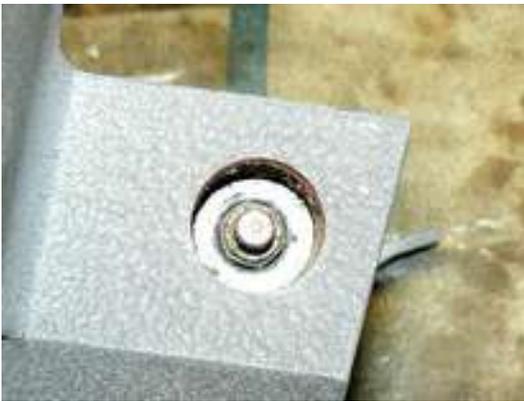
First the locking nut must be removed. It is shallow and is not easy to move, so a good socket wrench must be used to 'adjust' or remove it.

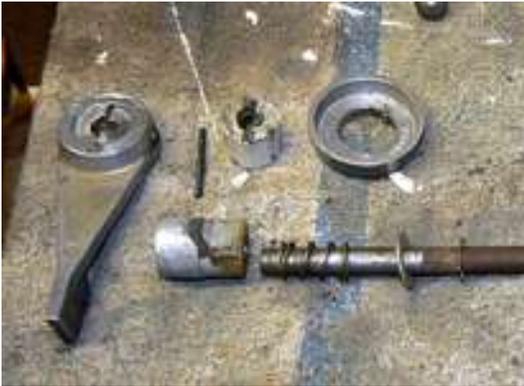
And all the stuff in front disassembled. I do not yet understand the handle/white piece/collar function, but do know the handle steps fit against the white piece steps and the collar nibs go into the white piece slots, and the collar fits over the pin in the carriage. I am guessing the white piece creates a stop to prevent too much pressure to the wedges.* That long tension pin secures the handle to the shaft.

* Nope! The white piece provides a camming surface that squeezes the wedges together. The step is a 'loose' stop.

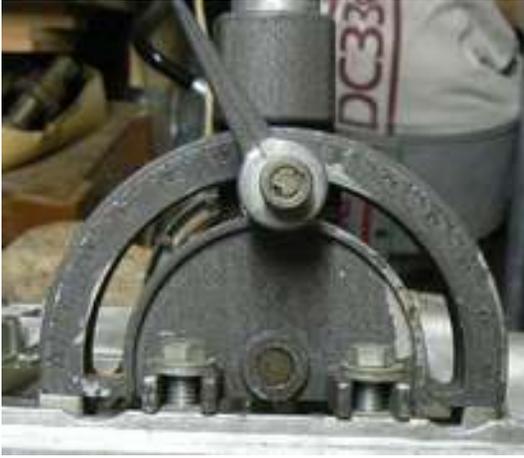
It has two trunions with clamps. This is the rear one.

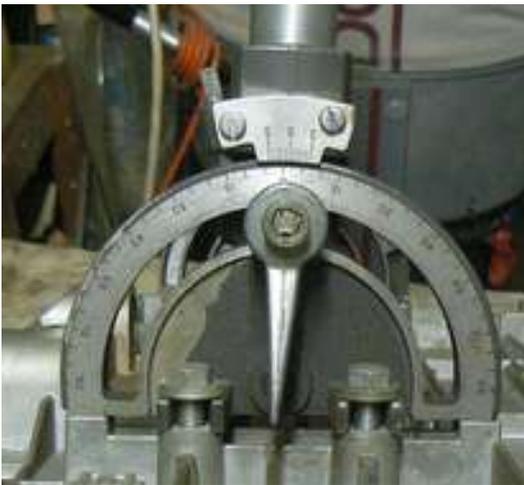
And this is the front one. Notice the tilt scale range is + - 90.

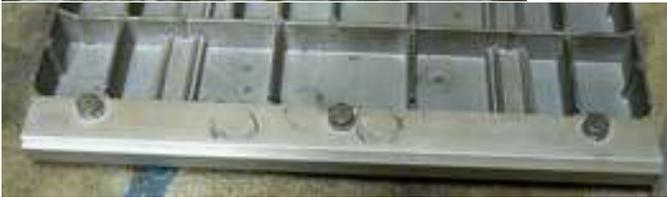
No surprises here. Just like Mark 5 etc.

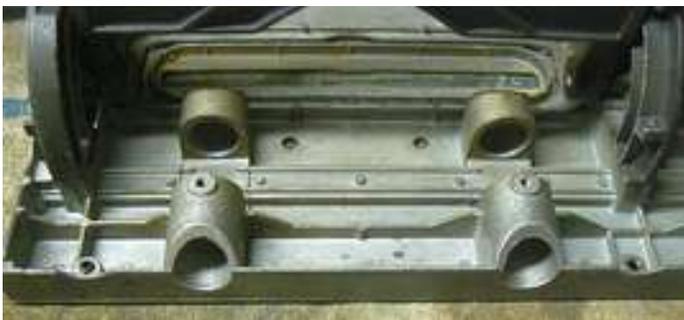
The extension table can be attached to the main table. Notice the two set screws. They provide the 90 degree stop adjustment. The extension table tube bores have tapped holes for securing (1/4" -20), but nothing to put into them. I do not know what the original design was(I have misplaced my MVII manuals). The right stop screw is jammed - it obviously was not 'functional'.

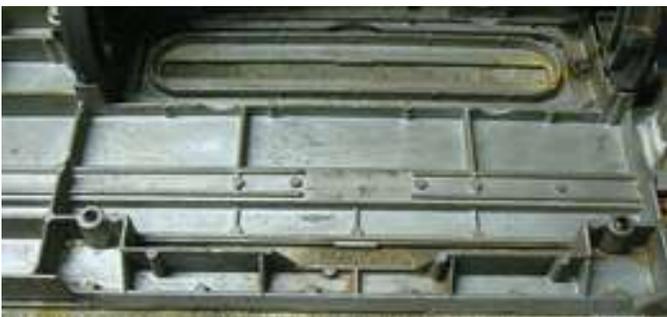
And the left side. Notice two more 90 degrees stop set screws.

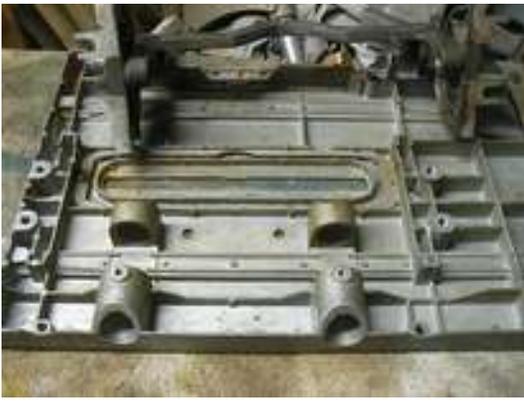
The trunion attaches with 4 screws and 4 thick washers. No shims were there.

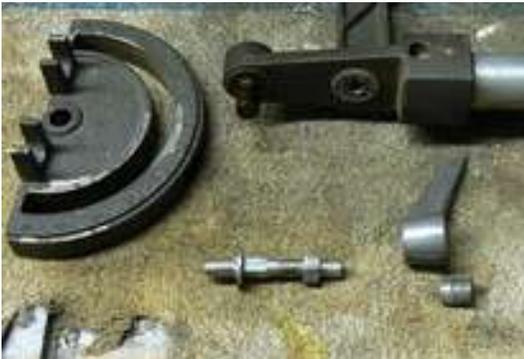
The rear trunion (just like a Mark 5). I will use blue loctite rather than additional peening on the wrench retainer.

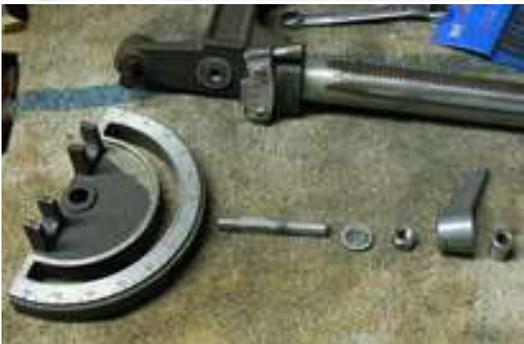
Front trunion same as rear but scale is unpainted and has the tilt stop adjustment screws. There are only two stops [90 and 45 right]. There is no 45 left tilt stop.

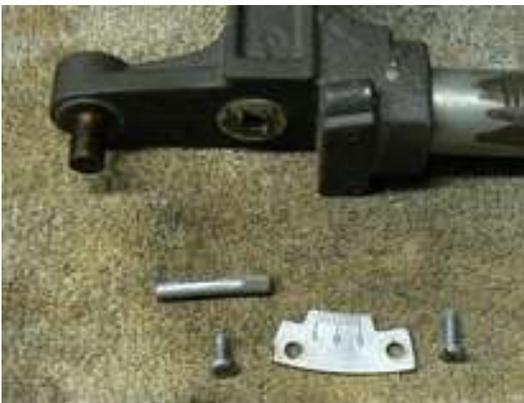
The tilt scale is also just like a Mark 5. I do not understand why, but almost all used tables I have taken apart have a bent stop pin. Not good since the pin has been reduced in od for the mark V etc.

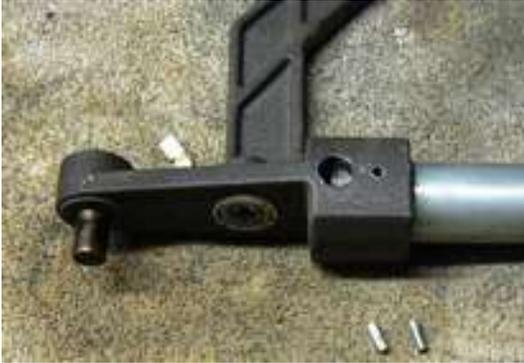
I was surprised that there are two pins(one on each side) holding the tubes to the trunion. The pins are not tapered, but the inner end has been squeezed to increase the 'interference'.

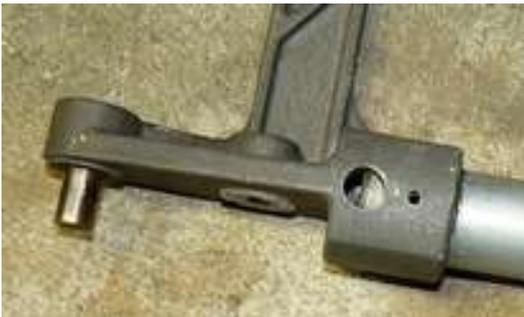
Still 'attached' after trying to force from the 'access' hole. Notice the depressed end of the tube. If heat does not help get them off, they will stay.

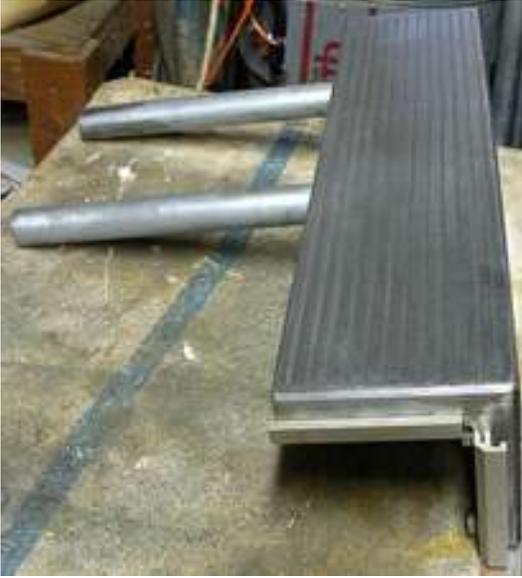
The Mark VII extension table has both a horizontal and a 'vertical' rail for attaching the rip fence. More about that below.

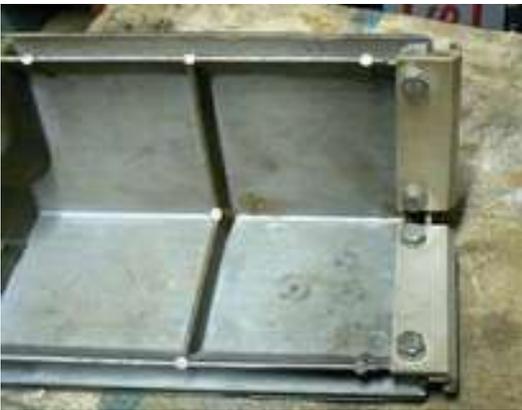
Both short rails are attached with two screws and washers like the main table rail.

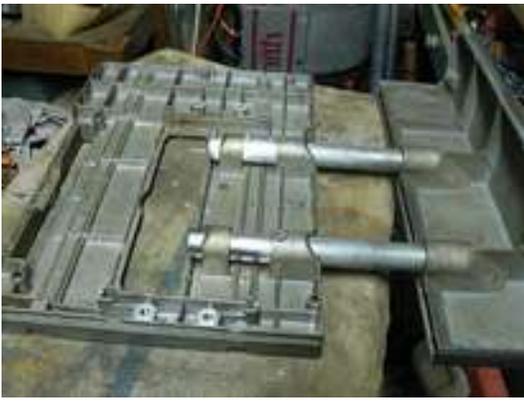
The extension table not only mounts like a Mark 5/V/7 extension table to the base end, but also can 'extend' the main table width.

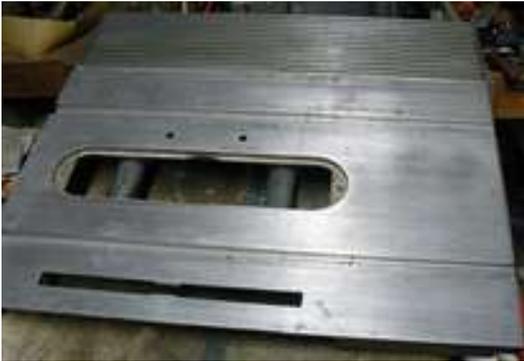
Notice that the extension table post interfere with the saw blade when positioned near the main table. The 'extra' blade slot allows sawing with the tables adjacent.

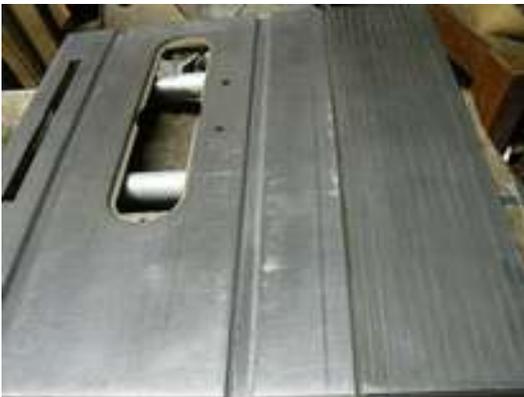
The Mark VII rip fence is a hybrid between the Mark 5 and a 510. A single lever clamp handle operates a rod that actuates both the front and rear clamps that are spring loaded to the open position.

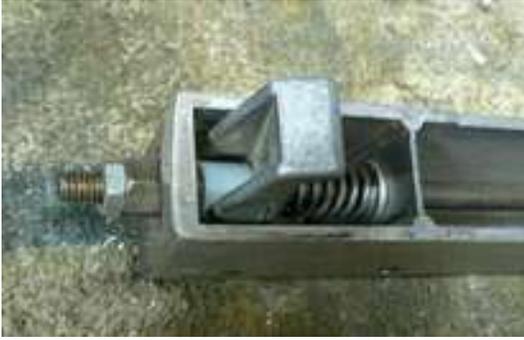
The elongated nut and jam nut are similar to a 510. The Mark 5 had a barrel nut behind the clamp. This adds an adjustment that the Mark 5 did not have.

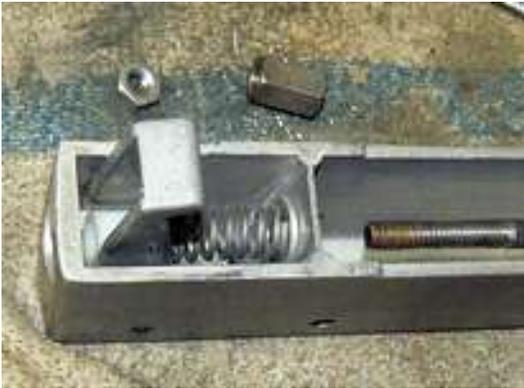
The spring opens the clamp when released. IMHO, a washer is missing between the spring and the clamp. The manual says not.

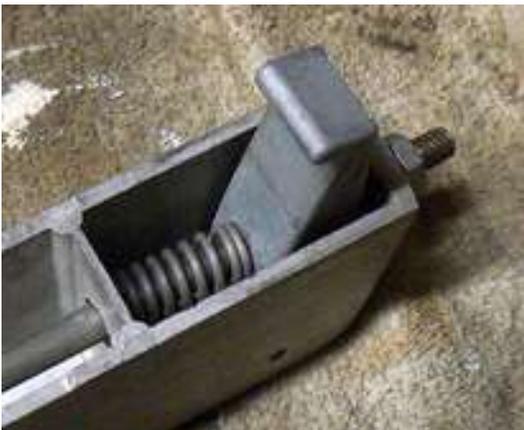
When I removed the spacer nylon another steel one 'appeared'. I assume a po lost it in thar!:D

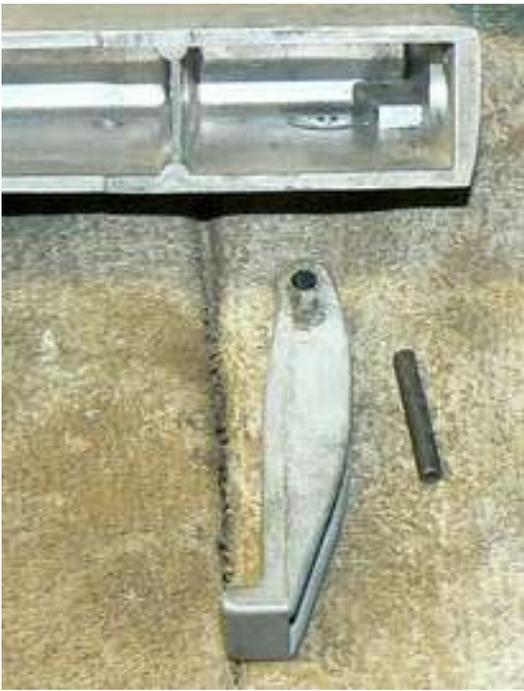
The clamp pivots on and is retained by a tension pin like the Mark 5.

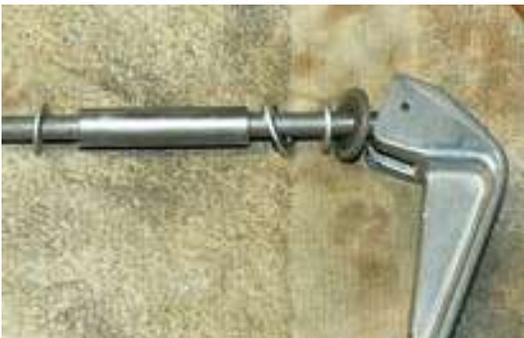
I believe there should be only two washers here. Also notice there is a washer between the spacer and the front clamp. The spacer and that washer are hidden from view when assembled.

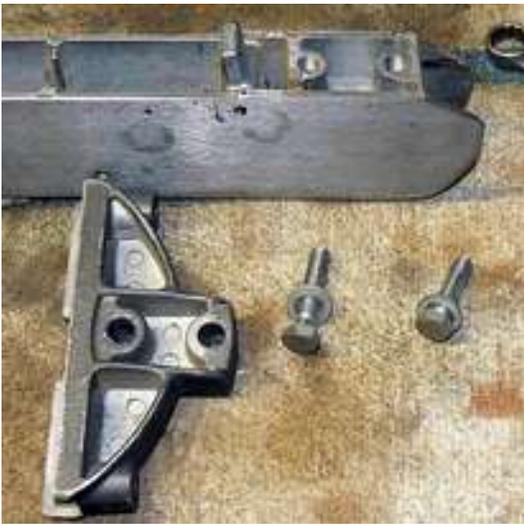
I next removed the front casting. The rear screw is longer than the front screw. It is Mark 5 'sized' but has a second biasing screw hole and is identical to the band saw fence casting(original single clamp version). More about biasing screws below!:mad:

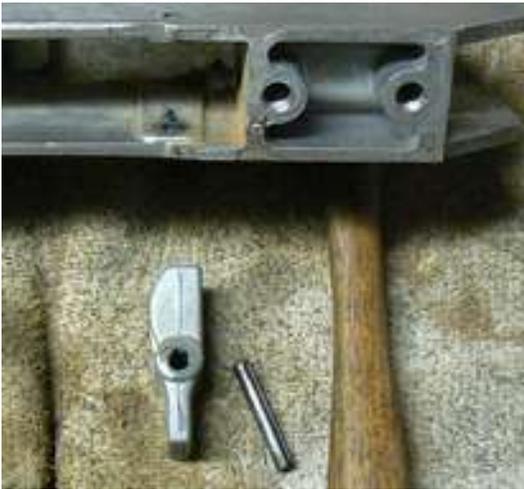
The front clamp also pivots and is retained by a tension pin.

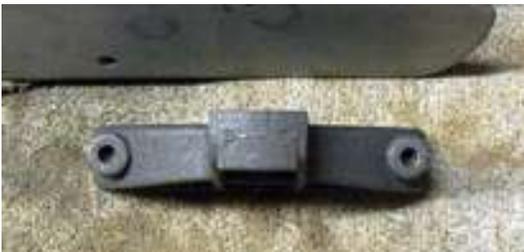
As noted above the front clamp casting has two bias screw tapped holes.

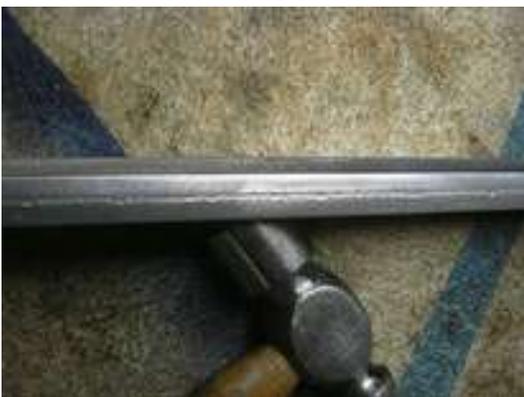
An illustration of why I get resonant regarding the improper use of these screws(to align the fence to the blade/miter gauge slot etc.) Obviously a po used the right screw as a 'permanent' alignment setting. This is a pix of the main table front rail. Fortunately that surface is not affecting 'normal' clamping/alignment.

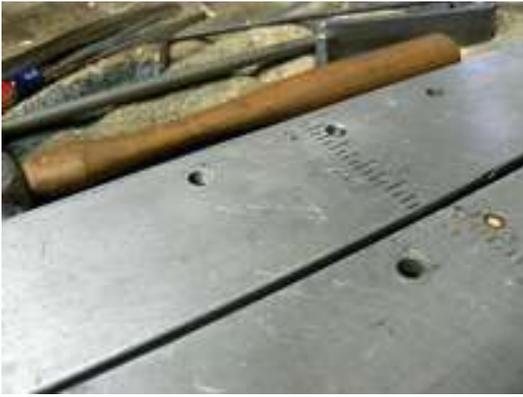
The Mark VII fence has tapped holes (5/16-18) for jig attaching. The Mark 5 fence (lower in pix) are 1/4" through holes (slightly oversized). Notice the locations differ.

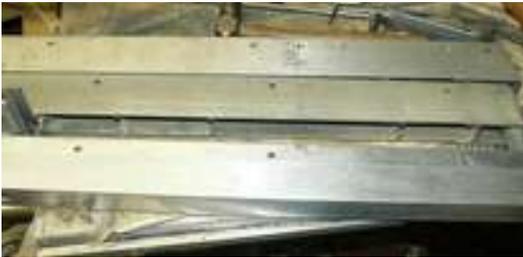
Adding a 510 fence in the bottom of the pix shows the original jig mounting holes are returned to their location relative to the arbor and are again through holes (not tapped).

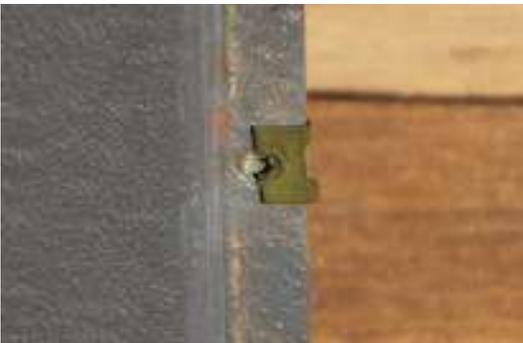
Front and back screws use tinnerman 'nuts'.

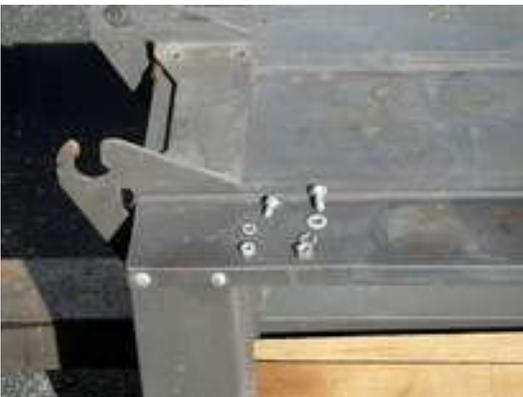
Next the tilt support bracket. There are screws attaching it to the side also. The larger screws on top, the smaller ones on the side.

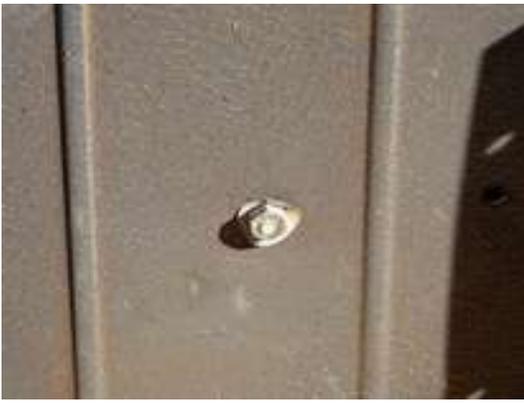
The vertical clamp mounts with a screw that includes a spring washer.

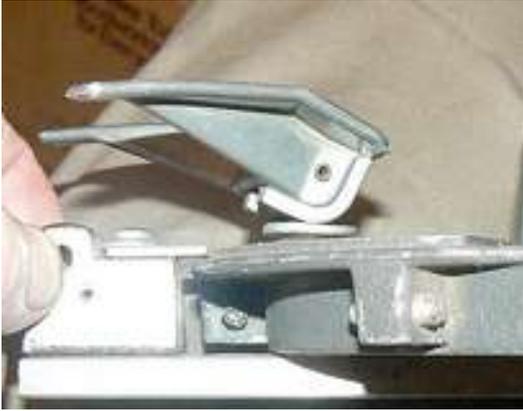
The distinguishing detail of the Mark VII miter gauge is the segment clamp. Instead of a knob, a lever clamp is used.

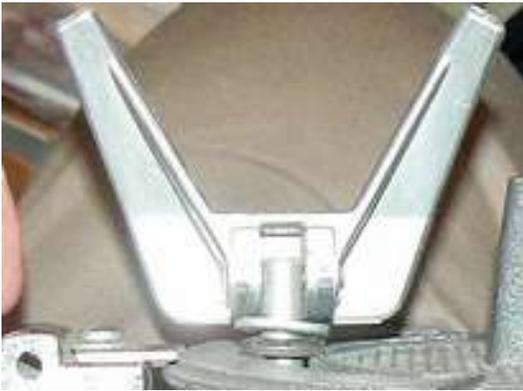
This clamp 'handle' has 'wings' that allow accessing it from either side of the safety grip handle(which has been removed in the pix).

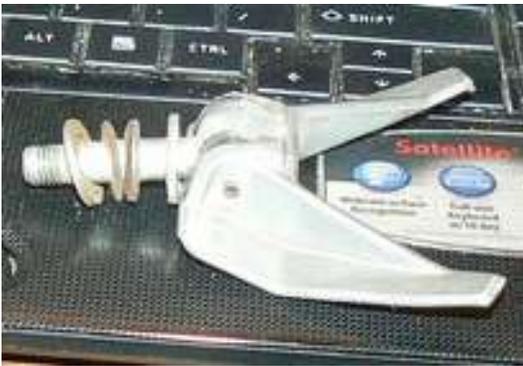
The only adjustment possible is the accumulation of washers between the lever and the segment. Originally(OEM) they consisted of two flat washers and a 'conical' washer. The conical washer provides some 'spring' action. This screws directly into a tapped hole in the miter bar with no 'stop' to make the screw tight.

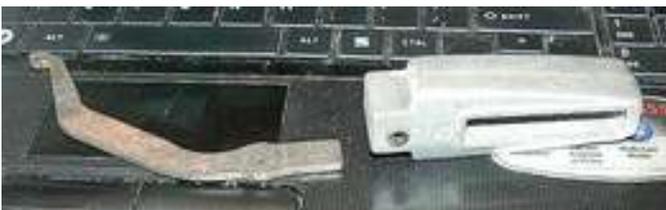
FWIW a pair of 'special washers'(thin) were between the segment pivot and the clamp area bottom. I will determine if they provide proper squaring of the face of the miter gauge at reassembly. The segment appears flat across the bottom. The second 'special' washer rests over the hole to the left which is for the lever clamp screw.

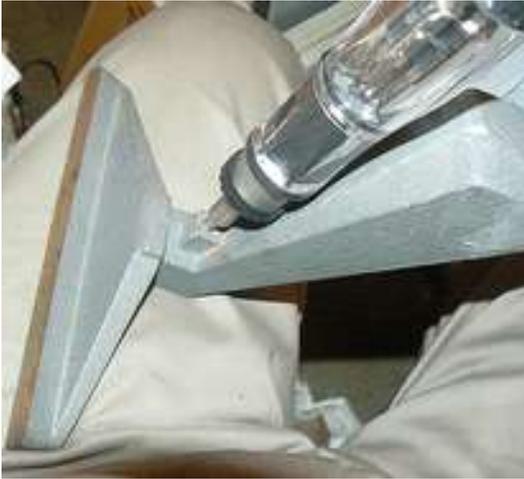
The lathe tool rest is included here although it is **almost** identical to current version.

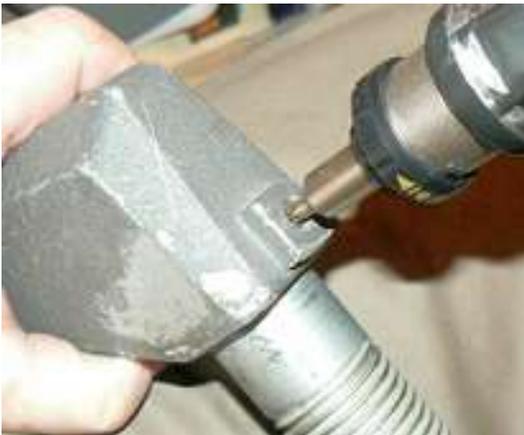
The tool rest bar is retained by a single set screw.

FWIW that is a T25(torx) bit in the screwdriver. Works on 5/32 allen screws.

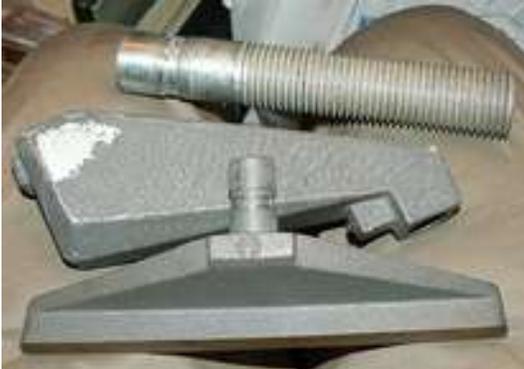
Same for the arm to the post.

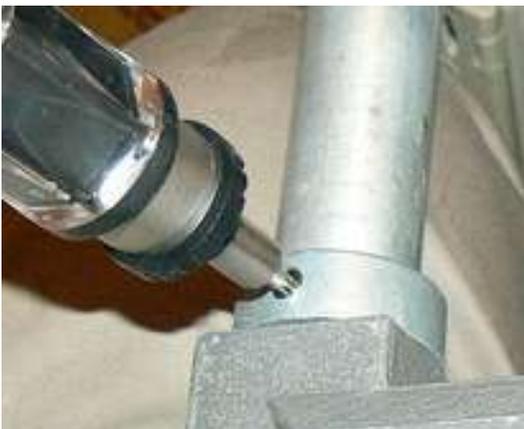
Here you can see Mark VII differences. The tool bar and arm are shaped differently. The post has the circular grooves like the Mark 5 instead of the one sided rack gear on the current posts(this allows the post to swivel - opinions differ on the good/bad of that). The arm is short like the Mark 5/V 500 to match the carriage post location(closer to the spindle).

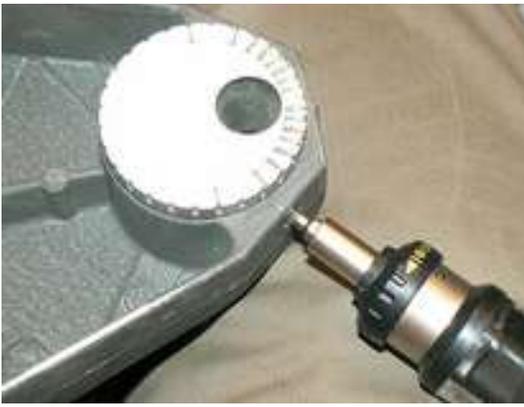
The tail stock stop collars are removed.

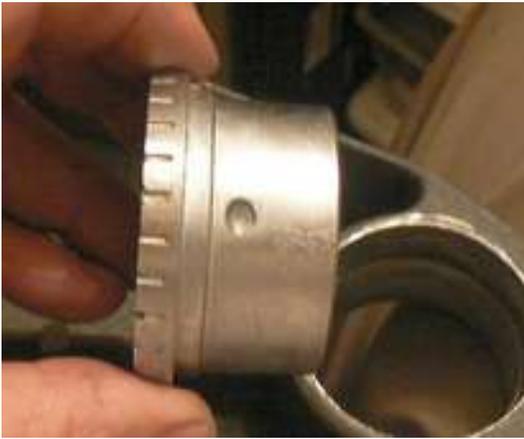
The off center cam is removed.

It does not appear the PO did any off center turning.

Well it would have been difficult since the 'cam' would not rotate freely. I initially thought paint buildup was causing it to bind, but after paint removal, it still wanted to bind. Closer examination revealed flash in the bore that was causing the binding. This is **after** I removed most of the flash. There is a seam(flash) in the middle of the entire tailstock.

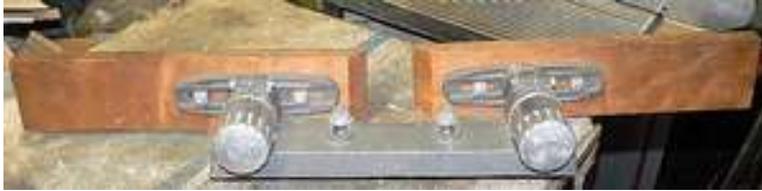
Before breakdown. Notice the location of the mounting screws.

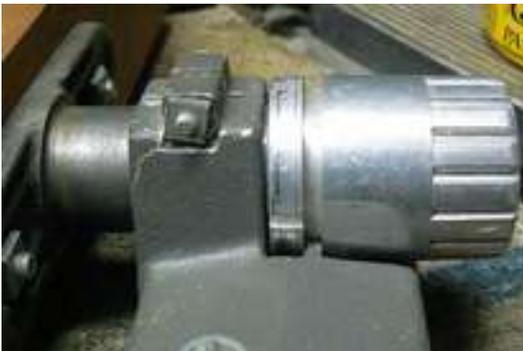
A 'design' modification common to later models with which I grumble! The casting was (and still is) dimensioned for 1/4-20 screws and square nut. When screw sizes became 'standardized', the 1/4" screw was no longer available with a 5/32" hex socket so the screw was changed to a 3/16 -24.

The 'standard' 3/16" square nut is too small to fit snugly into the notch intended for the nut. That causes the nut to turn in the notch when adjusting the screw. I call that a PITA.

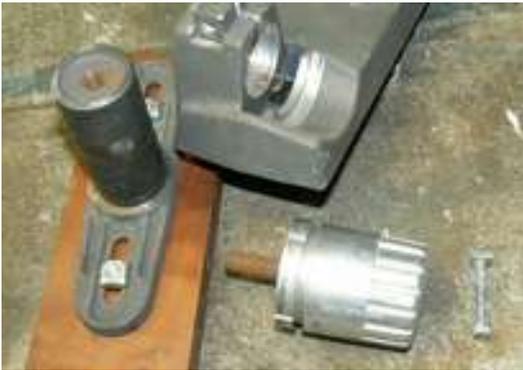
With removal of the clamping screw and mini nut, the fence half can be removed by adjusting the knob until the fence separates from the knob screw. Notice the clamping screw hole is proper for the 3/16" screw. The earlier Mark 5 version had a 1/4" screw hole.

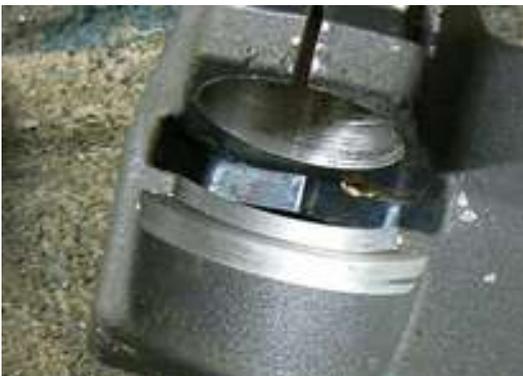
Only thing left to remove is the detent spring. It can be pushed out from the bottom (reluctant, but it will come out).

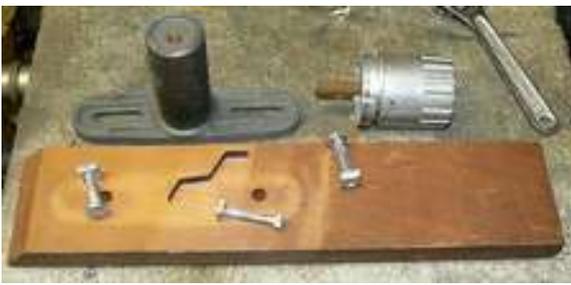
One side disassembled. The other side is identical.

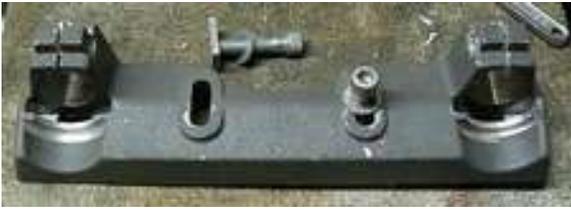
The mounting screws, washer and unique nut are all that is left.

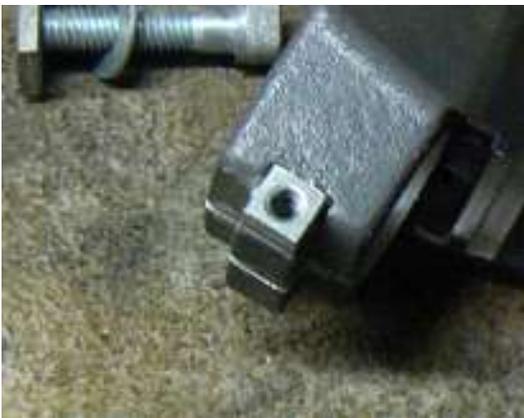
A look at a 1/4-20 square nut in the Mark VII shaper fence 'notch'.

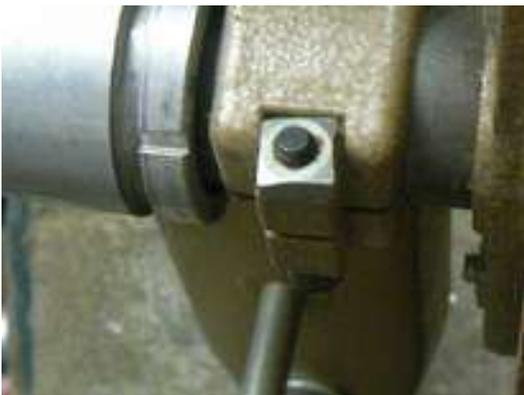
A pix of the Mark 5 version with 1/4-20 screw and nut.

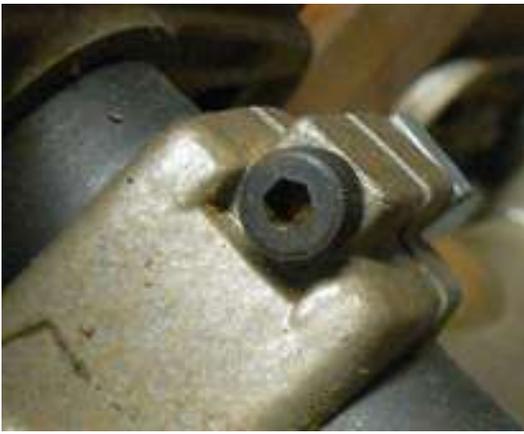
The 1/4-20 screw with 5/32" hex socket.

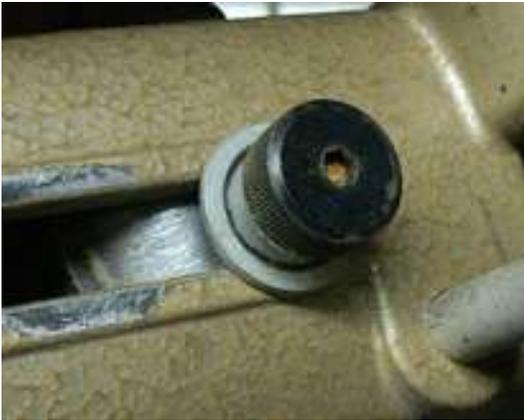
The 3/8-16 mounting screw with 5/32" hex socket.

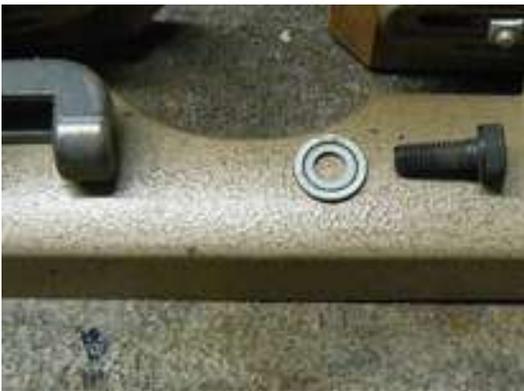
The Mark 5 mounting screw, washer and under table clamp(a pair fits over the front and rear edges of the work table).

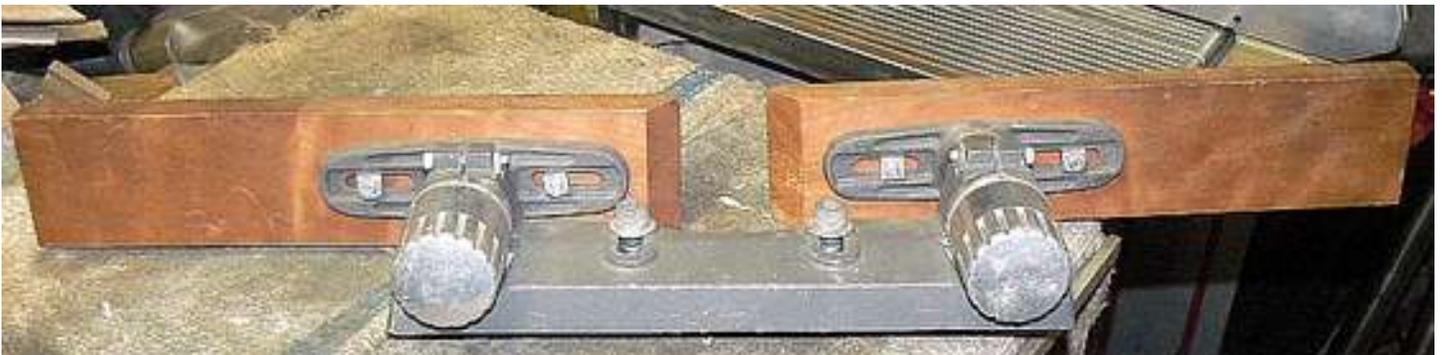
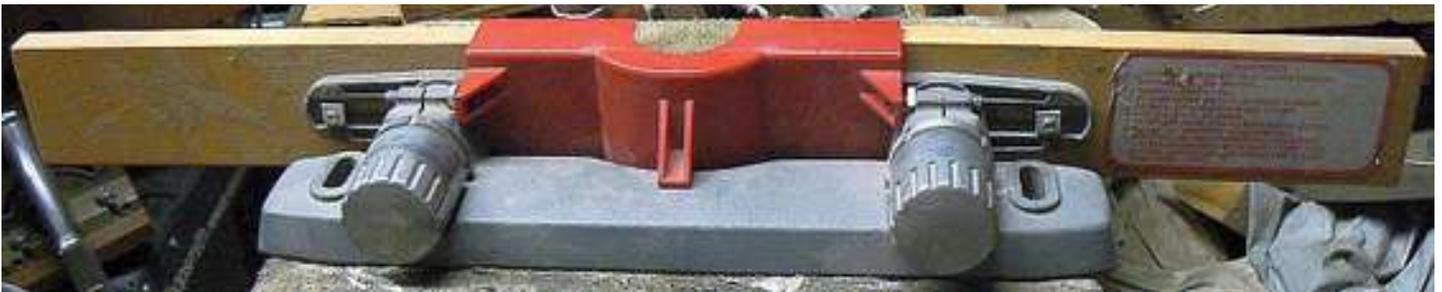
Shaper Fence Versions

These are the three Mark 5/V/VII versions.

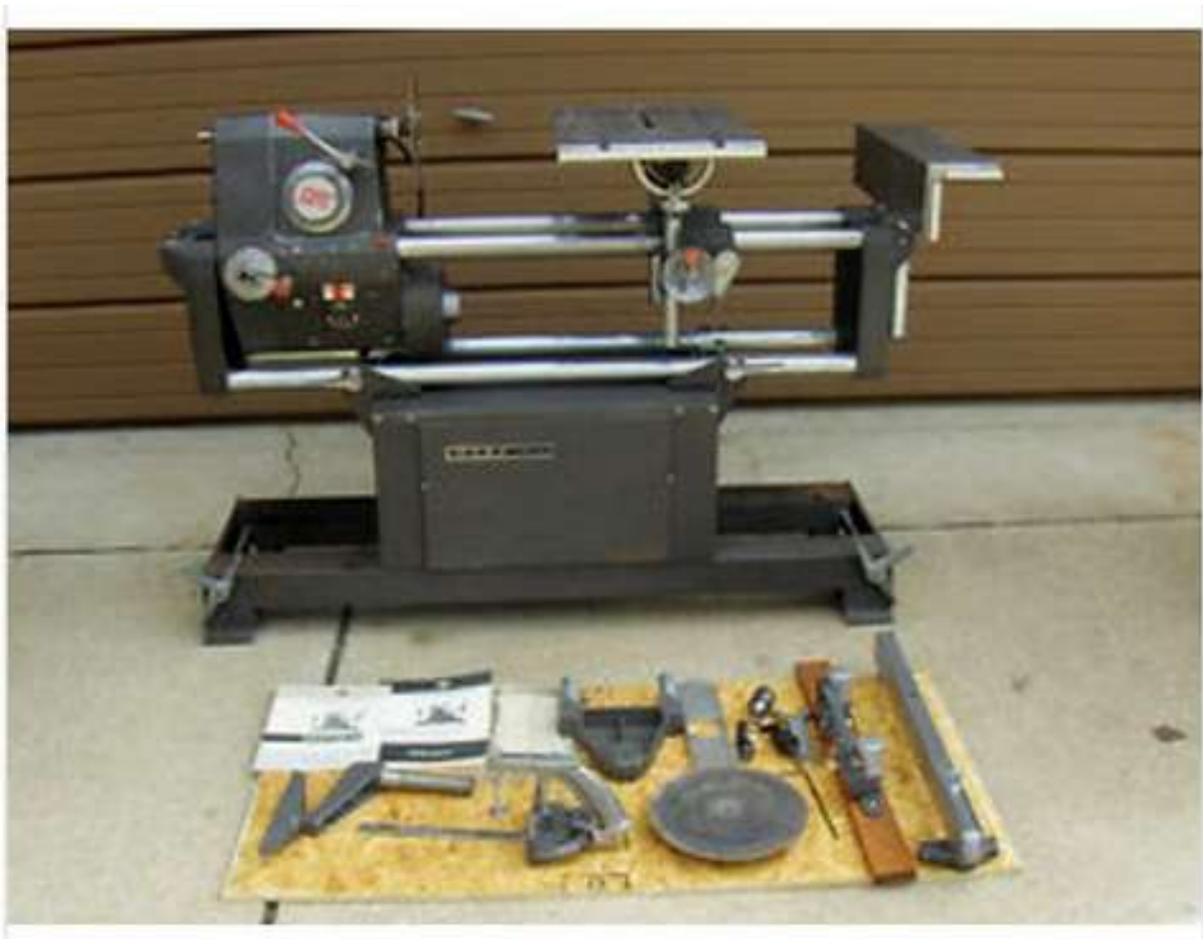
Paint chipped on headstock and slight rust spots on base.

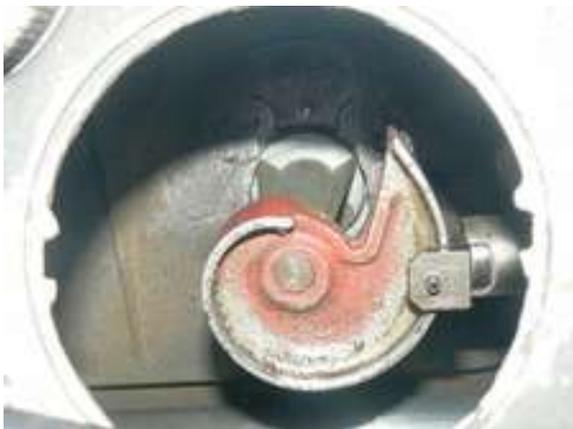
When examining the condition of 'the cam' I discovered a surprise = it is cast aluminum. Paperwork indicates the cam was purchased in 1990 with a few other parts.
