Mark VII Motor Reassembly

Mark VII Headstock Reassembly

Mark VII Main shaft reassembly

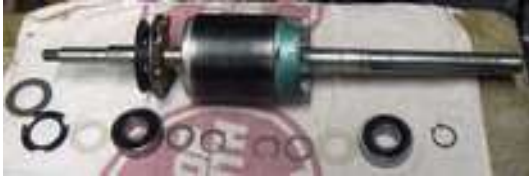
Starting with the armature. I am not sure of the correct placement of the plastic washers/shields. They may have been intended to be on the outside of the bearings to act as a dust shield. I placed them as shown in the second pix. AIRI that was where one of them was. I am not the first to be into this motor, so as found is suspect anyway.

There is a goof here. The output bearing retaining collar is missing. I had to later remove it all (press off/press on) to add it to the mix.

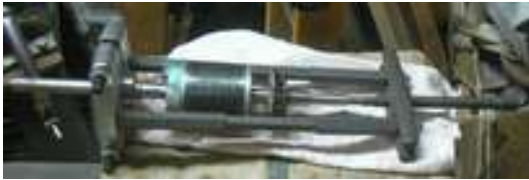
Pulling the output bearing on was pretty straight forward. There are two gotchas on this armature shaft though. The ends of both shaft ends are 5/8" which is slightly smaller than the shaft at the bearing id location. Make sure the bearing puller is open sufficiently to clear that part of the shaft.

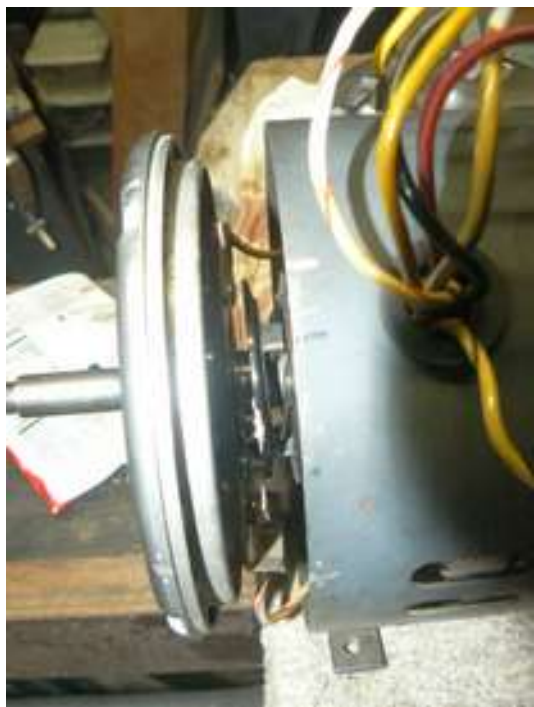
The start switch and end cap bearing spring are lubricated with lithium grease. The washer goes in the cap cavity before the spring. Lithium grease is what I have on hand.

When replacing the vac end cap, do watch for pinched wiring.

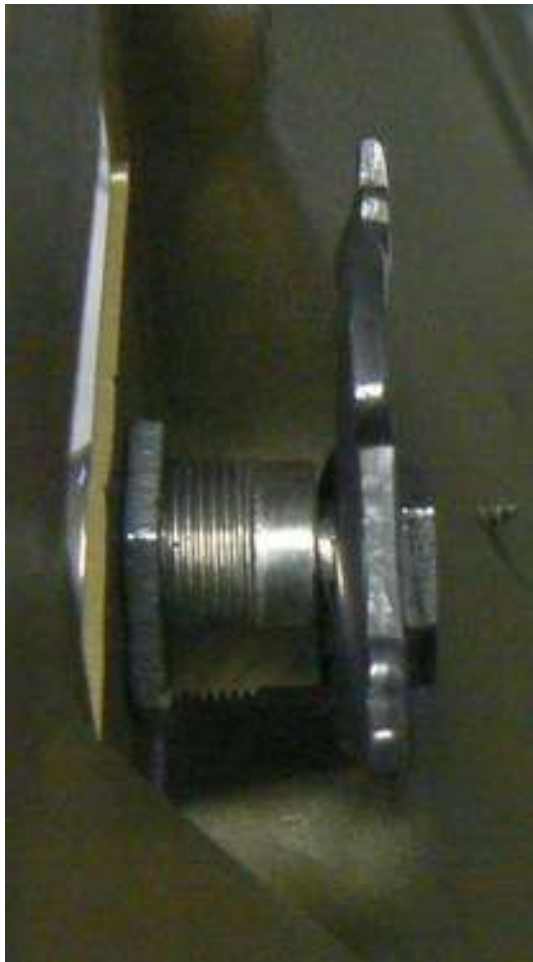
The lock has two flats that prevent it rotating in the double d shaped hole. The moving part also has double d flats.

The cam plate is secured to the lock core with a nut. A wave washer spaces the plate away from the lock base. The nut must not be over tightened or the lock core will not rotate.

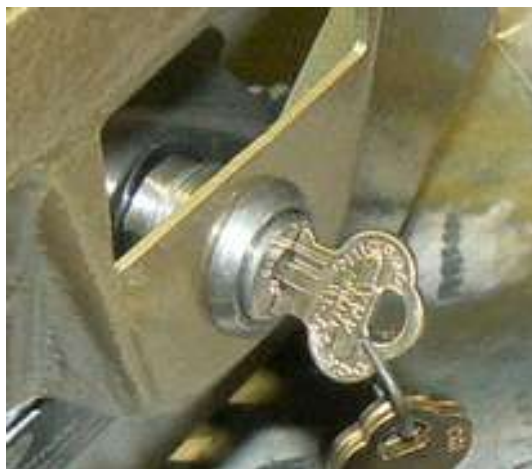
The cam plate rocks under the switch button shafts. The cam plate end must be rotated out from under the switch shaft to allow the switch to operate. This pix shows the cam plate in the off/locked position that prevents both the forward and reverse switch buttons being depressed. It also shows the plate 'offset' facing the inside.

Got lucky! Got both original keys! Third one is a copy and will be the 'active' one. The lock is shown in the forward run position. The cam plate is rotated so the forward switch to the right can be activated.

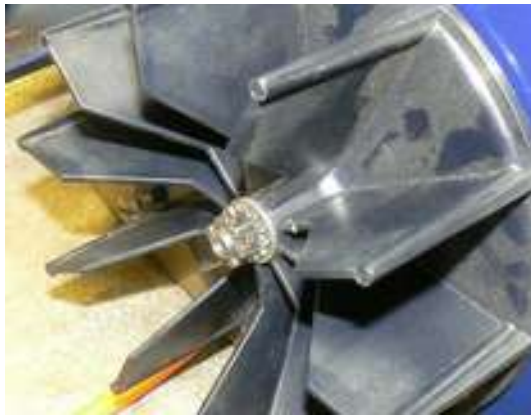
I does not show in the pix, but, the shaft at some time was dropped and the very end of the threads were slightly mangled. Had to chase the threads on both the shaft and the nut(since I first tried to force the nut on). 3/8-24.

After cleaning the threads, the castle nut is screwed on and a cotter pin inserted through a 'slot' in the nut and a hole in the shaft. The long end of the cotter pin is bent over to hold it in place. The original cotter pin shown will be replaced with a new one.

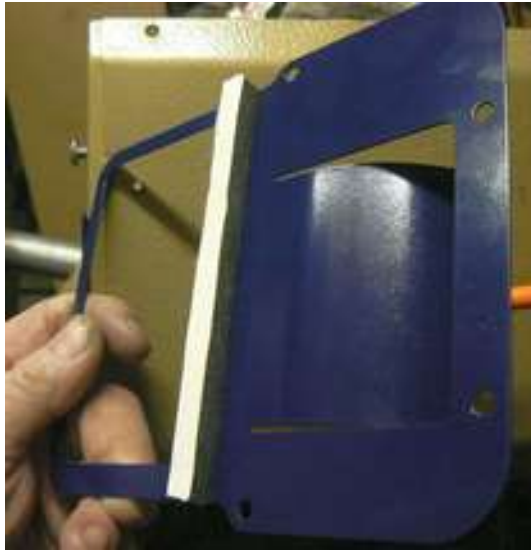
Weather stripping is used to prevent air leakage between adjoining parts. This is a deflector plate that directs the air flow to the output port. I used weather stripping that I already had. It is too stiff and will be replaced with a softer foam type. When it all is tightened down, the plastic parts became deformed under the screws etc.

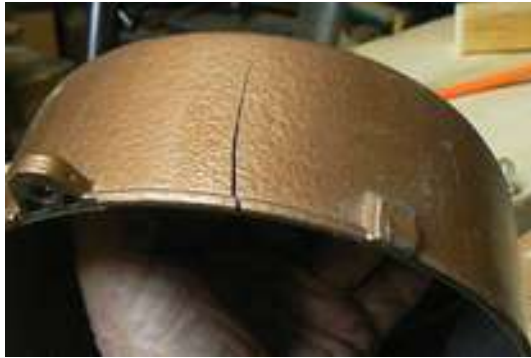
Well as a result of it being both idle and 'unattached' to the headstock, it became an insulation blower. Unfortunately it sucked up a nail and made some very disturbing noises.

The result was a couple of 'fractures' to the fan housing. 😞

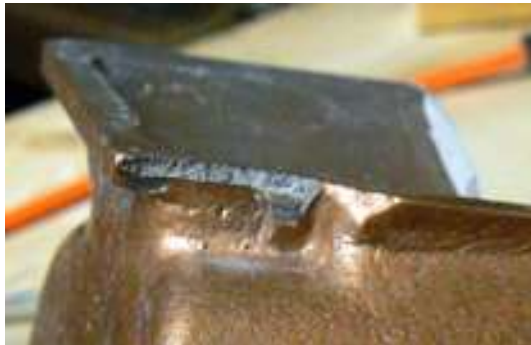
This one looks scary, but was easily 'fixed'.

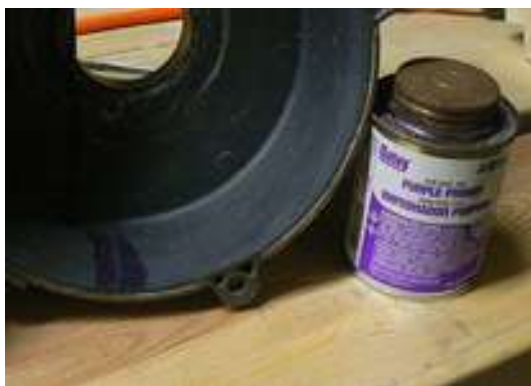
This one was the area which was previously damaged(so no surprise).

I recalled the problem I had with the paint dissolving the plastic, so I tried the purple pvc 'cleaner/primer'

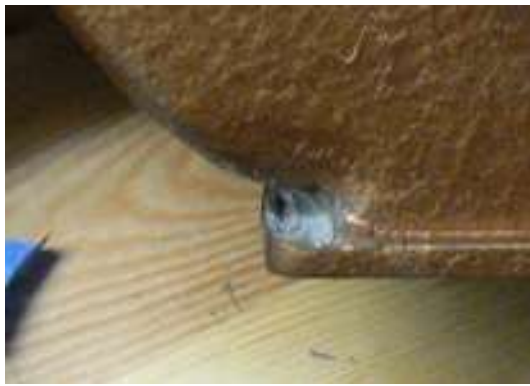
I decided to steal a clip from the other side and make that repaired side 'clippable'.

Crudely ground out the jb weld with a small cutoff wheel., and filed a groove for the clip. Not pretty, but functional.

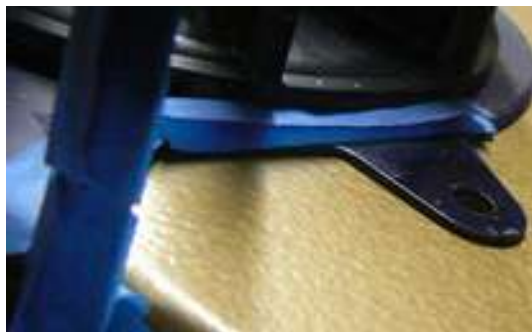
Masking tape with the fold always facing inward(towards the dust side).

Goofed here! Notice the dark triangle. The shroud goes there, not where I placed the tape. Discovered the goof after reassembly. Forced JPW into the crack and crossed my fingers. 😊

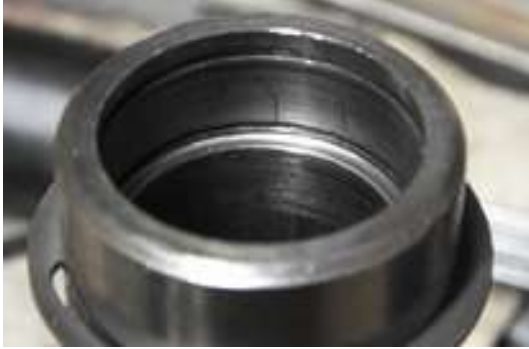
Leaving them out resulted in about 0.040" end play of the shaft. This was caused by the bearing seating too far into the quill. That created a gap between the bearing outer od and the retaining ring.

Herein is the cause and the reason for the unexpected shims.

Apparently a bearing had been slipping and wore the quill by increasing the bore depth.

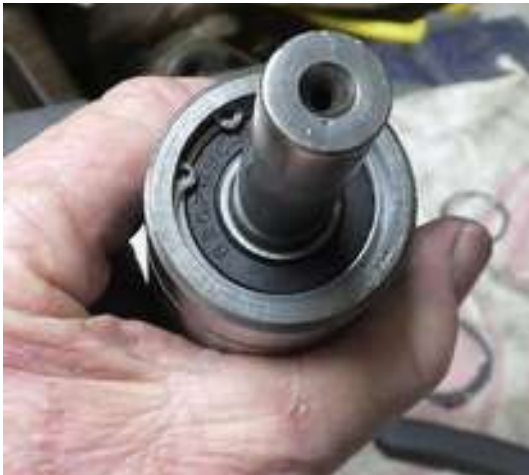
Another problem was the butchering of the shaft flat.

Some judicious hand grinding restored the flat.

I replaced the quill with another of Mark 5 vintage. All that I have are the same on the output shaft end, but Gilmer quills I believe are longer.

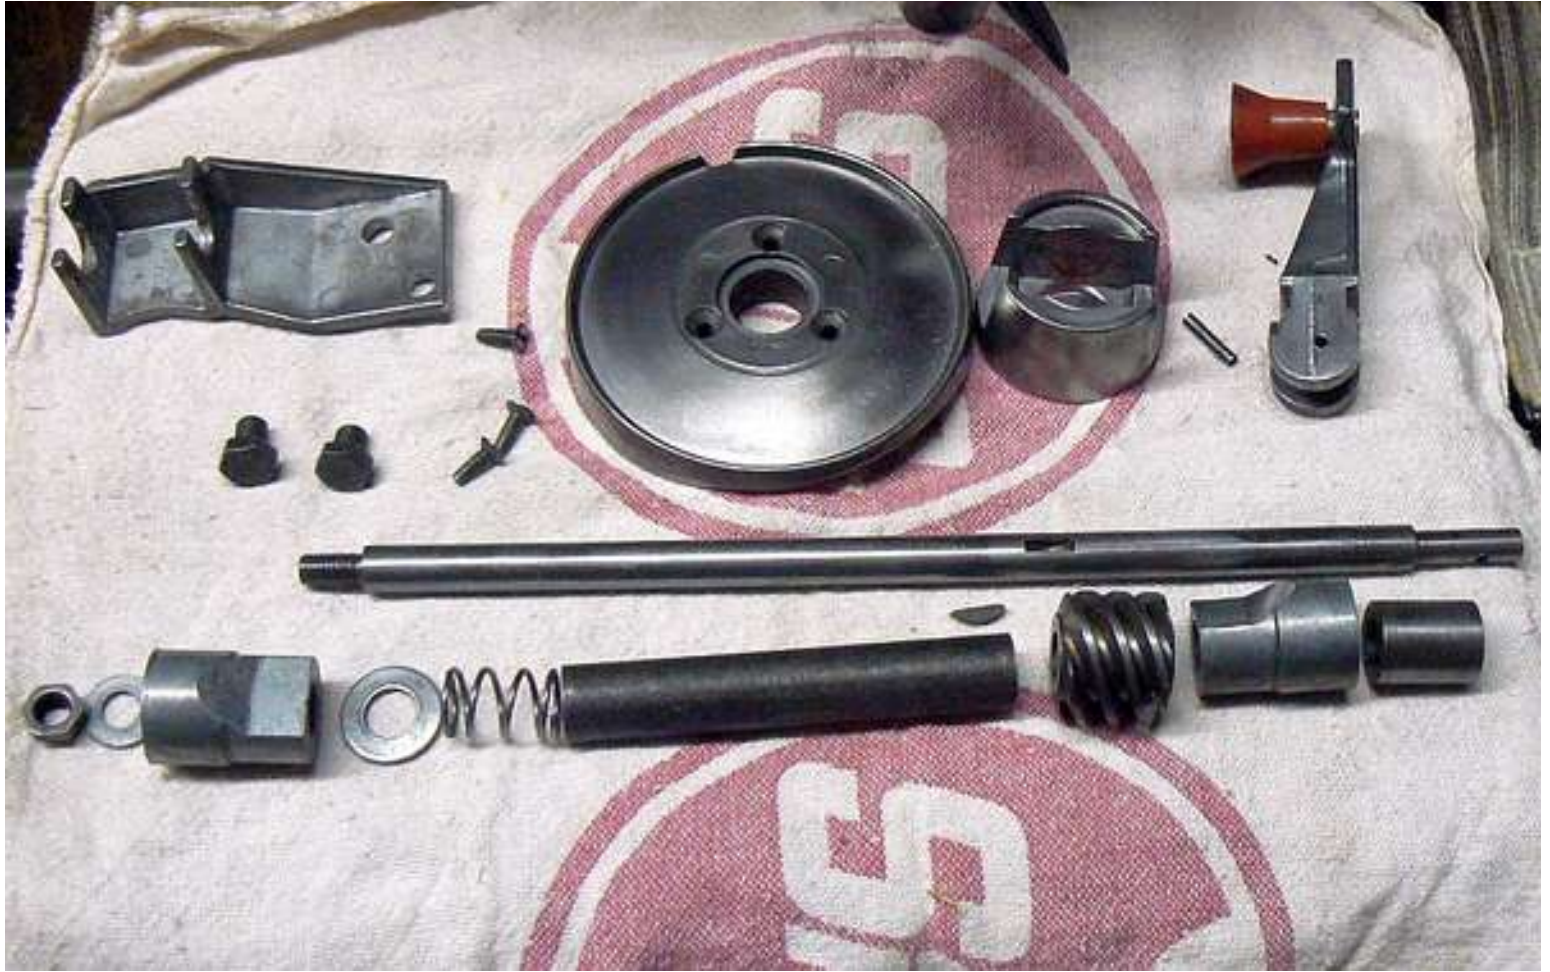
I was not satisfied with either the feel(not smooth but grating) nor the locking function. The front wedge was totally ineffective, and the tension needed to be maxed out for the rear wedge to clamp.

Two things were apparent. The 'spacer' and front wedge did not slide in the bore, but were jamming. There were some small burrs caused by dings and wear. The bore had a protrusion that I believe was caused by the screw that fastens the worm gear bracket bottoming out in the threaded hole. After gentle filing of those parts, they moved in the bore with no restrictions.

Even after cleaning that up, the original problems remained. I finally came to the conclusion that the grating was caused by the extreme tensioning. So after much examining, and much head scratching, I concluded that the spacer between the front wedge and the handle 'cam' was worn to the point of being too short. I slipped a retaining ring on the shaft between the spacer and the front wedge. This acted as a shim to effectively lengthen the spacer.

The shim was located between the spacer and wedge in the bottom right in this pix.

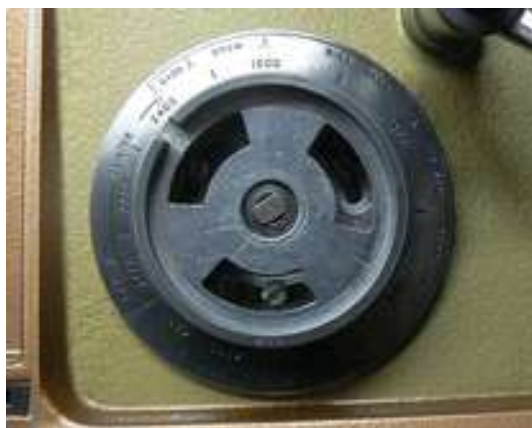
I put it together with the washer 'as found;. The retaining clip for the knob went on fairly easily.

That caused the knob to be pushed out away from the headstock creating a large gap.

Finally the spring washer works best where I found it(between the knob and the base).
