## Mark VII Carriage Reassembly

## Mark VII Rip Fence Reassembly

## Mark VII Table Reassembly

## Mark VII gear rack

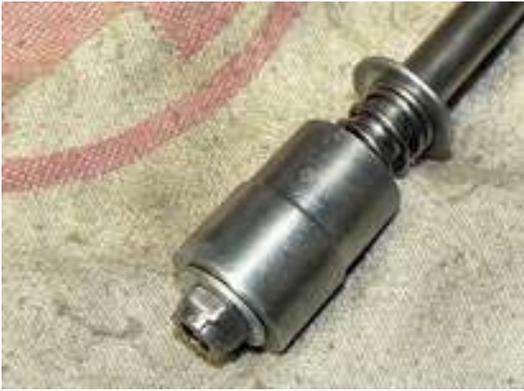
The handle will index to the cam in two positions. The collar anti-rotation hole will be at the top, so the handle 'top' must face the same.

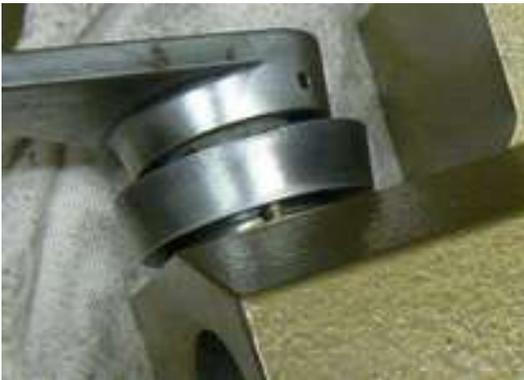
Finally the rear washer, spring, wedge, added washer and locknut. I added the washer since the nut had worn into the softer wedge. Wedge small end again facing in.

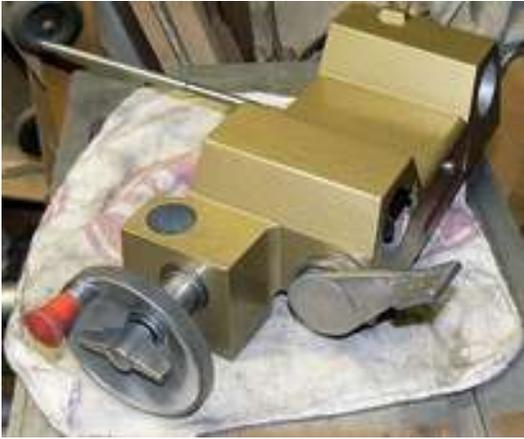
I decided to place the spacing rod jam nut on the inside of the casting. The nut has a 'good' side with a flat ring shaped surface that should face the casting.

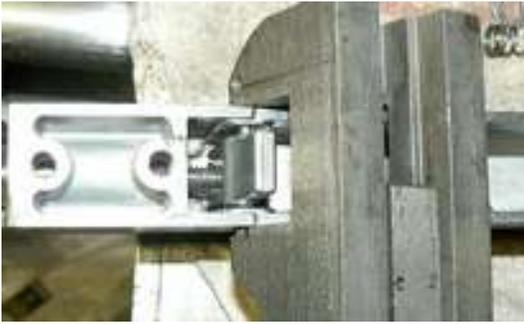
This shows the parts sequence on the front end of the rod. The large washer was not oem. I believe a po rightfully  
\* changed it to this one with a larger od. The handle/clamp was worn by pressing against a smaller washer. The next washer has a large id that allows the sleeve to penetrate it.(the washer slips over the sleeve)  
The washer on the inside end of the sleeve must be inserted after the sleeve is inserted into the bore in the fence.

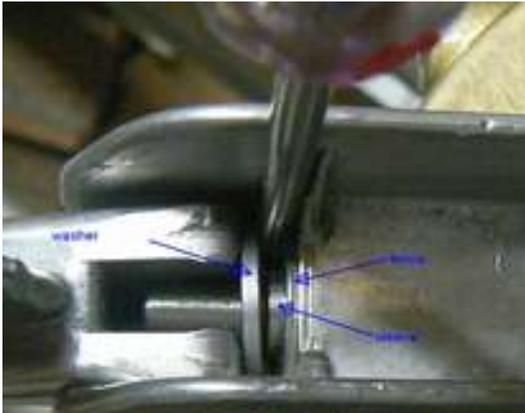
After trying to fit the fence onto the table(s), it became apparent all was **not** well. The large hole washer was causing the front clamp to not **clamp** fully. The sleeve was **not** being pushed in enough to pivot the clamp closed.

The thick outer washer is still a good alteration(wear to the clamp cam surface). The extra thickness can be compensated by rear adjustment nut.

The clamp is not releasing fully to clear the front rail, but by either pulling on the clamp handle or pulling on the rear clamp(moves the rod) the clamp allows fence insertion or removal. Not sure if this is 'normal/typical' but I do not see a good way to increase the sleeve travel(the sleeve moves the clamp pivot).

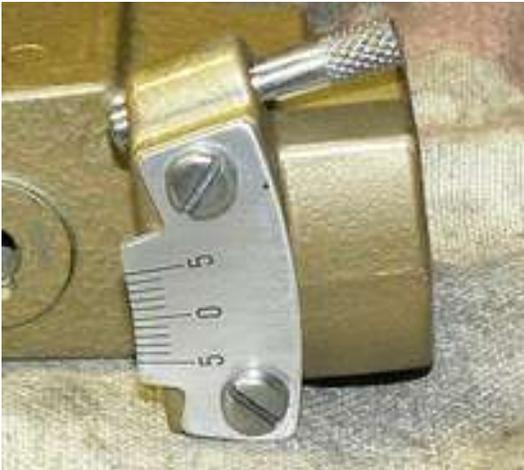
The longer screw also acts as a retainer for the detent pin. The screw passes through the cutout portion of the detent pin. Since these are self tapping screws, care must be taken to insure they are fitting into the original threads.

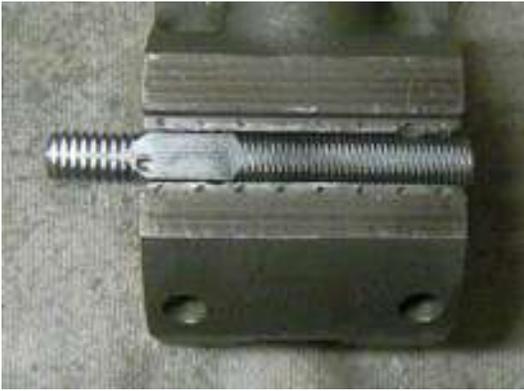
When the trunion clamp screws were removed, both (front and rear) screws were bent. I believe a PO's attempt to secure the screws by peening them caused the bend. The screw in the hole verifies to me the need for them to be straight. The screw remains centered in the segment slot at all angles of 'tilt'. The Mark VII has both a front and a rear trunion clamp. They are identical. This is the rear clamp and does not have a tilt angle index.

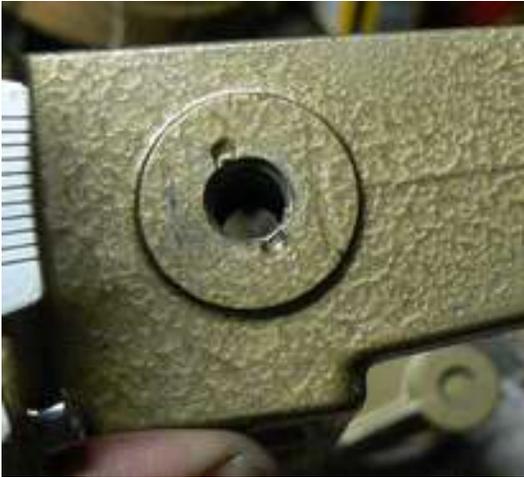
Not as obvious in this pix as I had hoped, but the screw is bent at the inner end on the threads to the left(the end that screws into the trunion). I spent way too much time mulling over how to straighten them. I was concerned re thread damage. In the end, I placed the course end into a large vise, ran a nut onto the fine thread end, and whacked the nut with a wooden mallet. The screw is actually a square bar stock with threads cut into the four corners. So the vise clamped onto the flat part and no thread damage occurred. Not perfectly straight, but much improved and 'good nuf'.

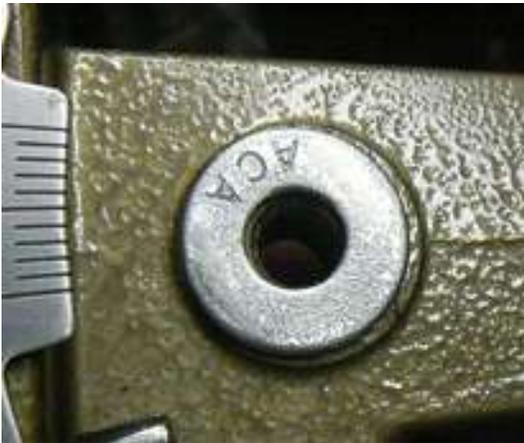
The boss that the rear of the trunion segment presses against has wear and more staking by a PO. I want to 'overcome' both problems.

First thought was to add a washer, but it's thickness leads to requiring further alterations/spacers.

So a thin mylar washer was 'created' from a sheet.

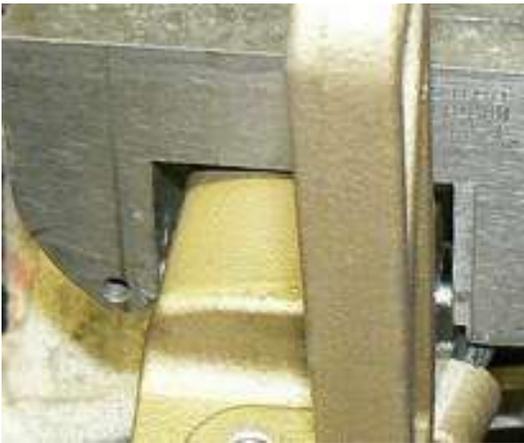
The trunion holes are slightly larger than the post holes. The pins are a tight fit into the post holes. The pins are swaged to provide a wedge fit into the larger trunion holes. There are two pins per post on opposite sides.

After starting the pins on both sides, I used a small vise to squeeze them in place. The span of the pins required me to use the inset at the top of the jaws.

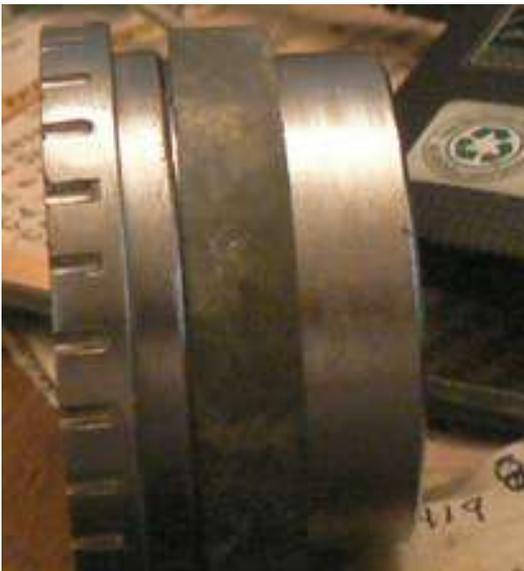
The dimple caused by the set screw pressing against the eccentric was JB Weld filled and filed down.

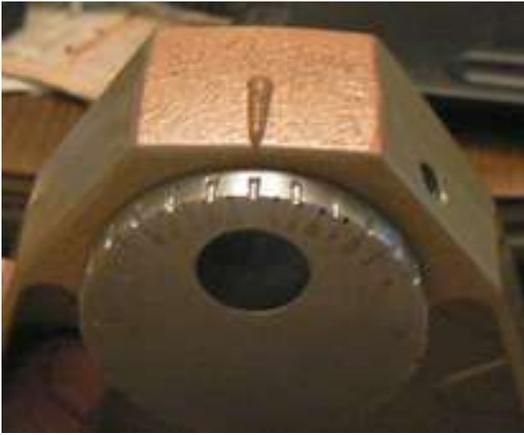
A 3/8" wide strip of sheet metal was formed to a ring to slip over the area of the eccentric that the set screw presses against. This could be up to 18 Ga thick (this one is thinner). I believe this will serve as a sacrificial lamb rather than future dimpling of the eccentric. There really is room in the casting for the 'ring'.

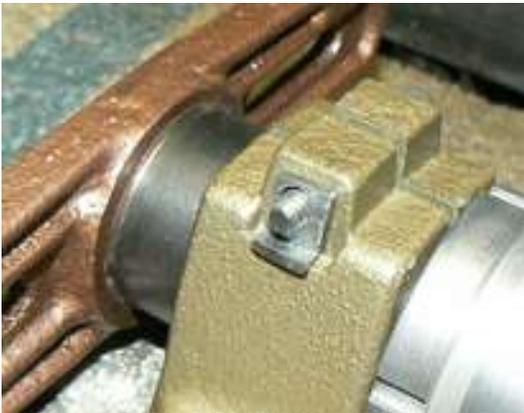
The original shaper fence design(Mark 5 vintage) included 1/4-20 screws and nuts to clamp the fences. The casting had a square(half) shaped cavity into which a 1/4-20 square nut nested. This allowed adjusting the screw with the SS tool kit only. With the Mark VII redesign(and later Mark V) the 1/4-20 screw was replaced with a 3/16-24 screw(and hole) that has a smaller square nut. the casting was not changed, so the nut has excessive space and will turn partially when the screw is adjusted. Part of the reason for this change I believe was the 'standardization' of socket head screws socket sizes.

I initially set out to acquire some 3/16-24 nuts with the same outer dimension as 1/4-20 nuts, but ended up making the 'new parts' instead. A simple L shaped piece with a 3/16" hole.

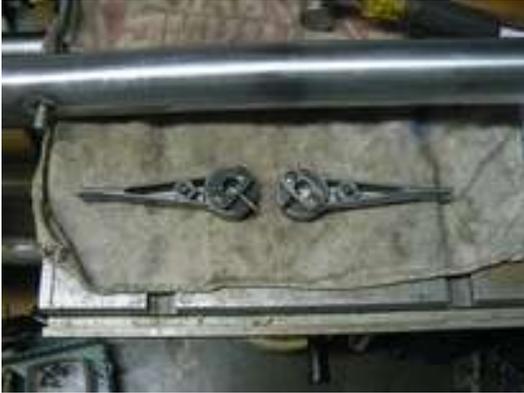
Now comes the 'moment of truth'. The cams will attach to the shaft either of two ways. Notice the 'ends' of the cams are different. The tapered 'end' allows the cam to slip into a 'socket/pivot' on the bottom assembly. The 'shafts are not straight, but bent. All that means they could be attached backwards. 🤪

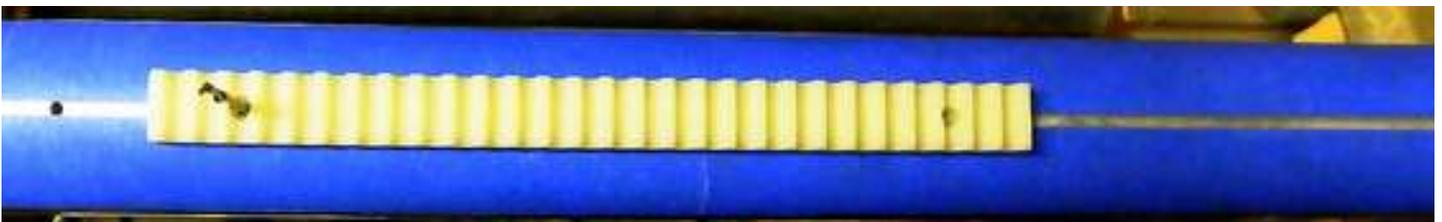
So align one new rack piece using a 0.120 drill bit by using one of the end holes securing the original piece. Then mark the location of the other hole centered between the two tape edges.

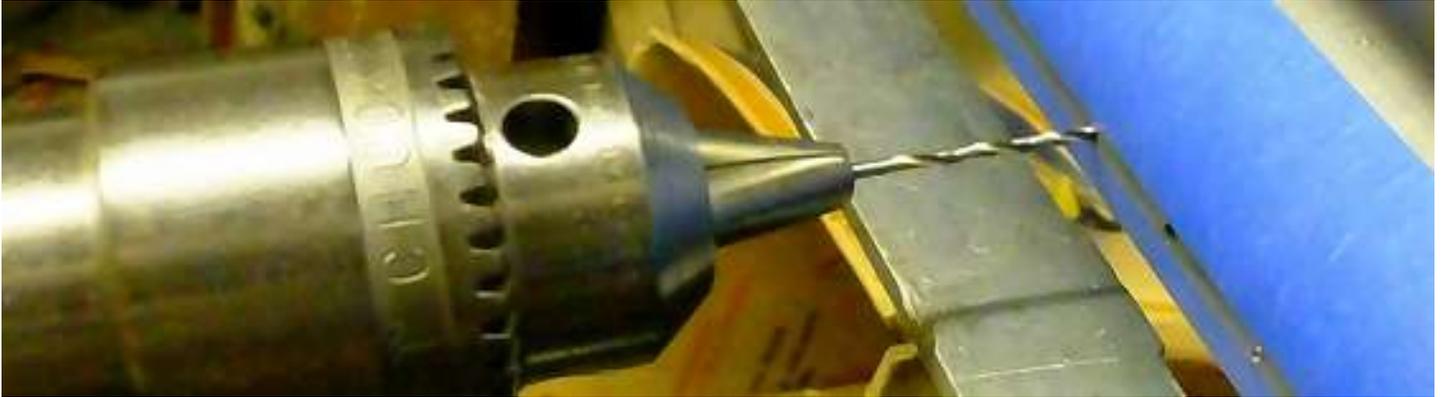
Now for the dicey part. I located the table top  $7/8$ " below the drill bit center. Then used the rip fence to back up the way tube. I manually positioned the way tube horizontally to place the dimple directly in line with the drill bit. I used the smallest bit the chuck would securely hold to drill a pilot hole. It is quite easy to break a bit unless you hold it all very tightly. I find that clamping does not allow me to make minute position adjustments. The drill bit will let you know the way tube needs tweaking without breaking. A product of much practice. 😊

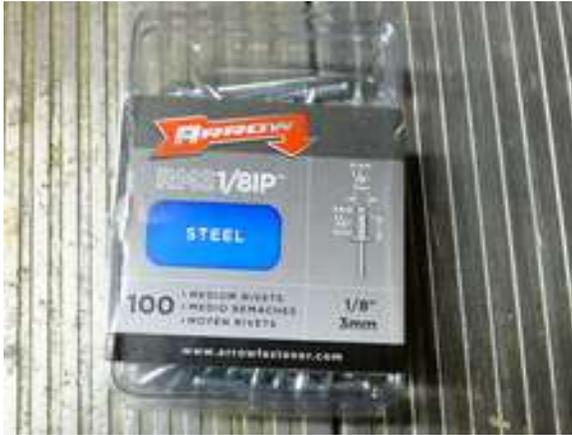
As just mentioned pop rivets like the originals(I have never ever seen them elsewhere). The closest I could locate were supposedly 3mm(also 1/8"????) but measured 0.122" (3.09mm) so I bit the bullet and enlarged the holes. The new rack pieces needed to be enlarged also.

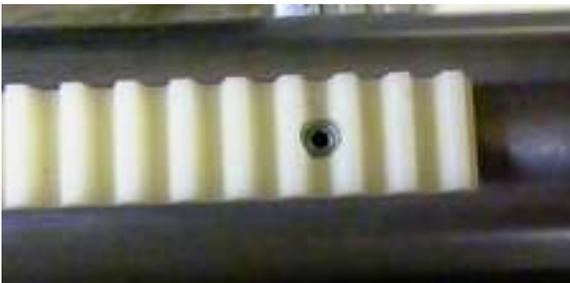
FINALLY! It is time to get out the pop rivet tool. I needed two squeezes to break the pin loose(a result of both the added spacer and the parts being less than the 'grip range'(1/4"). It is easier to only set a half pull the first time then go all the way the second pull(the tool gives greater leverage at the end of the pull where greater pulling is needed to break the 'pull pin').
