## Refurbing a Scroll Saw by JPG

I acquired a ss mount Scroll Saw in 2011 and have decided to take Y'all on the journey to restoring it. It is not in bad condition, but is in need of 'cleaning' up and some TLC and a few parts replaced. The PO had a sick spell and he had not used it recently. He was acquiring 🤪 Stand alone:EEK: replacements. Real nice Guy!!! Never met him b4.

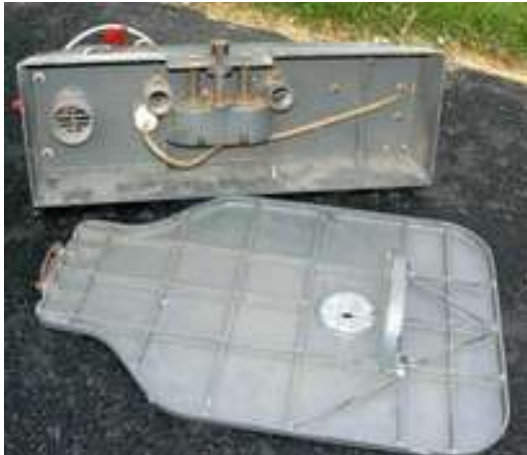
Before from the bottom

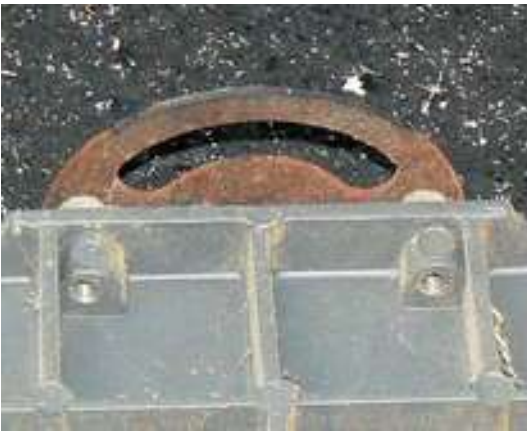
Before rear trunion

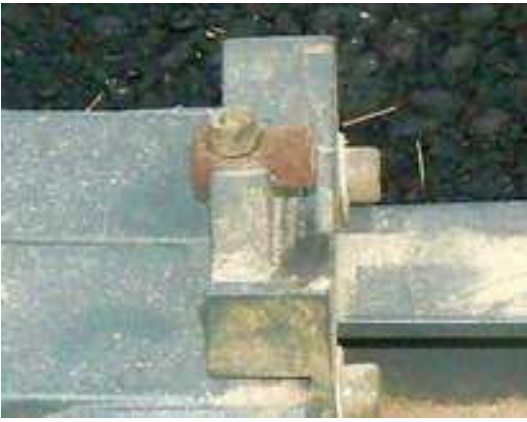
Before rear trunion pin

Not sure it is significant, but the rear trunion pin was loose. I do not know if the PO loosened it to make tilting easier. I doubt it and think it just came loose on its own.

As I mentioned earlier, the pin was loose on the rear trunion. The reason it was 'loose' is that the trunion bracket does not provide adequate clearance for the segment to rotate in the bracket.

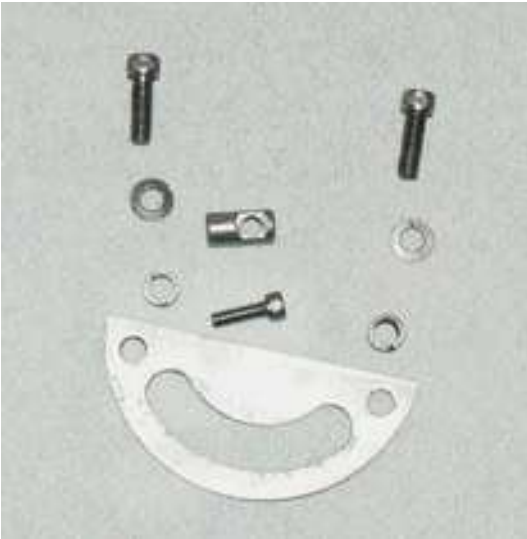
After evaporust wire brushing and JPW(original)

The evaporust removed the black oxide as well as the 'red'. I will retain the 'natural' finish and hope the wax does its thing.

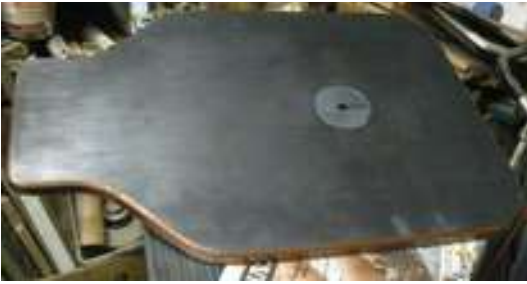
Table after

Not as evenly colored as I would have liked. Discoloration removed by light wire brushing. The original finish is quite rough so polishing is out of the question.

I decided to change the gray color to the Goldie combination. I discovered the original gray paint is impervious to Citrusstrip AND Lacquer thinner. Therefore the original gray is now a primer! The outer edge of the table and the trunions are painted Rustoleum Hammered Coppertone.

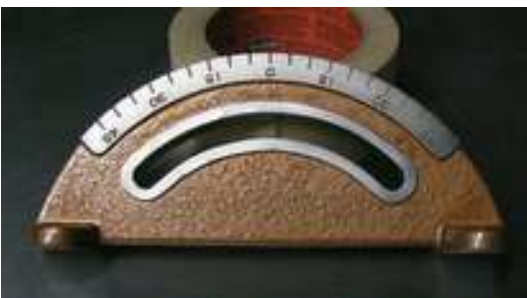
Front Trunion After

The upper arc(lower in the upside down pix) was masked off. The degree scale was painted over, then after the paint set slightly, masking tape was pressed onto the areas where I wanted the paint removed. Once the paint was nearly dry, light rubbing with a cloth and citrustrip removed the remaining undesired paint between the lettering.

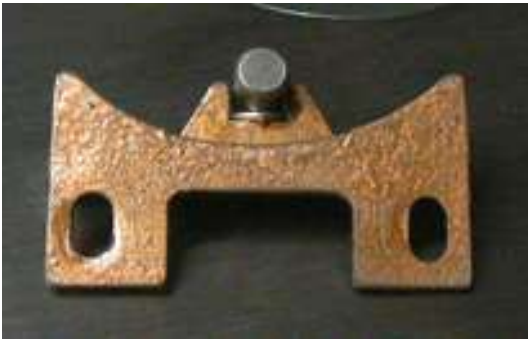
Rear Trunion Pin shimmed

**EDIT** I have since 'discovered' this was intentional so it could act as a clamp.

The pin needs to be shimmed about .060". The washer is about .050 and the paper under the washer is about .010. I will fabricate something close to .060 thick prior to reassembly.

I scavenged a piece of steel about .060" thick, and made a shim for the rear trunion pin.

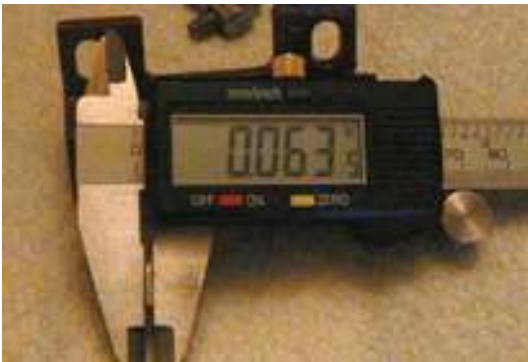
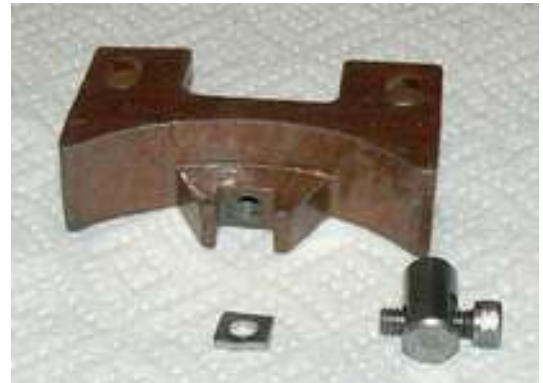
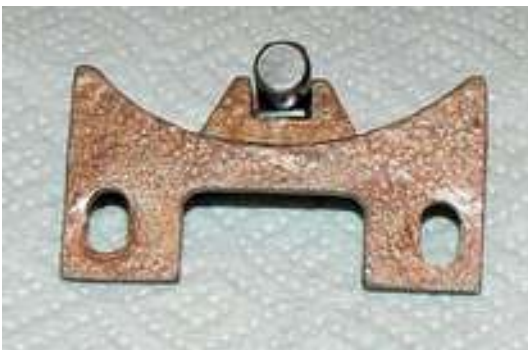
The material was originally a cheap stamped faucet wrench in a box of garage sale junk.

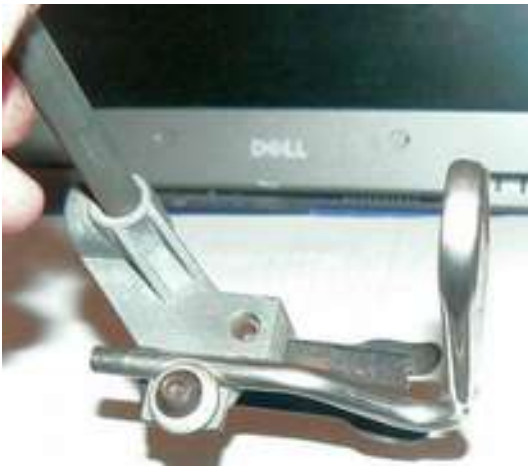
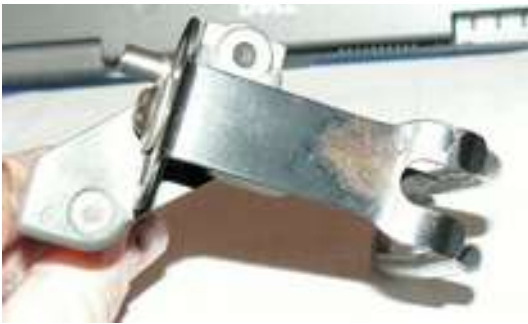
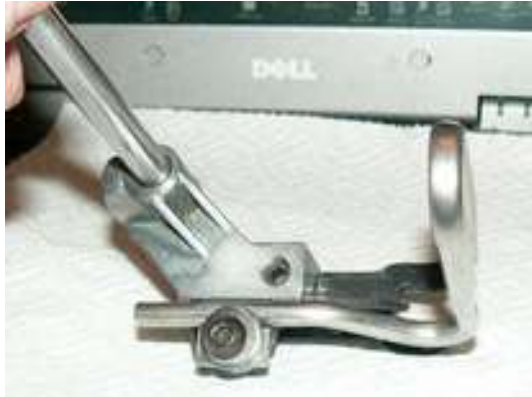
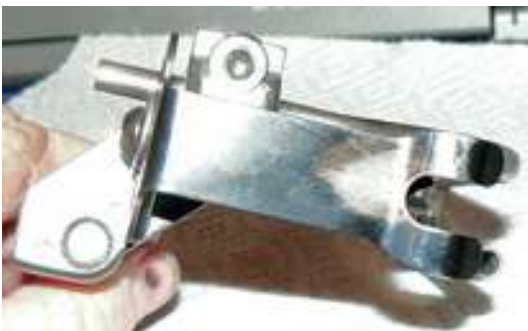
The rust was light and scattered on the black oxidized parts so I spared them the Evaporust soak. Gentle sanding with 800 grit paper flattened the rust with minimal black oxide removal.

The casting was fine wire brushed as best I could. Deep interior areas were left as is. The mounting post was chucked in a drill chuck and first 220 grit then 800 grit was used to remove the grunge.

Everything(including screw threads) received a JPW(original) coating.

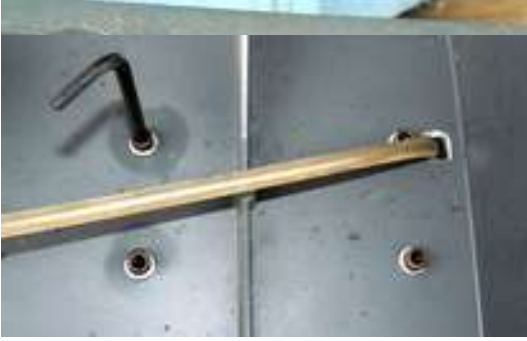
Overnite with a drop of 'TC-11' in each end made the 1/8" tension pin come out easy. TC-11 is a penetrating/rust preventative that is near impossible to locate today. The connecting rod attaches to the lower arm with a shouldered screw through a ball bearing.

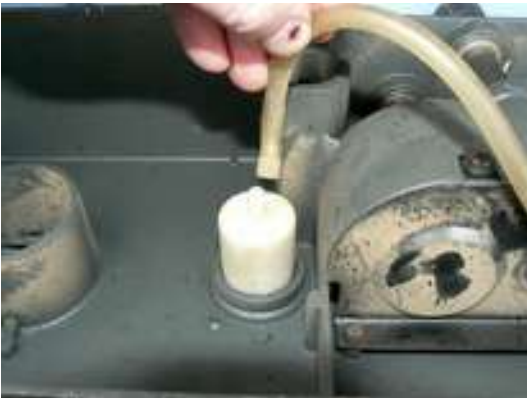
The air tube slips off(both ends).

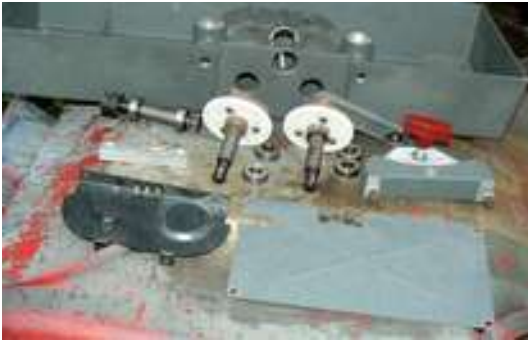
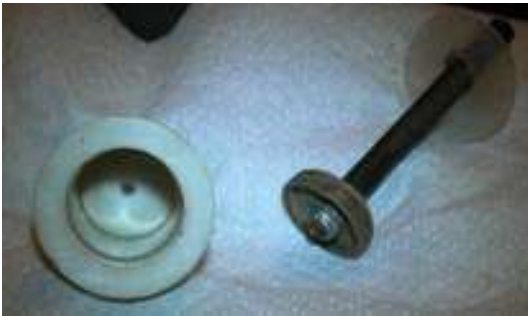
Now the fun begins. Taking it apart. The first pix shows all the parts removed from the lower base assembly. The pix following are details encountered as it was disassembled. The sheet metal cover(s) removal was uneventful so no pix were taken of removing them. Neither were the removal of the front trunion clamp nor the blade alignment jig. I assume it was the PO who attached it to the base.

Once the flat plate was removed, the air pump was free to be removed. Simple pump with no valves. The piston leather seal allows air in when it is 'retracted' and forces air out the bottom when pushed into the bore.

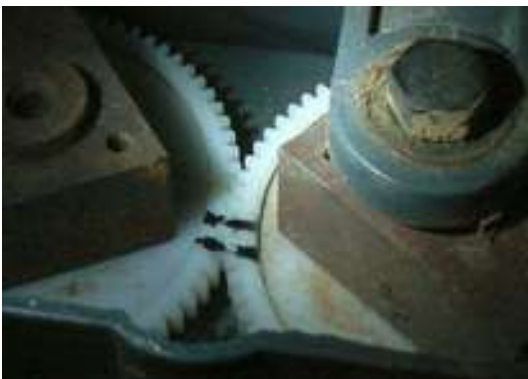
Not expected was the one tooth offset of the counterbalanced gears. Not sure that was intentional.(?) I'll decide at reassembly whether to keep them that way.

Notice the inner end where the shaft rode on the bearing. Due to both the wear and looseness, I decided to use locktite blue sparingly as I installed them(all 6)(inner and outer races) into the lower assembly. Since this was done as previously described, I will not repeat it here. However I did align the two counter weight gears with no tooth offset. I decided I probably allowed them to slip while disassembling since I did push in on the left shaft prior to the 'off tooth' pix.

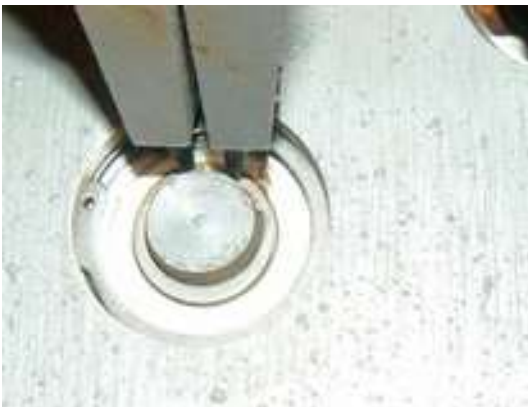
The shafts were retained by a small retaining ring. The outer bearings have a larger retaining clip also, but they did not need to be removed since once the shaft was free to move(in), the shaft and bearings were pushed out the back. The spacers on the shaft maintained the spacing between the inner and outer bearing on each shaft.

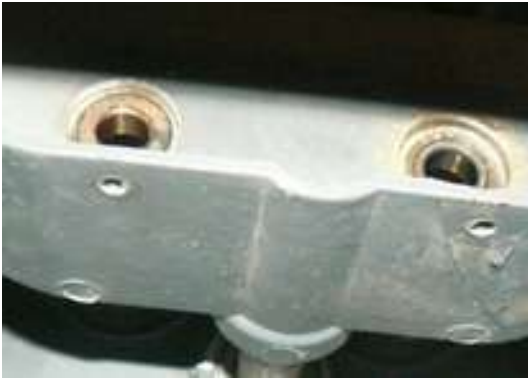
A surprise was what appears to be a shim washer behind the left rear bearing. **EDIT** I need to mention that there was a shim washer on the back of the right rear bearing also!

An additional surprise was that all the bearings are NOT metric!

The six drive shaft/cam/counterbalance bearings are all 1/2" id x 1 1/8" od x 3/8" wide. 1616ZZ

The two connecting rod bearings are 3/8" id x 7/8" od x 1 1/32" wide. 16042RS **EDIT (2RS) not (ZZ) Sealed not shielded.**

All the bearings are rubber sealed. **EDIT The six drive shaft(s) bearings were 'shielded', not sealed.**

They all appear to be in good condition so I may reuse them. Only the connecting rod bearings seem to have a slight amount of 'play';.

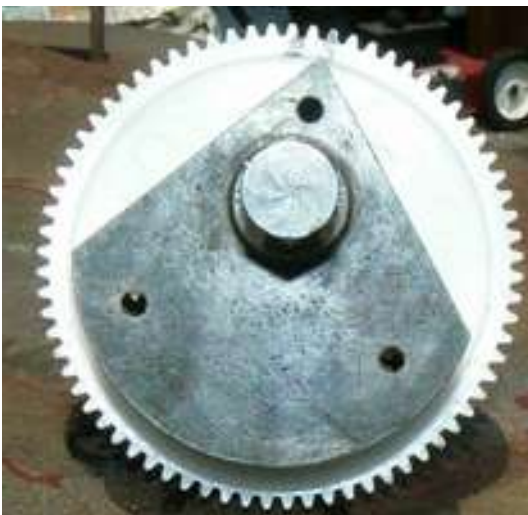
The counter weight and shaft were reattached to the gear in their original locations. The gear is secured to the counter weight by three screws with split tooth lock washers. These need to be tightened **securely!**

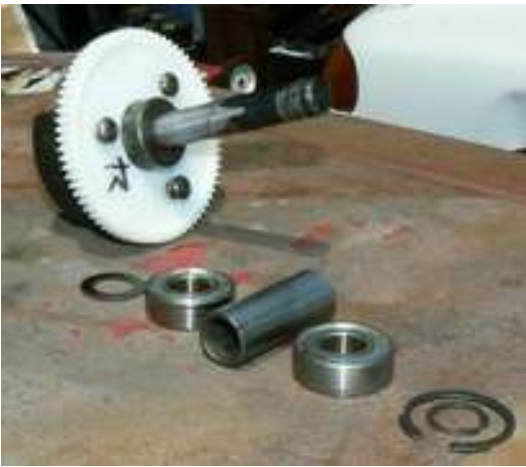
This pix shows the assembly sequence of parts on the shaft. The pix following show the sequence I followed. The large retaining clip fits into a groove in the base casting bore. It prevents the bearing(and shaft etc.) from coming out the front of the bore. The small retaining clip fits in a groove in the shaft. It prevents the shaft from moving out the back of the rear bearing.

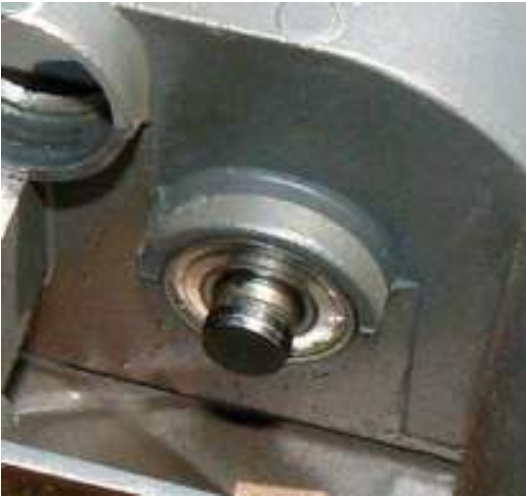
The rear bearing is inserted into its bore. The bearing is inserted from the front as the back of the bore has a lip which prevents the bearing from moving out the rear. The shim washer is placed on the shaft, and the shaft is inserted into the bearing from the rear. We shall see whether this is possible with new bearings!

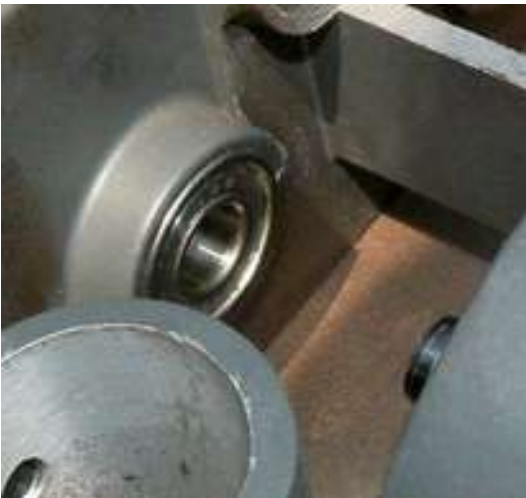
The front bearing is inserted into the front bore from the rear(the presence of paint or the retaining ring makes that necessary). Originally the area between the retaining ring groove and the front was unpainted - tis now(intentionally). We shall see with new bearings if that will remain!

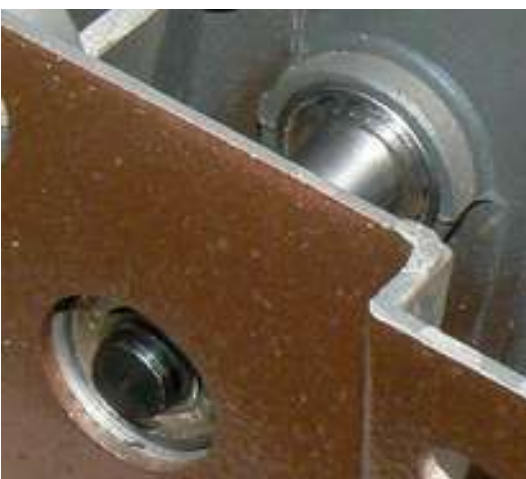
The spacer is slipped onto the shaft and the shaft is pushed through the front bearing. Both retaining rings should now be installed.

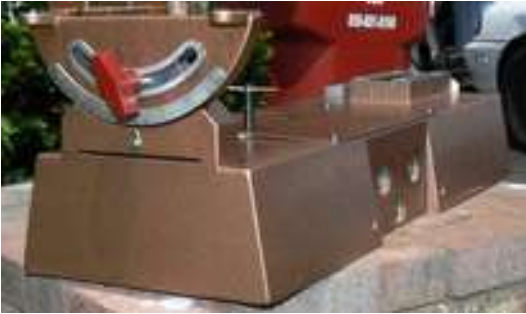
While the counter weight were 'soaking' the base was prepped for 'recoloration'. Only the outer surfaces were painted over the original gray 'undissolvable' original splattered gray paint. Various other parts were painted to match.

If you do not know already, the paint being used is Rustoleum Hammered Coppertone. The upper assembly will be painted Rustoleum Hammered Gold.

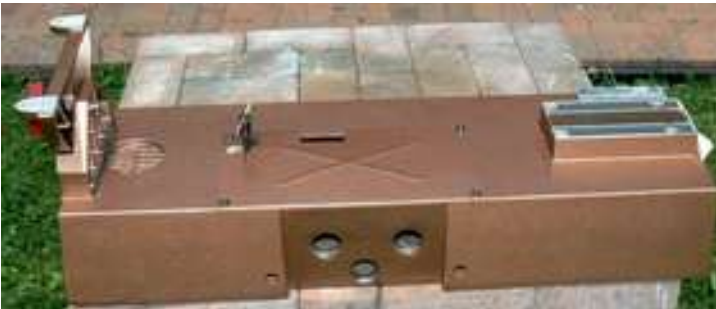
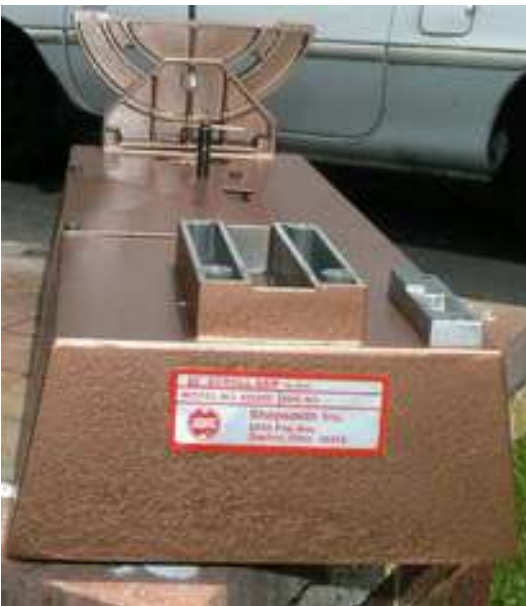
The label was initially masked off prior to painting. When I peeled the masking tape off, the label came with it leaving a very pretty gray area where the label once was. 😞 Had to repaint over that! :eek: The label may or may not stay put, but I am hoping an afternoon in the sun will make the adhesive stick. If not, more effort required.

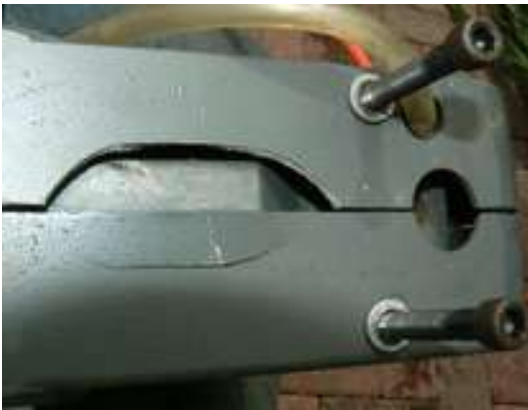
Got a surprise damage! This is under the lower arm.

Apparently the PO allowed a loose screw to get trapped.

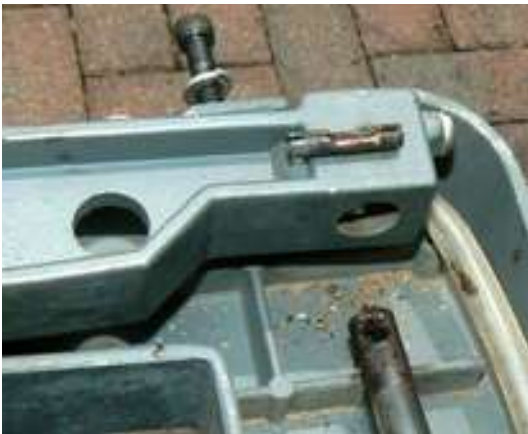
Badly worn roll pin. Attached tensioning rod to lower arm.

The tensioning rod is worn at the roll pin bore and is also bent. Apparently that part is no longer 'available'. I do hope that upgrading to the newer blade tensioning will be an option. I assume I will need a different(new version) tensioning rod.

The roll pin that connected the air pump shaft to the lower arm will be replaced also. No where near as worn as the tensioning rod pin.

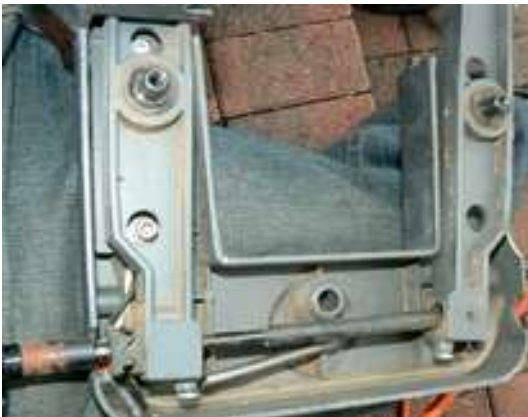
Broken spring.

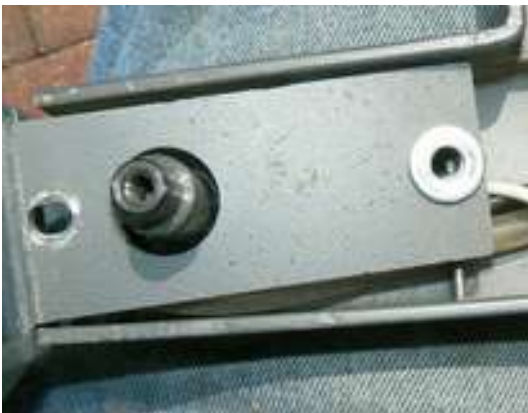
Extra washer. I think PO added it because the threads are jammed in the arm preventing full tightening.

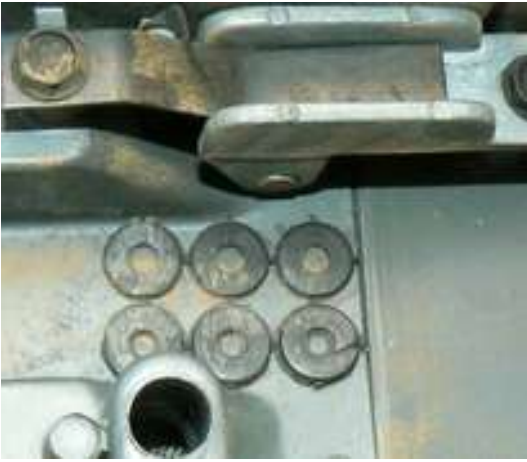
I think the PO added a 'silencer'.

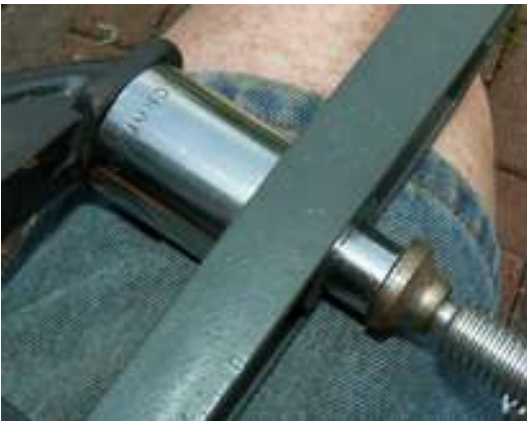
Shade tree bushing press.

I decided to replace the bronze bushings and 'shafts' since the arms had side to side play. The wear was mostly to the bushings. They are 5/8" x 13/16" x 1" flanged bushings. Found some at 'MSC'.

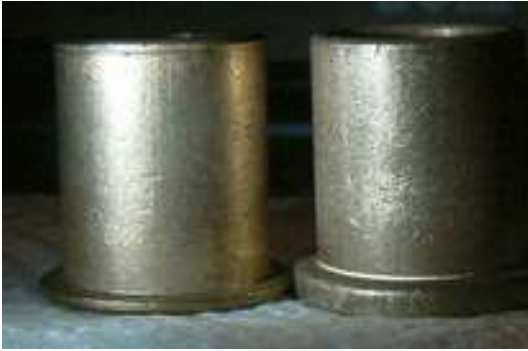
Well the bushings arrived and SURPRISE!!! Although all other dimensions are 'correct', the flange thickness is twice the original.

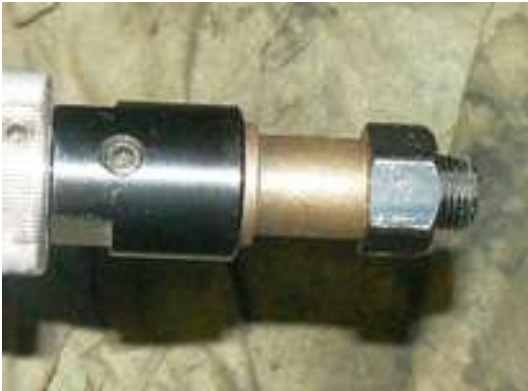
Bushing 'Arbor'. The sawdust gremlins who reside on the floor stole the keyed washer which I DID use when modifying the bushings.

I first roughed out the flange with a 1/2" skew then filed(while turning) and finished up with a small jewelers file. I got very close to the dimensions of the originals(so close I will not say since I do not believe it myself).

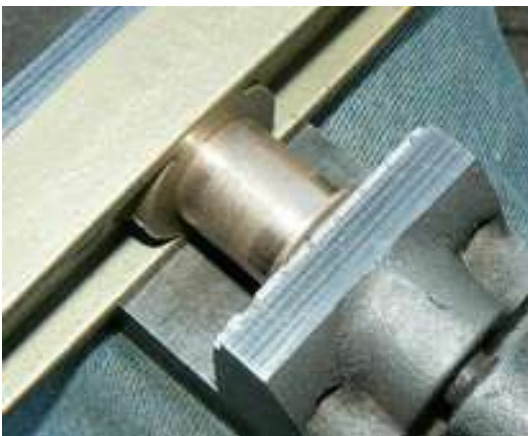
A little more accurate press than the shade tree one.

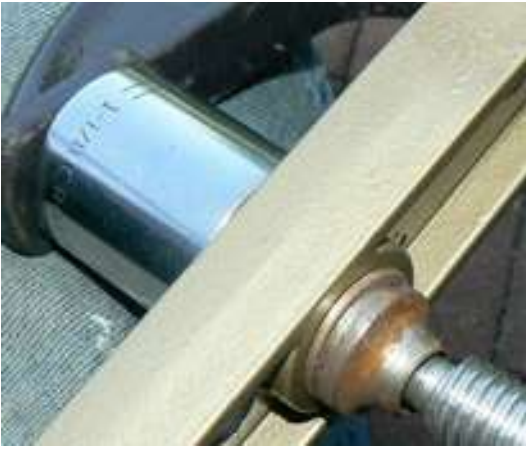
Finally the flange was seated fully since the other end of the bushings is proud of the opposite side of the arm.

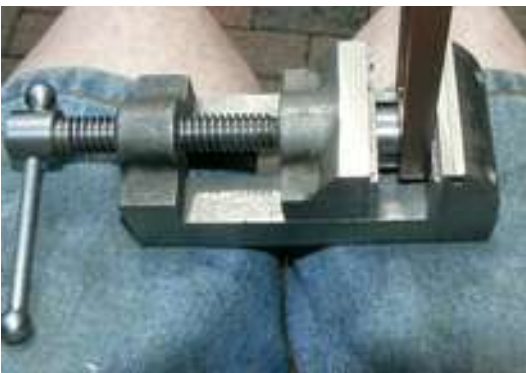
The smaller connecting rod bearings were a tight fit. The inner race is tight against the arm/cam when the shouldered screw is tightened(no locktite needed).

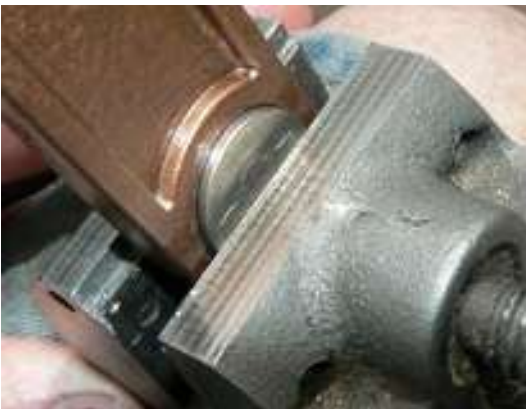
I used a nickel to position the bearings close to the center of the rod casting.

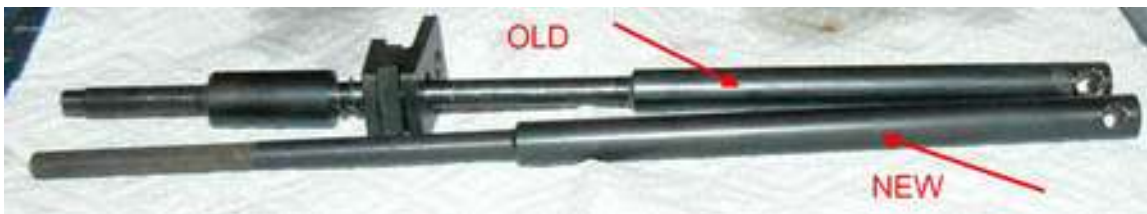
The old and new tension rods are almost the same. The old one has a relief on the knob end and a 6-32 tapped hole to secure the center part of the knob. The larger portion(3/8") is longer, but is not 'functional'.

The new tension rod is slightly longer than the old one and is threaded all the way to the end and does not have a tapered hole in the end. As I will show later, adding 1/4" between the tensioning sleeve and the bottom of the adjustment knob compensates for the different positioning of the knob further out on the tension rod end.

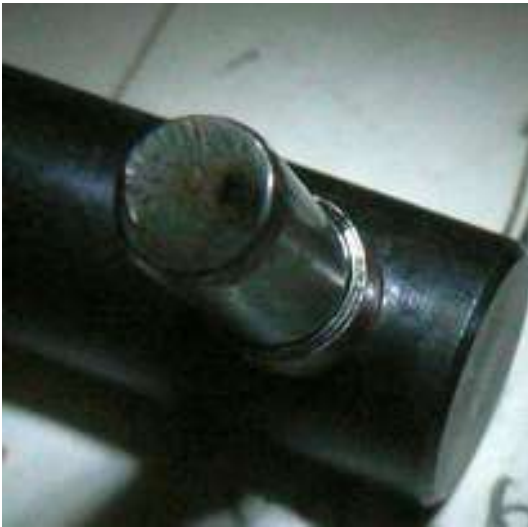
The original roll pin was severely worn so I measured the pin and the hole(both **new** parts) and found the hole to be .212 that a .187 roll pin goes into. I decided to do two things differently. 1) use a hardened dowel pin(.187) rather than a roll pin. 2) Shim the hole. I added 3 layers of aluminum pop can between the pin and the outside of the hole in the tension rod. That decreased the hole diameter by about 0.018. Since the rod needs to rotate on the pin, that is all I dared shim it.

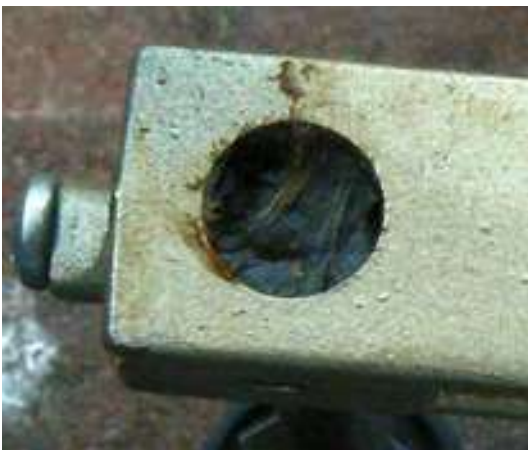
The pin hole was packed with grease to provide lubrication. I believe the original was also. I believe the extreme wear to both the tension rod hole and the roll pin was due to the amount of play between them. The roll pin hammered the tension rod hole as the saw was operated. The creased side of the roll pin increased that 'slop' as it wore down. The opposite side suffered little similar wear.

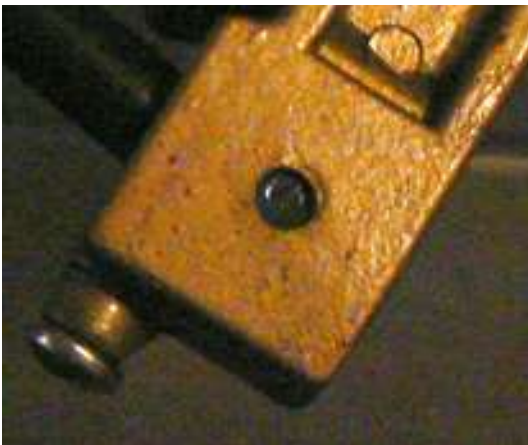
Since the dowel pin was shorter(.750) than the roll pin(.875), the pin does not extend to the outer ends on the hole in the lower arm. I centered the pin in the arm hole and used blue locktight on both ends. Strange lighting used so the arm though gold, looks 'coppery'.

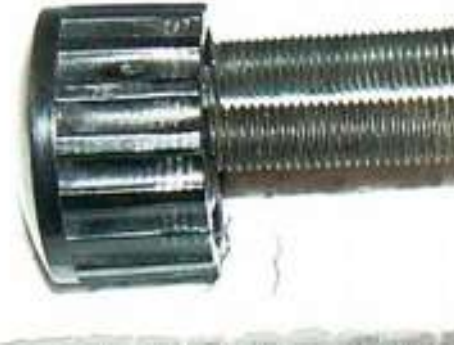
The knob on the new tension rod is about 1/4" further away from the pivot end than the old tension rod as shown by the mark on the paper.

The old parts were used with the new tension rod. 5 3/16" flat washers(1/4" hole) were added as a spacer.

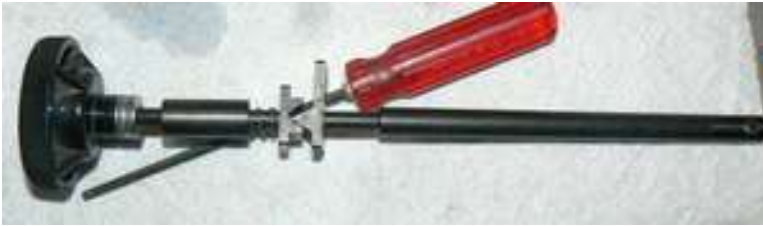
5 3/16" flat washers provided about 1/4". This places the outer knob in the proper position relative to the center knob. The center knob is a detent for the outer knob. The outer knob applies pressure against the tension sleeve and spring.

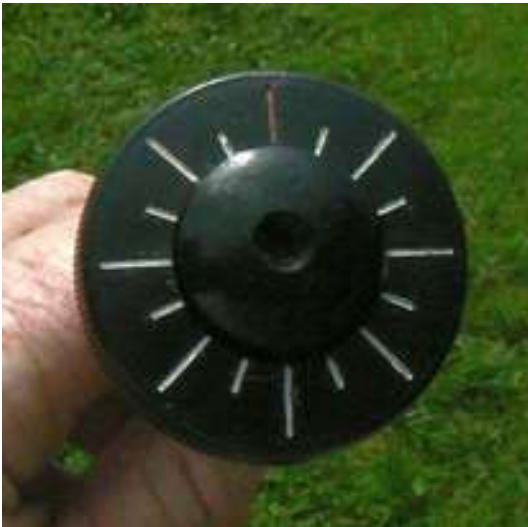
The PO had marked one of the knob 'lines' with red nail polish. I kept that, but also whitened up the remaining 15 'lines'.

By tightening the center knob against the end of the tension rod, I think it will stay put. If not, there is that blue stuff! The center and outer knob must be kept close to the original positioning relative to each other since a ball bearing and spring inside the outer knob that presses against the detent grooves on the inner knob. If the outer knob is screwed down too far, the ball bearing drops into the outer knob.

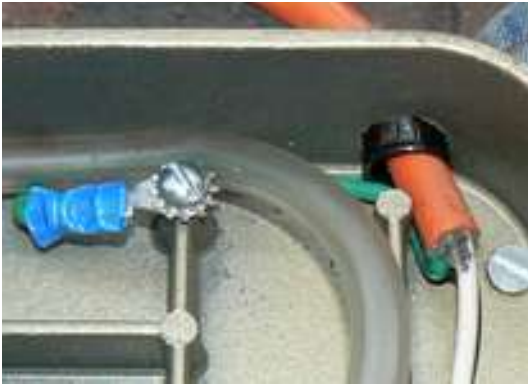
The small boss near the top had a hole in it and I tapped it to 6-32 so as to provide a grounding point for the power cord. External tooth lock washer both above and below the terminal. The paint was scraped off the boss so the lock washer did not have to penetrate that. The outer sheath of the power cord was removed since there is precious little room for it and the air tube.

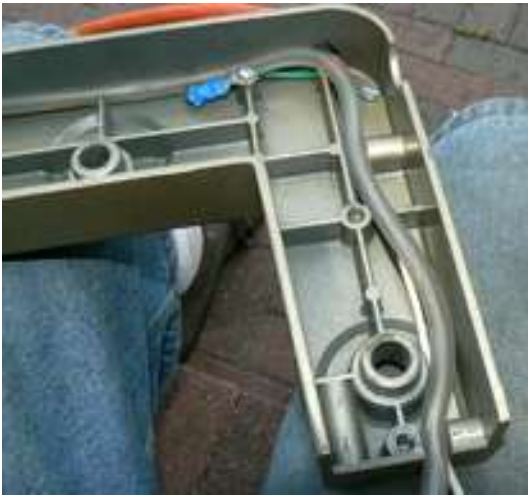
The lamp wires and the air tube were snaked through the right side. Keeping them in position while attaching the arm cover was a PITA, but it eventually got done. Too many potential pinch points to ignore!

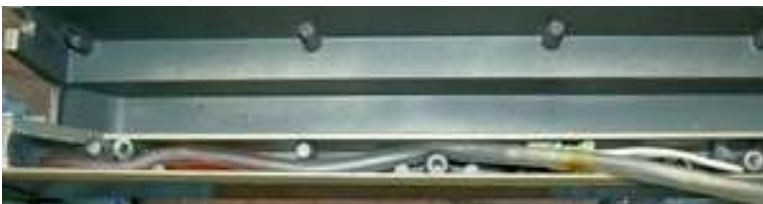
The web that the wires and air tube must pass through in the arm cover was deepened to make room for them.

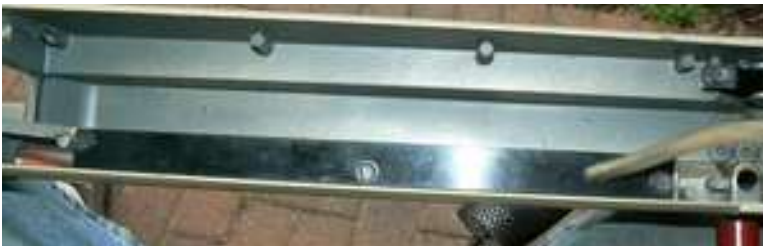
Not easy to see, but I inserted a short piece of the power cord outer sheath over the wires as they entered the arm cover. The wires and air tube were routed as shown. I added disconnect terminals to the lamp wires.

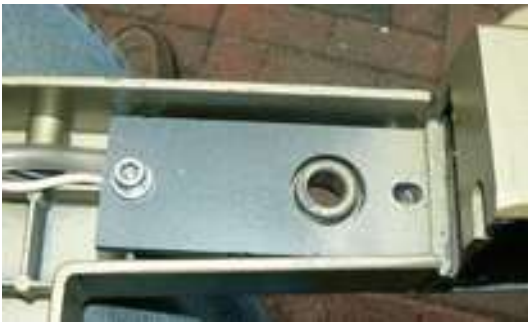
This is out of sequence, as the single screw securing the arm cover to the right side has to be done before routing and covering the wires and air tube in the cover as shown in the previous post.

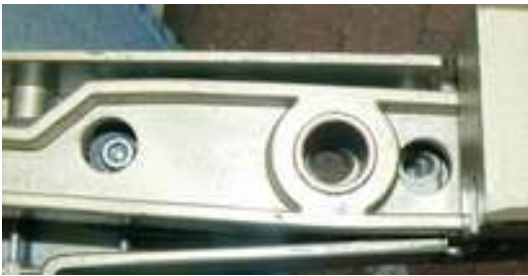
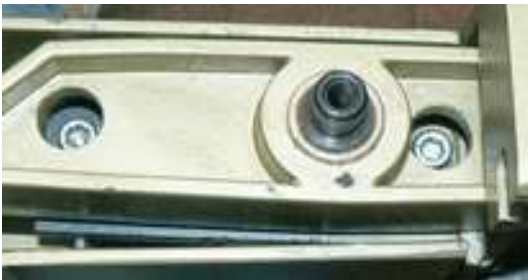
Slip the upper arm into the arm cover and into the right side.

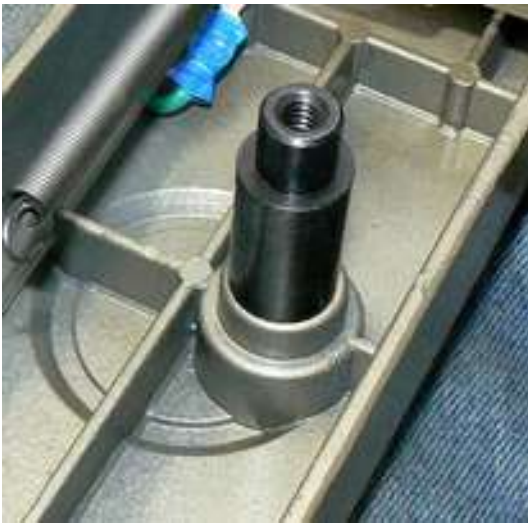
Install the upper arm shaft and secure it from the outside end with the flat washer, lock washer and screw. It must be inserted through the arm bushing and into the bore in the right side. The second screw securing the upper arm cover can be installed and tightened through the hole in the arm. I aligned the cover mounting tab to square it with the top of the right cover, and pushed the cover firmly against the right cover while tightening the two screws.

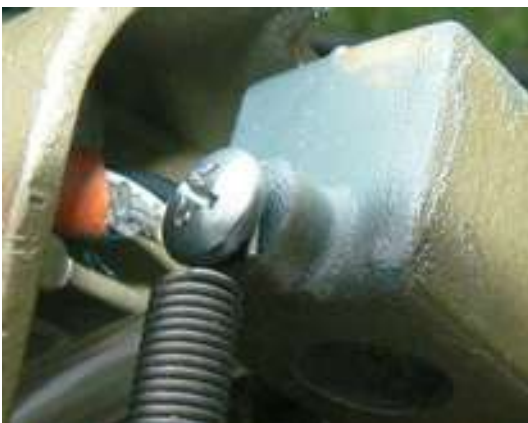
The tension spring was attached to the upper arm. Note the positioning of the loop on the end of the spring.

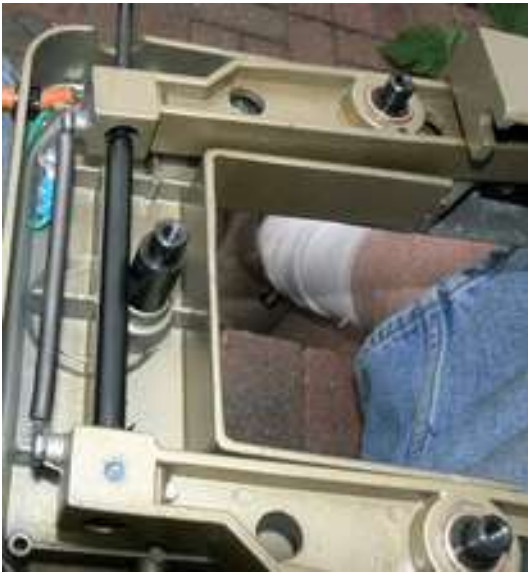
Place shaft in lower arm bushing, place into right side bore, and secure with flat washer, lock washer and screw. Attach free end of spring to lower arm.

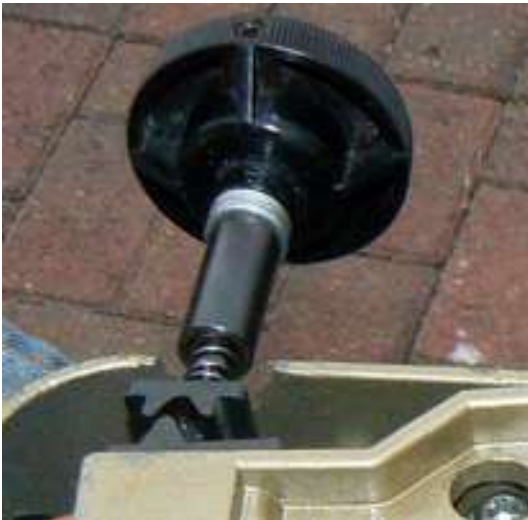
Not clear from this pix, but the rocker assembly is secured to the upper arm by a screw.

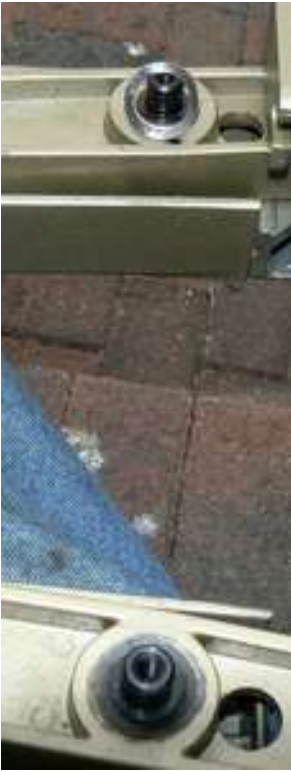
Position the left side onto the three shafts then, shims are inserted between the left side and the upper arm cover and secured with the screw, flat washer and lock washer. The ss parts diagram shows one shim. but there were two when I disassembled it.

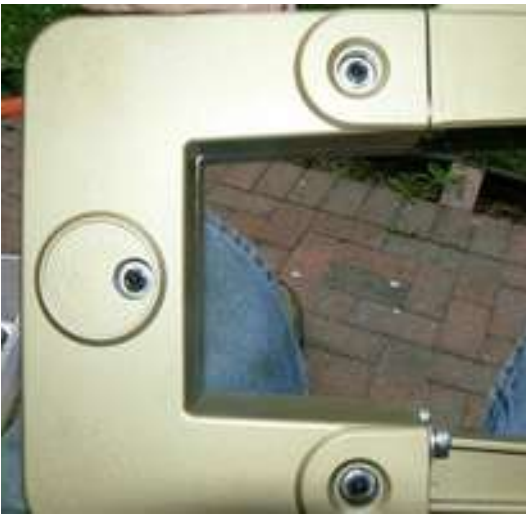
Finally secure the left side with three screws/flat washers/lock washers.

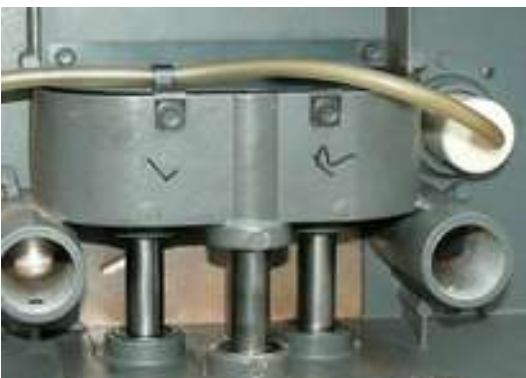
Air tube is attached to the air pump outlet and slipped under a tab on 'counterbalance cover'.

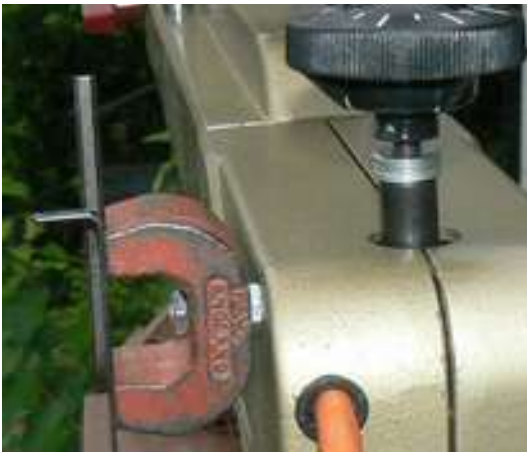
As promised, here is the 'tool' holder mounted using the po original power cord strain relief hole.

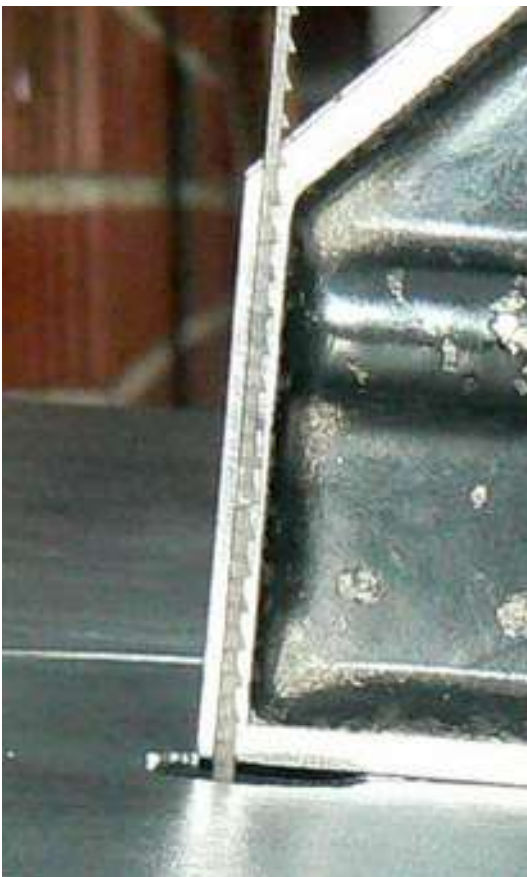
Front to rear blade alignment. This is adjusted by moving the rear trunion arc up/down. Although the 'shimmed' rear trunion is a bit 'sloppy/loose' I am keeping it as is. IMHO it is does not move enough to affect cutting accuracy, and eliminates the need to loosen it when adjusting table tilt.
