## MARK VII SWITCH MODIFICATION FOR REPAIR

Brandon M. Ausmus

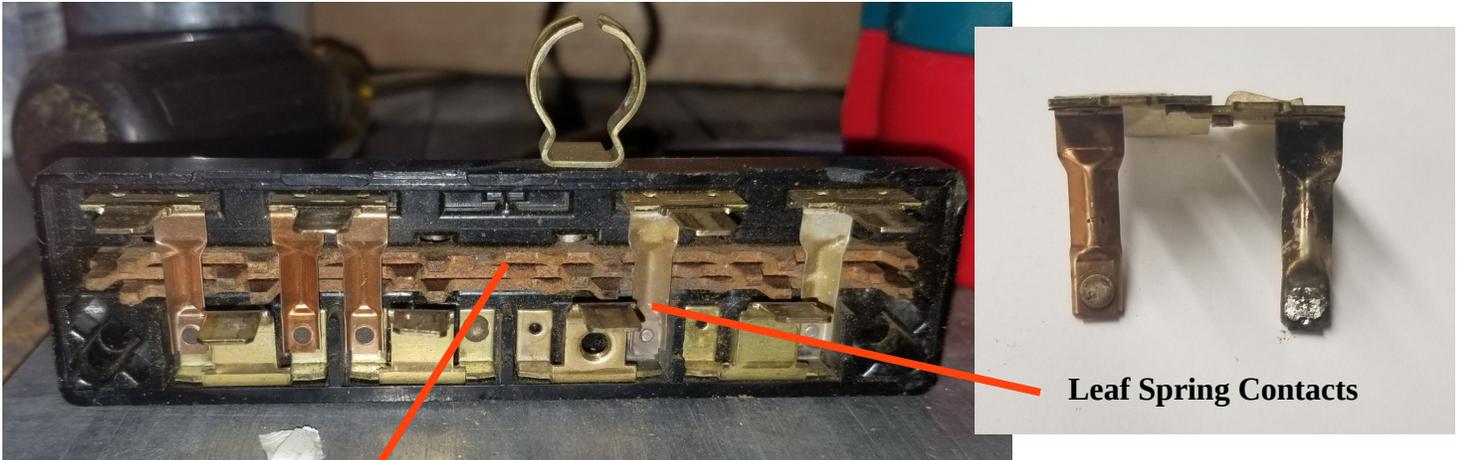
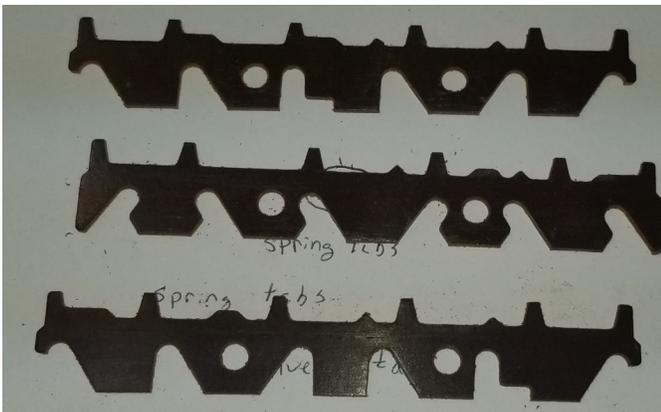
**Formica selector boards**

Inside the switch are three formica selector boards that move into three different configurations and press leaf switches up or down for each of the FWD/OFF/REV states. Over time, the leaf switches get dirty from arc fouling. This modification will allow a user to inject sensor safe electronic contact cleaner into the switch.

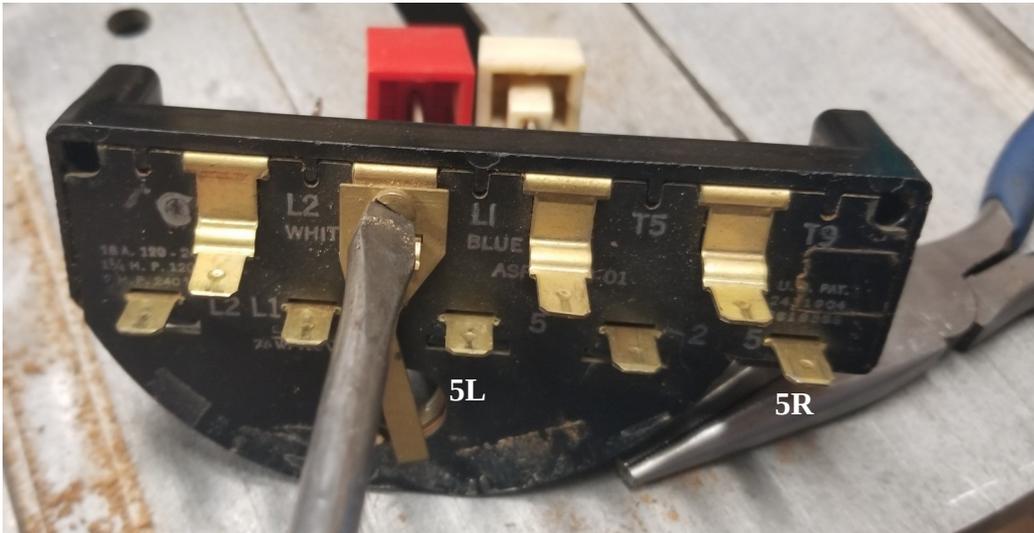
Open the headstock of the Mark VII to access the back of the switch. You'll see nine wire posts on the switch. There has been some documented variation in the wire colors, so it is wise to both photograph the wire positions and label them using masking tape. They are labeled "L2 White", "L1 Blue", "T5", "T9", "L2", "L1", "5", "2", "5". For clarity, the two connections labeled "5" I will refer to as "5R" and "5L" as shown in the photo below. After labeling and disconnecting the wires, remove the switch from the headstock.

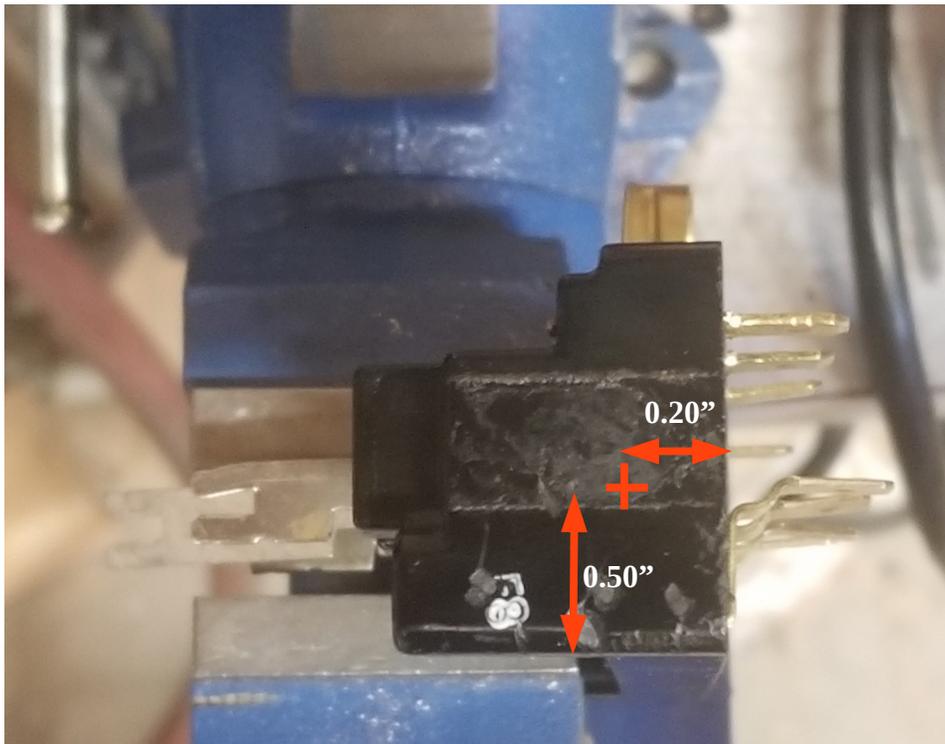
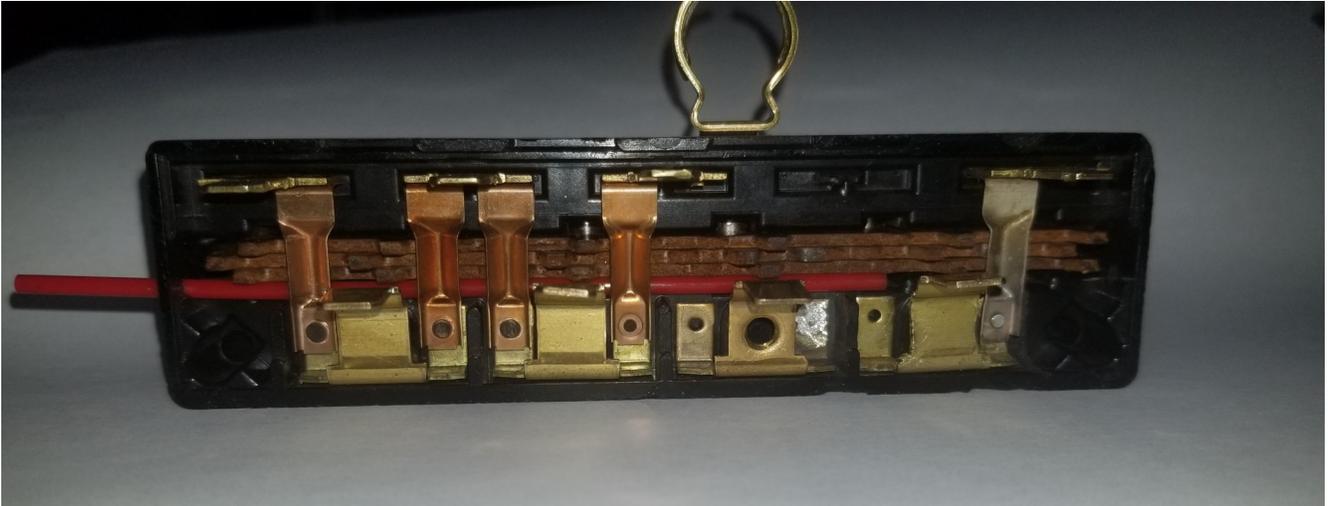
1) Using a 3/32" drill bit, gently and slowly drill a small hole into each side of the switch at the locations marked in the image below. Try to be as close to these measurements as possible. The closer you are, the easier it'll be. Again, be careful to only drill through the 1/8" case

These two holes will allow you to put the straw from a can of sensor safe electrical contact cleaner into the body of the switch. My straw measured  $\frac{11}{128}$ " in diameter and fit perfectly. The straw is guided on one side by the selector boards and on the other side by the inside of the case. It should not require any force to slide the straw into the case. If you encounter resistance, gently twist the straw in your fingers and it should free up. **Do not force the straw into the case as it may cause damage the contacts. It should slide in gently.**
