# Buying a Used Shopsmith Mark V - Revised and Annotated 2015

*A checklist to help you find the bargains and avoid the basket cases*

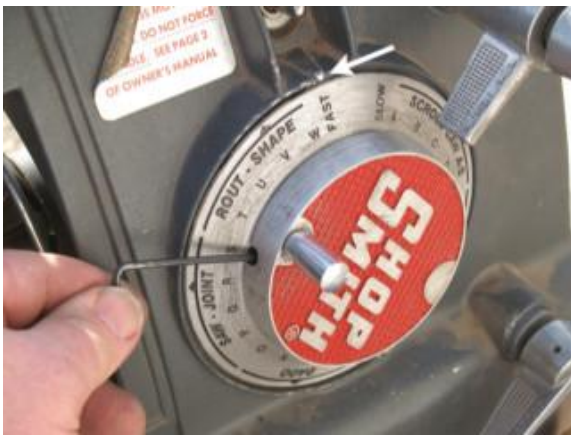
**Speed Changer set to Fast** – Photo credits - Nick Engler post #1321

As you turn the **speed changer**, the sheaves on one shaft (**Control Sheave on the Idler Shaft**) get closer together and the sheaves on the other (**Motor's Floating Sheave on Motor Shaft**) get further apart.

This changes the speeds at which all three of the power take-offs or **arbors** turn – one at the end of the quill at the front of the headstock and two at the back. The **quill** extends and retracts from the headstock, like the quill of a drill press. Additionally, there is a **switch** to turn the motor off and on, and a **headstock lock** to secure it in position on the tubular frame.

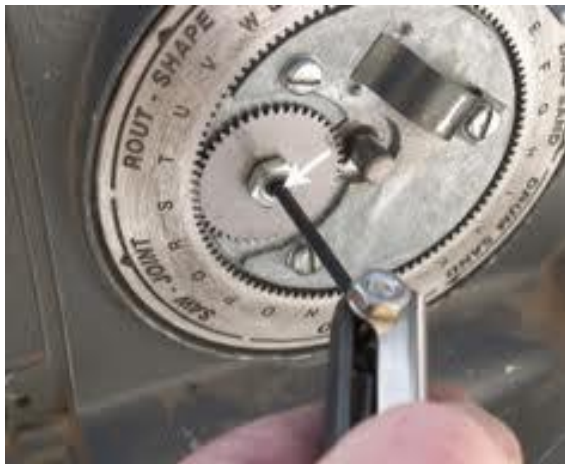
**Speed Changer Mechanism** – Photo credits - Nick Engler post #1321

After removing the control dial with an Allen wrench as shown in the photo above, Nick exposed the mechanism that drives a worm gear in the Headstock that moves the Quadrant. The Quadrant is a 'Pork Chop' shaped threaded arm that moves the Control Sheave described previously which sets the speed of the machine.

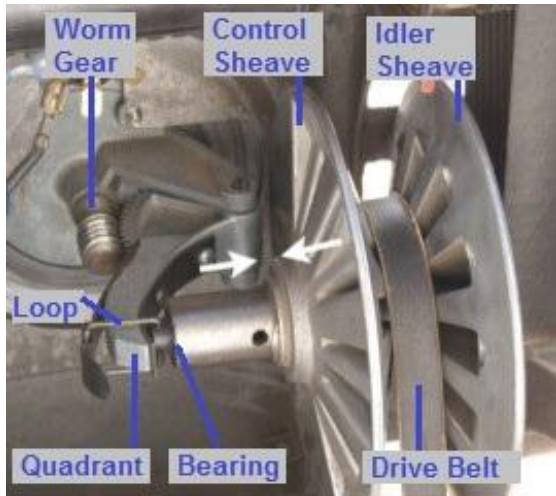
Quadrant – Photo credits - *Nick Engler post #1321*

You can see the Worm Gear that is rotated by the Speed Control Dial on the front of the Headstock connects to the Quadrant (Pork Chop).

As shown, this is in High Speed setting: Idler Sheave on the Right - Control Sheave on the left, separated, setting the 'effective' diameter of the 'variable pulley' to its smallest setting by pulling the Loop secured to the Button protruding from the Control Sheave. *The Button face at the Quadrant and visible Oil Hole will need routine lubrication.*

Imagine if you will, now rotating the speed control dial without the belt rotating. Quadrant would fail to move the now stationary sheaves. Speed Control mechanism's gearing provides extensive mechanical advantage, continuing to force the Worm Gear to try to move the Quadrant right, along the plane of the white arrows.

Even though the Quadrant is exerting tremendous force, there is no place for the Drive Belt to move as the Floating Sheave and Fan Sheave on the motor below are fully together with the Drive belt on the outermost radius of the two sheaves as seen previously in Dusty's photos. The Drive Belt is fully tensioned at all times and it is not going to stretch.

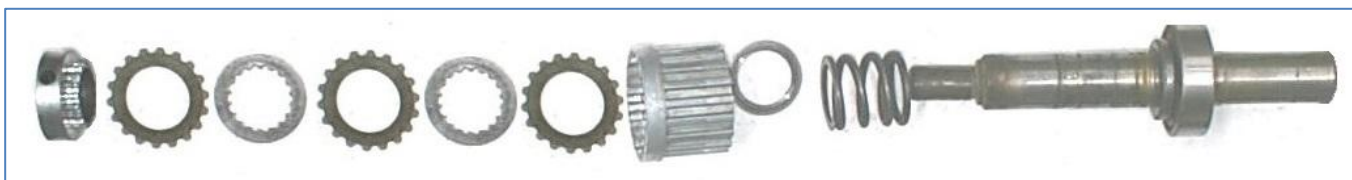
Clutch above is really a collection of edited and combined photos. *Source Photo credits 'mickyd' – post #32872*

The earlier Gilmer Drive Sleeve Assembly above has an internal mechanism (clutch assembly) designed to provide consistent drive to the Quill and output shafts for an accessory, but it is designed to slip if the torque required exceeds a pre-set safety threshold.

Without proper maintenance and adjustment, any condition such as a saw blade binding could cause the clutch not to disengage and damage internal parts of the Headstock. This occurs as even though output shaft is seized, the Gilmer drive belt continued to drive against it and caused damage. Poly-V replaced these in 1960.

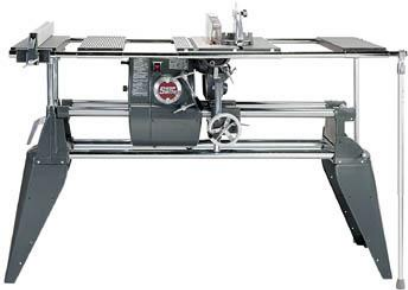
1984 saw the introduction of the 2 bearing Quill that had bearings both in the front and toward the rear of the metal sleeve housing the main shaft. It provided more rotational stability for drilling, boring or turning large objects on faceplates where the material is held only on the end of the spindle while turning. This run-out only measured in a few thousandths of an inch with one bearing and was reduced even further with two.

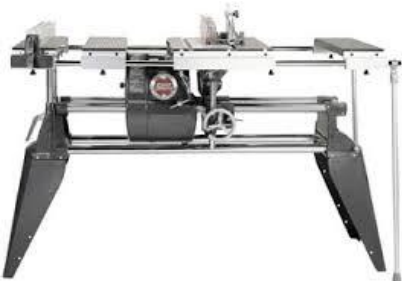
1991 introduced Headstock revision "C" which housed the new square Red Safety Key Switch.

The change necessitated a square hole in the Headstock where a round hole for a toggle switch had been since the Mark V introduction in 1953 with the 'Greenies' in Headstocks 'A & B'.
