102-1 Headstock for S/N 1077, Note the Pin for the Quill Return Spring Housing and not cast on blocks. The Spring Housing (102-11) is Aluminum. The Pinion Shaft (102-10) is different and does not have flat spots on the end for the Feed Lever Knobs set screws.

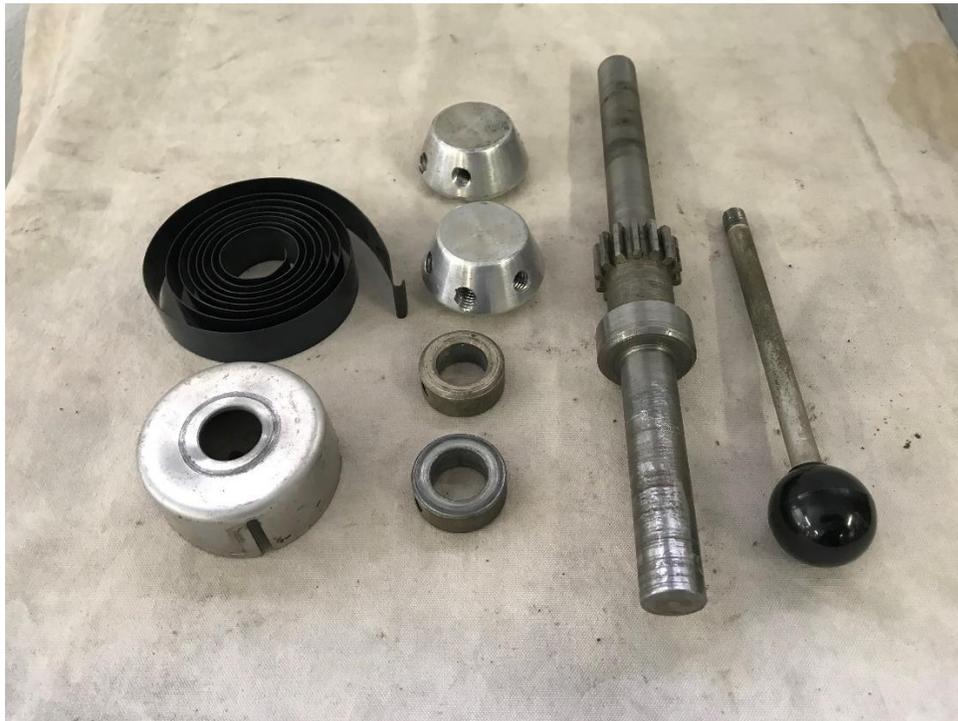
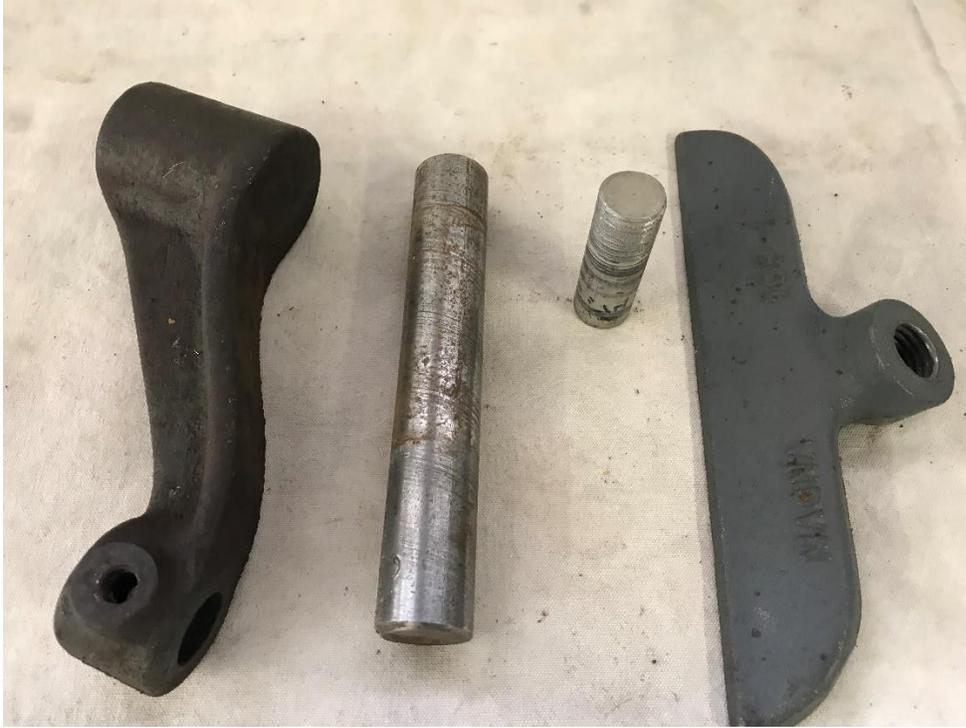
The Lathe Tool Rest has a screw in post and the arm is the same as later 10E's with a plain post
The Extension Table bracket (104-6) and pins (109-2) with wing nuts (109-3) are the same. The Top Bar (109-4) is the thickness of the Fence Bar and has three extra small holes. This could be a replacement.

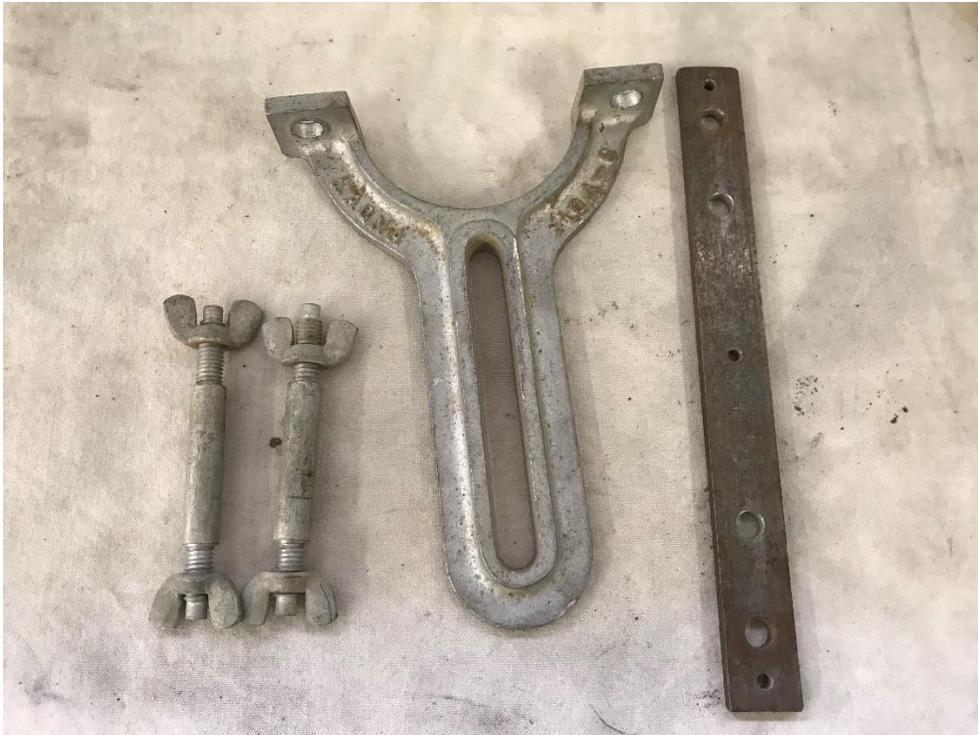
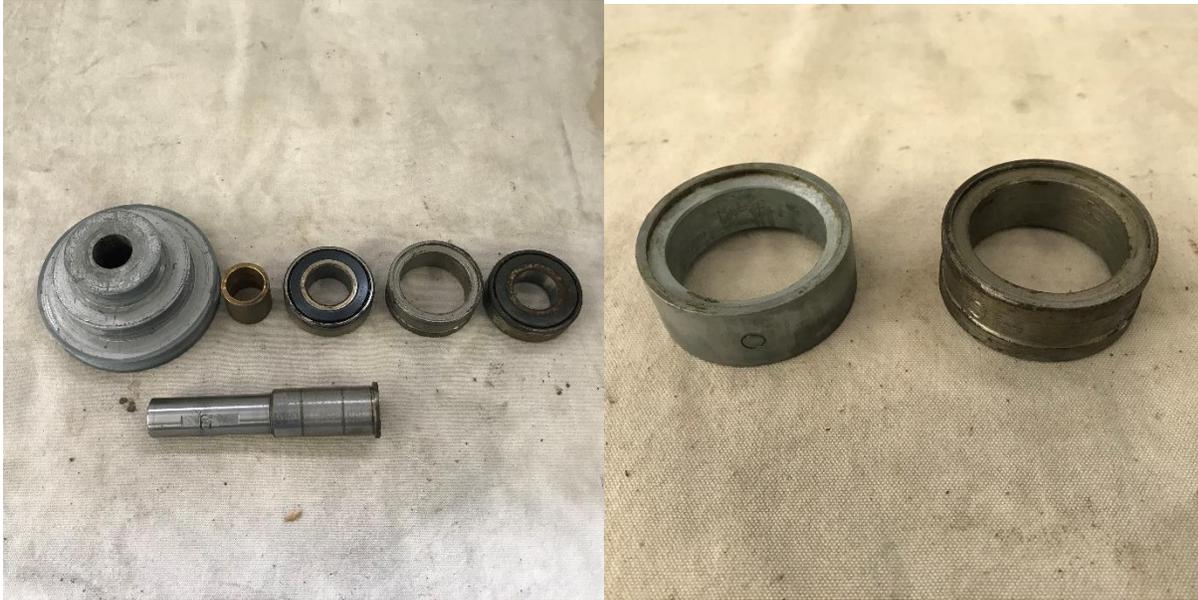
The Drive Sleeve Assembly (above left picture) has a brass spacer sleeve that was between the bearing and pulley. This kept the pulley near the end of the Drive Shaft (102-15). This may have been added by the user. In the right picture above the Spacer Ring (102-19) is steel (right) shown next to a regular non-ferrous one (left).

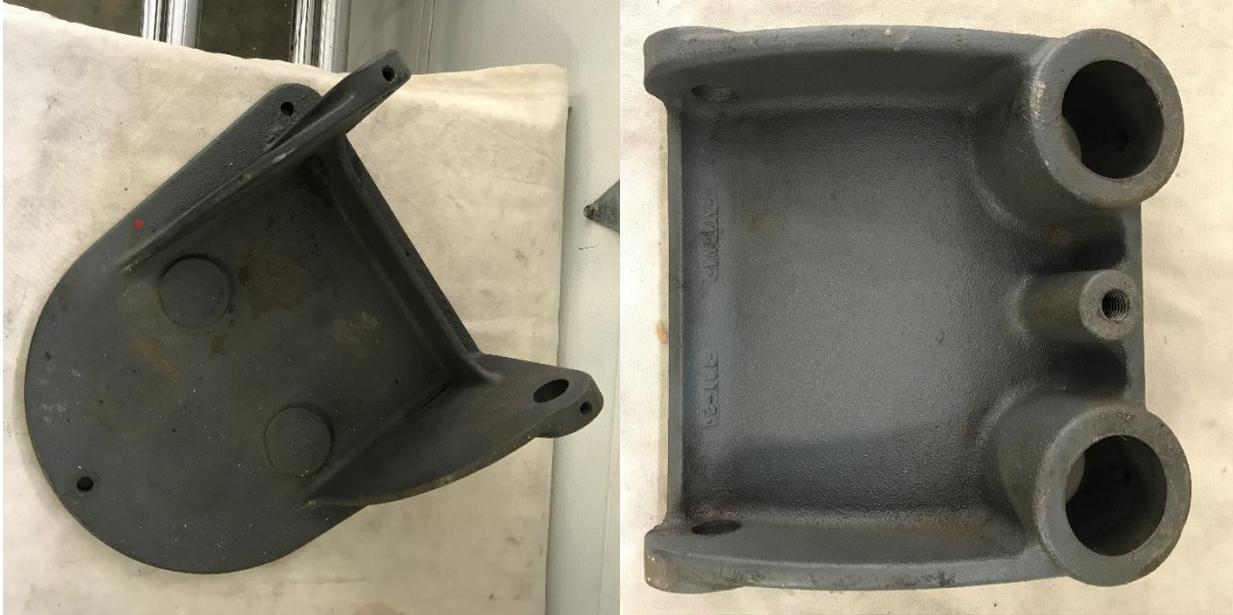
The Baseplate 101-1

The following parts appear to be the same as later 10E's including the tubes not pictured.

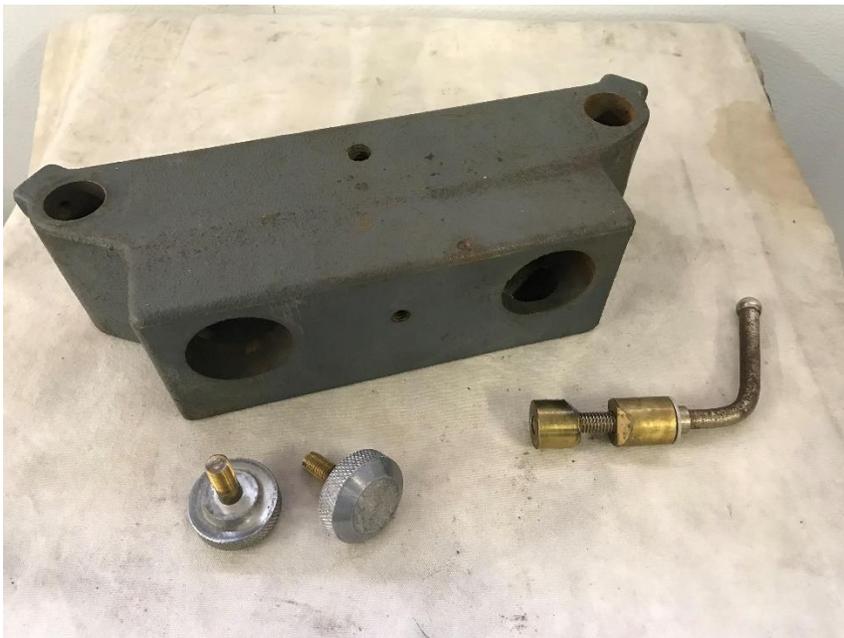
Carriage 103-2 with Carriage Knobs 103-25 & 103-26 and Carriage Lever 103-24 plus Wedges & Washer.
