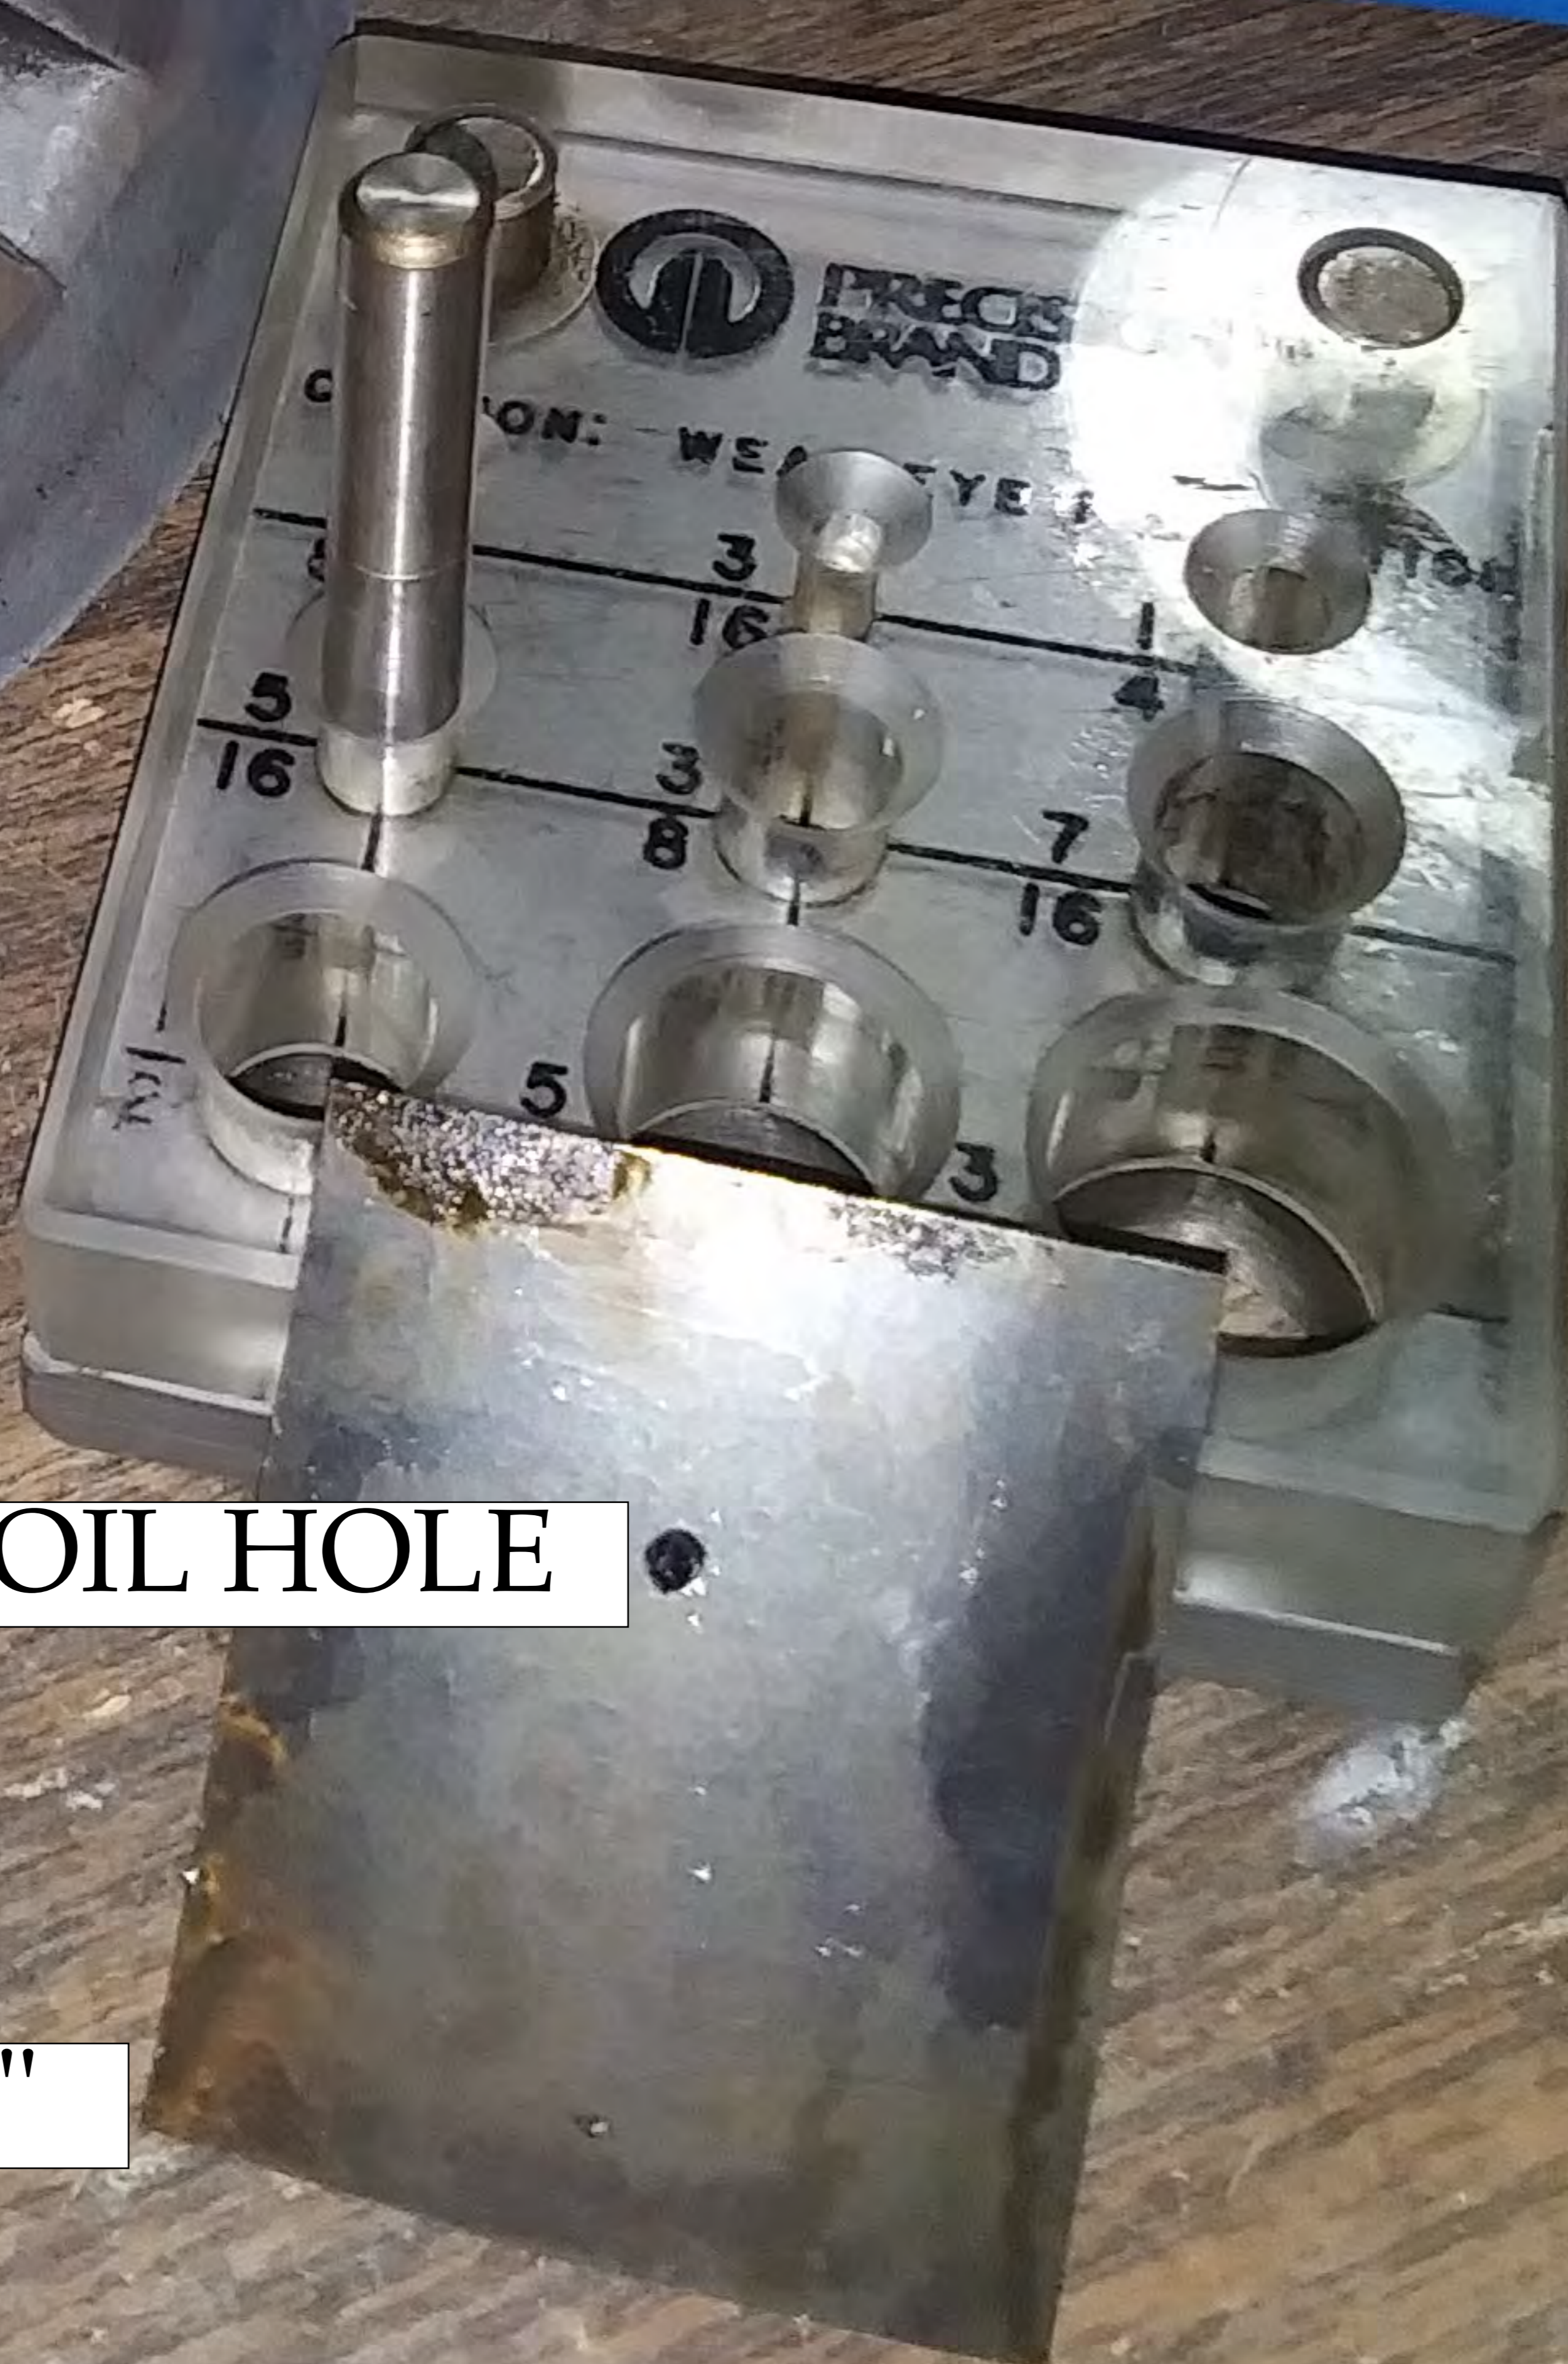
OIL HOLE

SST SHIM, .002"

ROLL THE SHIM  
INTO THE BORE

ADDED THE BILL MAYO HINGE  
UPGRADE + SHIM WASHERS TO  
TAKE UP AXIAL SLOP.

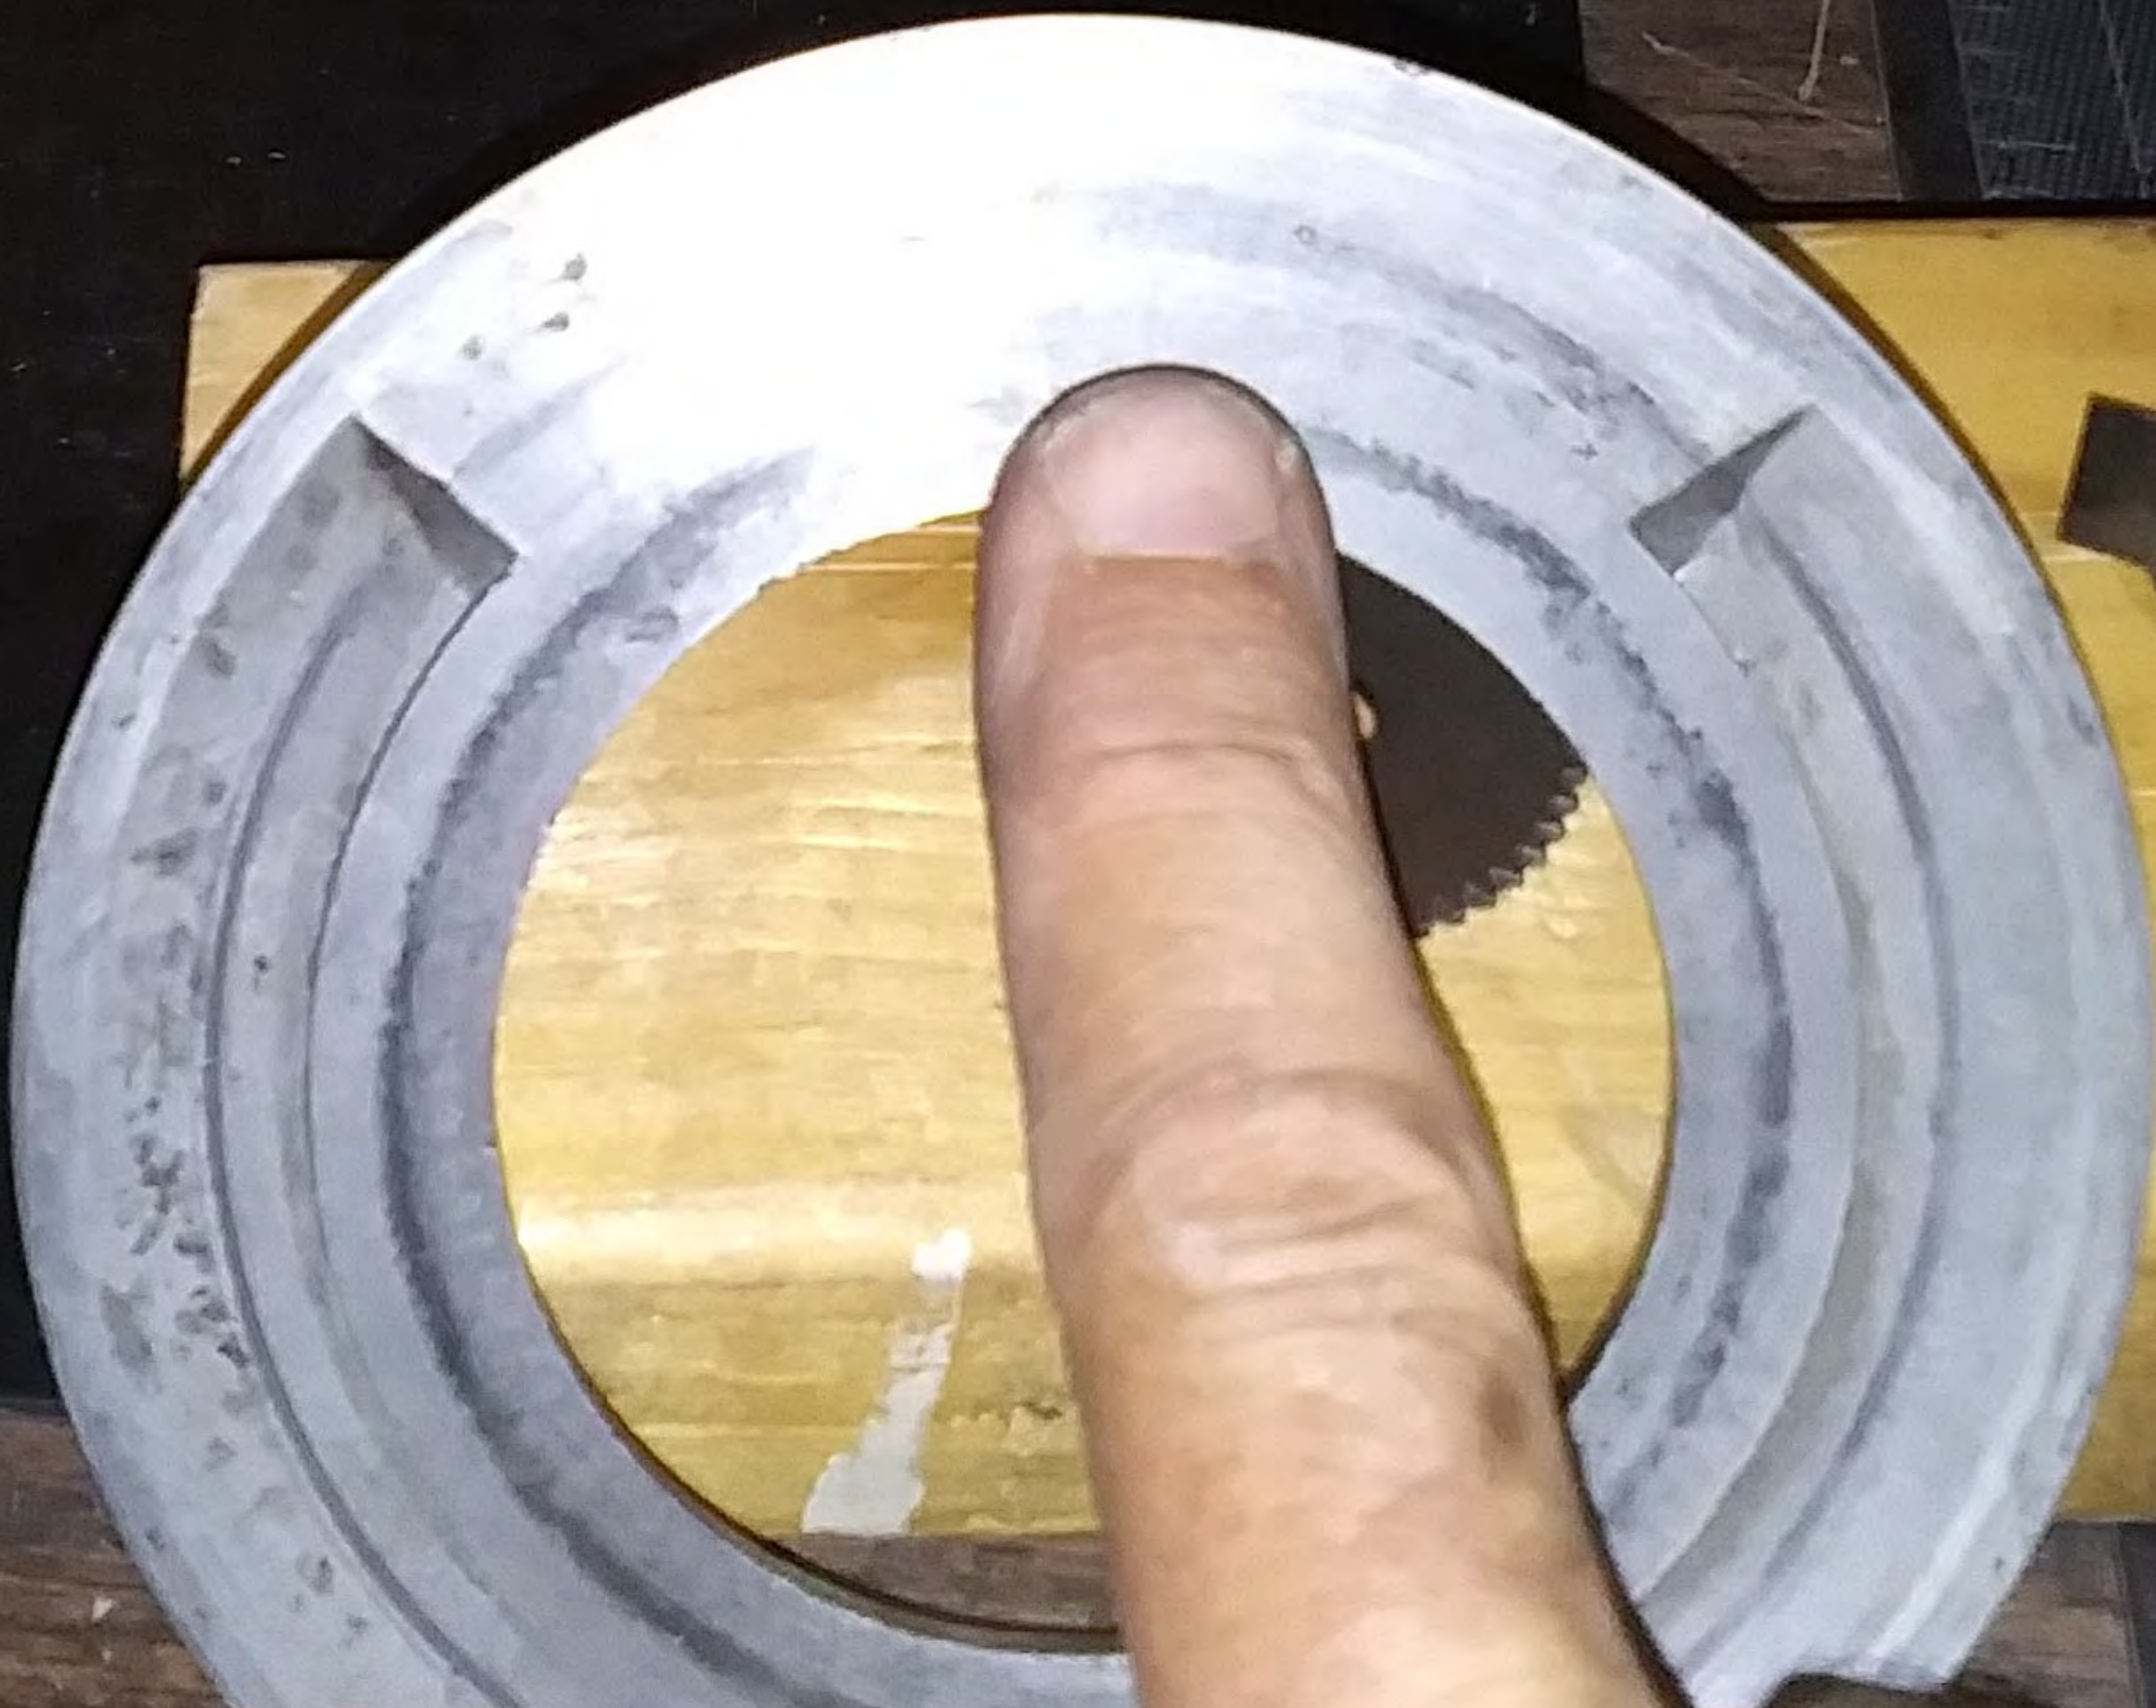
REAR VIEW OF SPEED CONTROL DIAL.  
THIS FEATURE BLOCKS ACCESS TO  
SPEEDS ABOVE "R" - WHEN WAS THIS  
INTRODUCED?
